2024-05-01

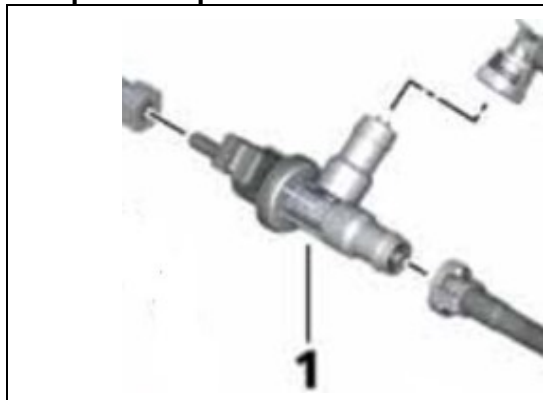
For the eligible vehicles and for the issue described below, BMW of North America, LLC (BMW NA) is extending the limited warranty for the vehicle's **Evaporative Emission Control (EVAP) System's Purge Valve** to:

Over time, the EVAP system's vent (purge) valve may develop material and operational issues, this can cause hard starting, and a rough running engine, especially at idling.

There could also be an audible metallic noise emanating internally from the purge valve.

If a vehicle listed above arrives at your center with the issue described in this Service Information Bulletin, perform the corresponding diagnosis and when applicable, replace the EVAP system's vent (purge) valve as instructed or as determined by the diagnosis.
