## 167 Check Washer Fluid Level Message in IC -- Washer Fluid Leaking at Reservoir Connection

Topic number	LI82.35-P-077796
Version	1
Function group	82.35 - Windshield washing system
Date	5/16/24
Validity	167 produced on or after Jan. 1, 2023
Reason for change

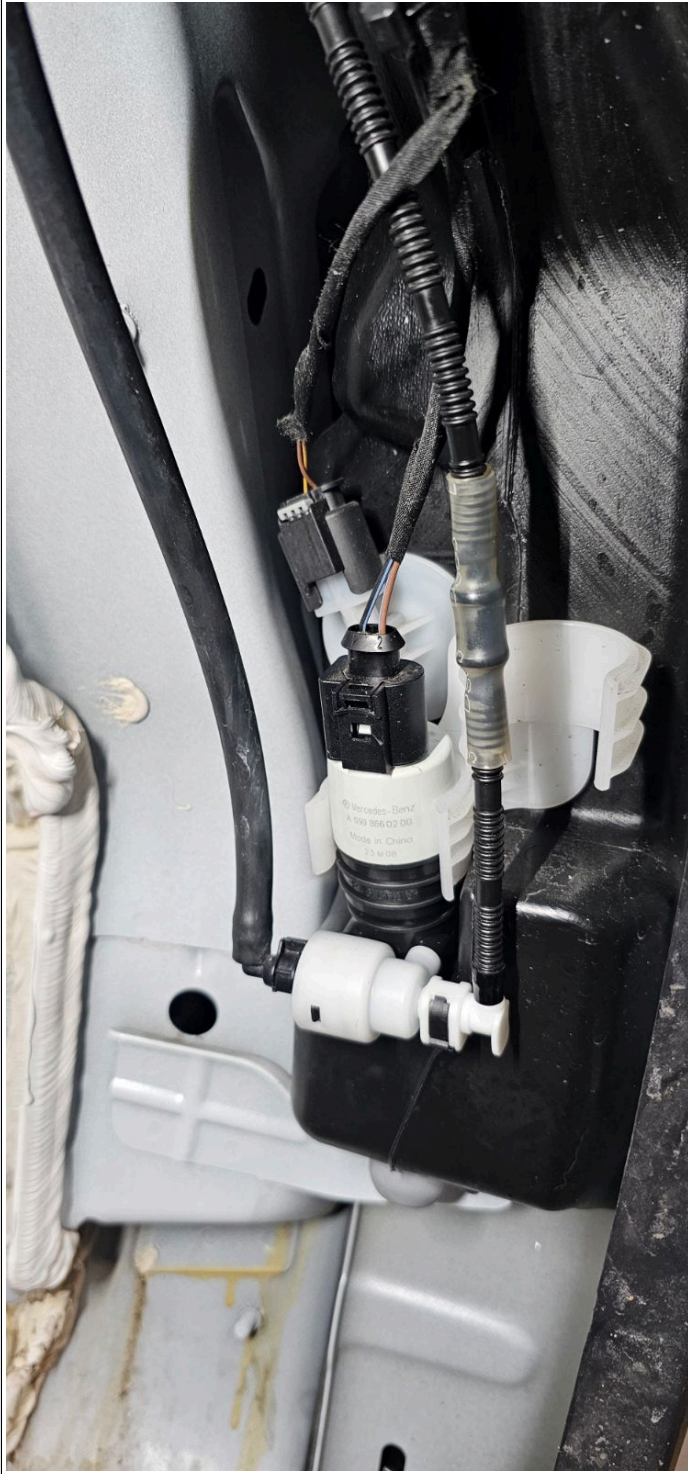
O-ring missing or damaged inside hose connector

Attachments	
File	Description
<a href="#">washer line repair instructions 1.0.docx</a>	Washer Line Repair Instructions
<a href="#">Repaired_connection.jpg</a>	Repaired Connection - Final

Follow repair instructions to repair washer line.
