SIB 16 01 24

SERVICE ACTION: R 12 nine T Fuel Contamination

2024-05-30

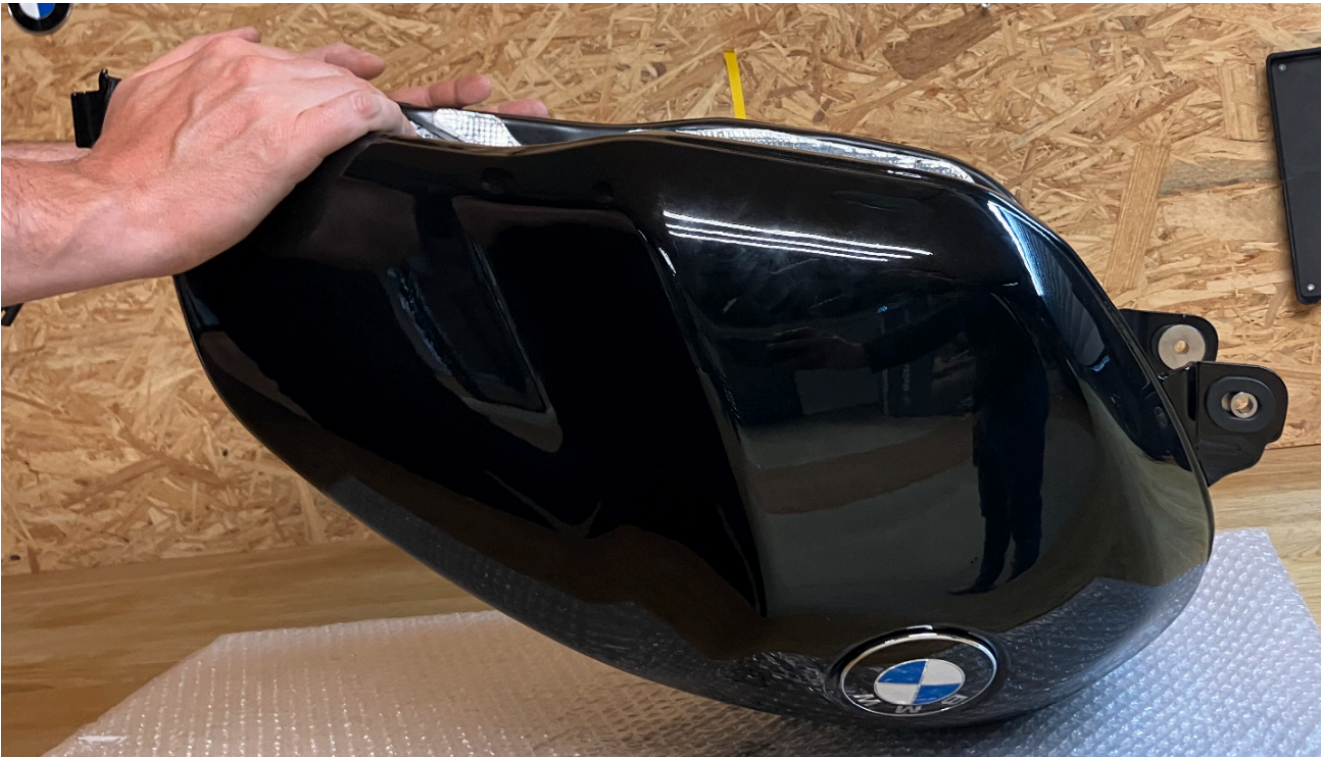
3. Rotate and move the fuel tank in all direction so that the fuel reaches and cleans all areas of the interior of the tank.
4. Place the tank upside-down on a suitable surface with protection against scratching the tank.
5. Remove the fuel pump flange and hang it sideways, then bring the tank into a raised position shown in the pictures below.

Note: the fuel pump does not have to be released and doesn't have to be completely removed.

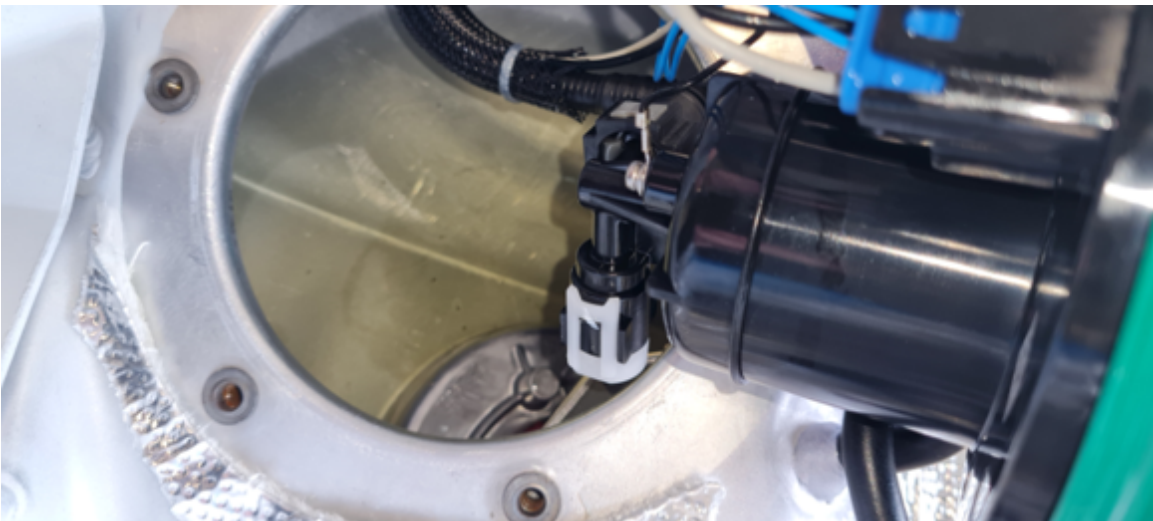
6. Vacuum (with a suitable tool e.g Mityvac) the fuel completely and wipe out the remaining residue with a clean lint free cloth.

7. Add up to 9 fluid oz (1 liter) of new clean fuel.
8. Rotate and move the fuel tank in all direction so that the fuel reaches and cleans all areas of the interior of the tank.
9. Vacuum (with a suitable tool e.g Mityvac) the fuel completely and wipe out the remaining residue with a clean lint free cloth.
10. Reinstall the fuel pump, replace the fuel pump flange seal if damaged. If not damaged the seal can be reused.
11. Reinstall the fuel tank.
12. Fill the fuel tank **full** with new clean fuel.
