Red display in Charging status indicator

Topic number	LI47.70-P-077900
Version	1
Function group	47.70 - Powertrain energy supply
Date	5/29/24
Validity	206,223,254 and 214 Plug-in Hybrid vehicles
Reason for change

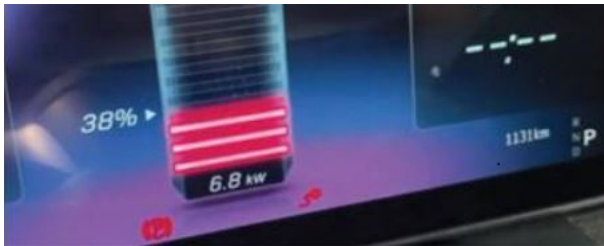
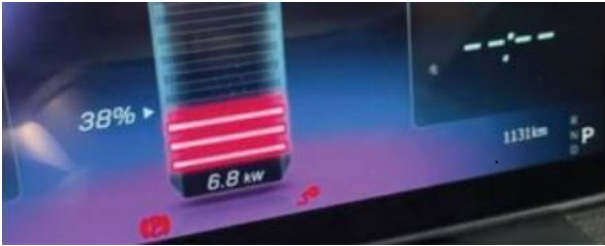
File	Description
Ausschnitt .PNG

- Red display in the Charging indicator status in MBUX during AC Charging.
- Error message in Mercedes Me App.
- Fault code P0E5F97 exists in N83 (AC charger for high-voltage battery (SG-LG))

The message/indicator status appears when the vehicle is parked outside, under direct sunlight or in higher temperature regions.

- Not an error. Vehicle charging continues and does not abort. Charging power might be reduced temporarily until the temperature comes within threshold.

- Do not replace any components.
- Please inform the customer: Park the vehicle in the shade during charging where the outside temperature is lower.
