| RE: <b>Service Campaign Launch Notification</b><br><b>Check Front Diffuser Attachment Point Seal</b><br><b>MY21 GT Black Series (190 platform)</b> | DATE: April 28, 2023 |

Campaign No. 2023030016, April 2023

## **Check Front Diffuser Attachment Point Seal**

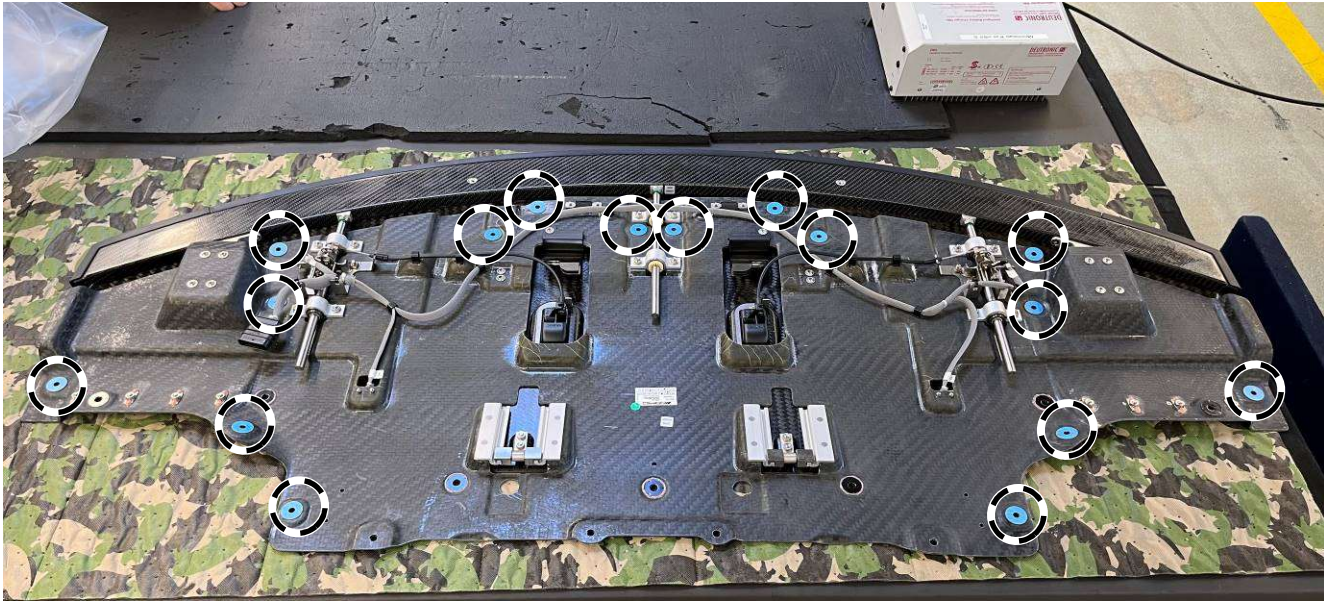
Figure 5

1. Check the removed front diffuser to see whether all 16 (blue aramid pads) are affixed to the marked locations (Figure 5).

- a. All 16 (aramid pads) are **present** (Figure 5): Carry out **Work Procedure B**.
- b. All 16 (aramid pads) are **not present** (Figures 11 and 12): Perform **Work Procedures B and C**.

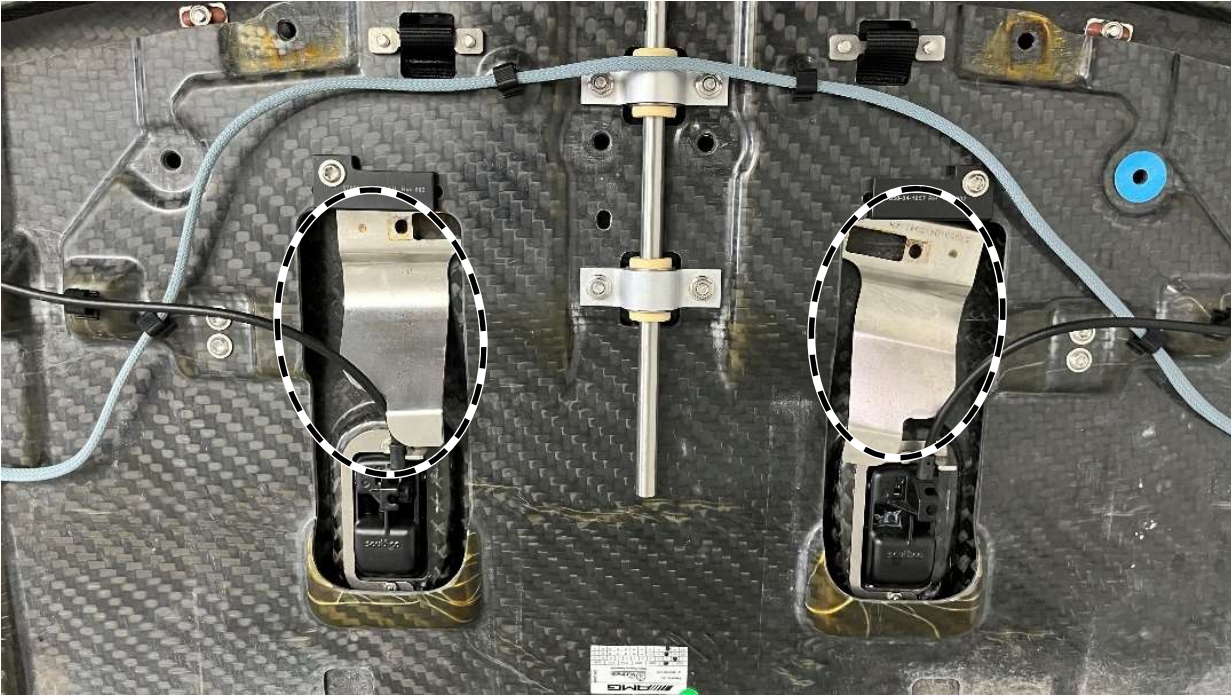
Figure 9

4. Disassemble both spring elements (Figure 9).

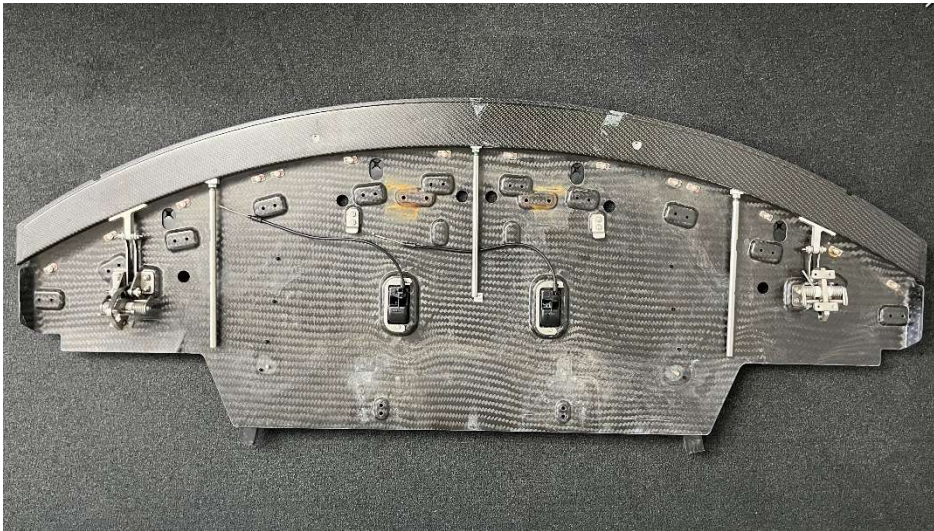
Figure 11

6. Carefully pull apart front diffuser upper and lower parts (Figure 11).

7. Reassemble new part in reverse order.
8. Reinstall front diffuser.

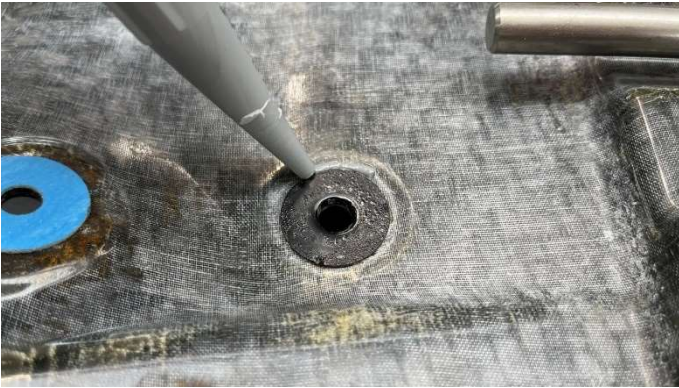
2. Fill all 5 attachment points around the decoupling disks with Teroson bead (Figures 13 and 14).

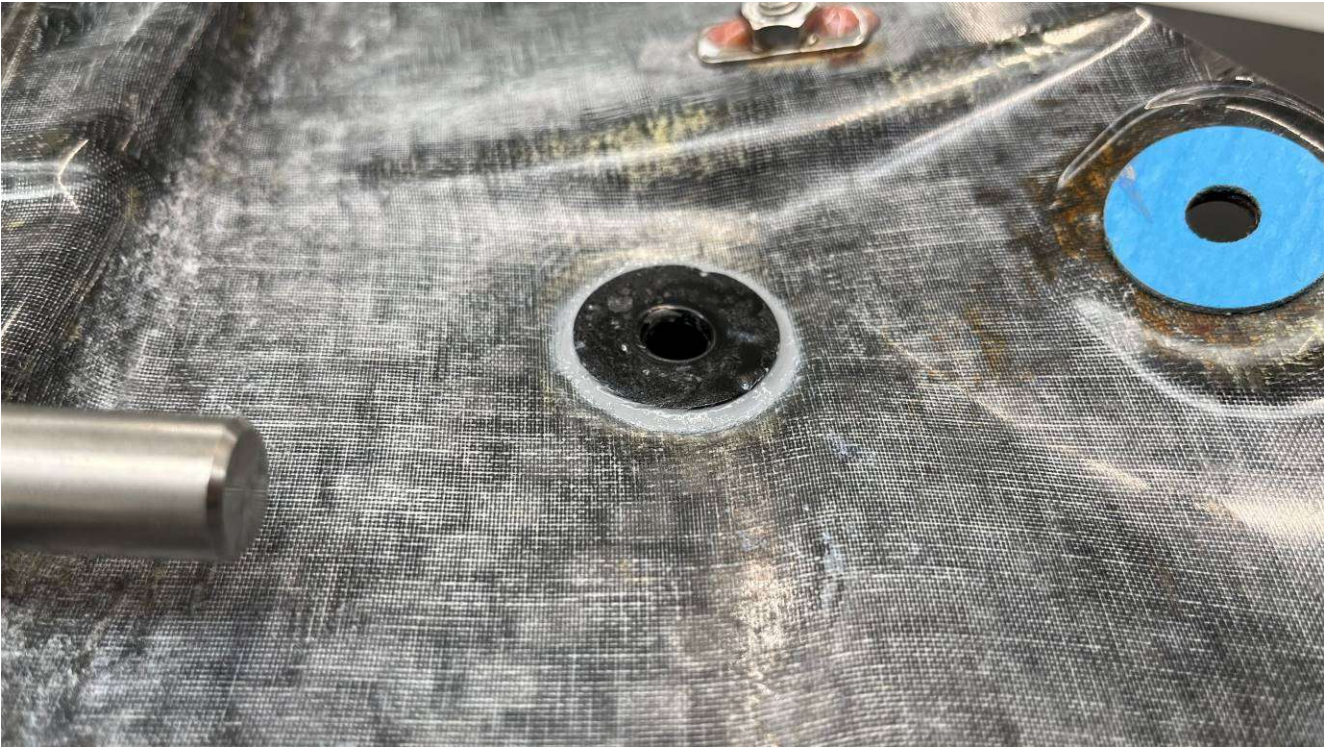
**Figure 15**

3. Spread/remove Teroson bead to/from surface of decoupling disk (Figure 15).

- i** Teroson bead may ***not protrude by more than 1.5 mm*** beyond the disk.
- i** Ensure there is no Teroson on the screw-on surface, clean if necessary.
- i** Allow Teroson to cure according to the specification.

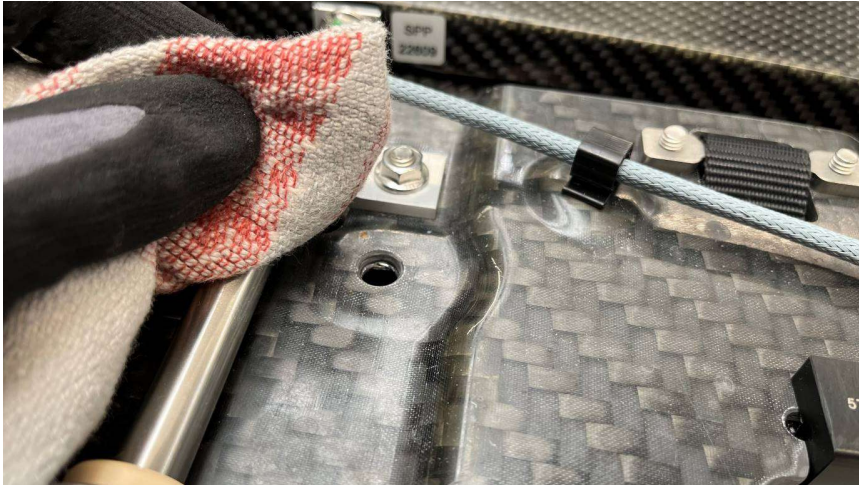
1. Clean 16 marked attachment points (Figure 16) of front diffuser with isopropanol and allow to dry (Figure 17)

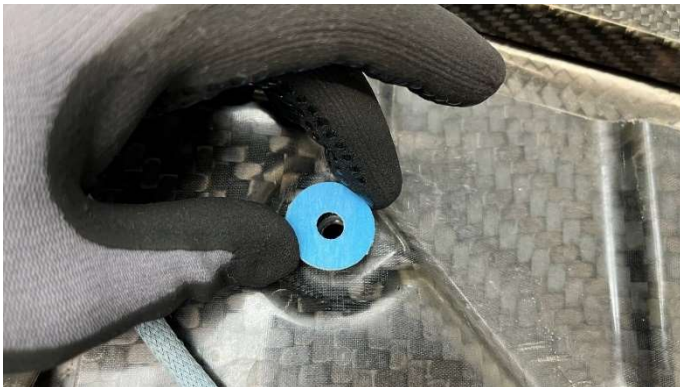
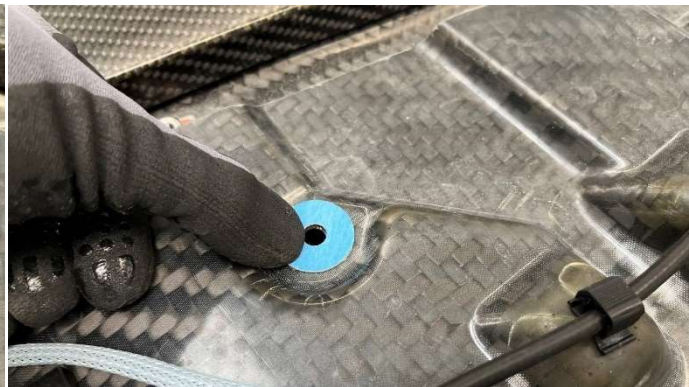
2. Affix the self-adhesive aramid pads as centrally as possible on all 16 dried attachment points and press on all round with your thumb (Figure 18 and 19).
