Technical product information

Topic	Coolant pump leaking (part number 07P 121 008B) - Low coolant warning - Engine overheating - DTC's evident
Market area	Bentley: worldwide (2WBE)
Brand	Bentley
Transaction No.	2071238/2
Level	EH
Status	Approval
Release date

W12 Bentayga - New Continental GT/GTC - New Flying Spur

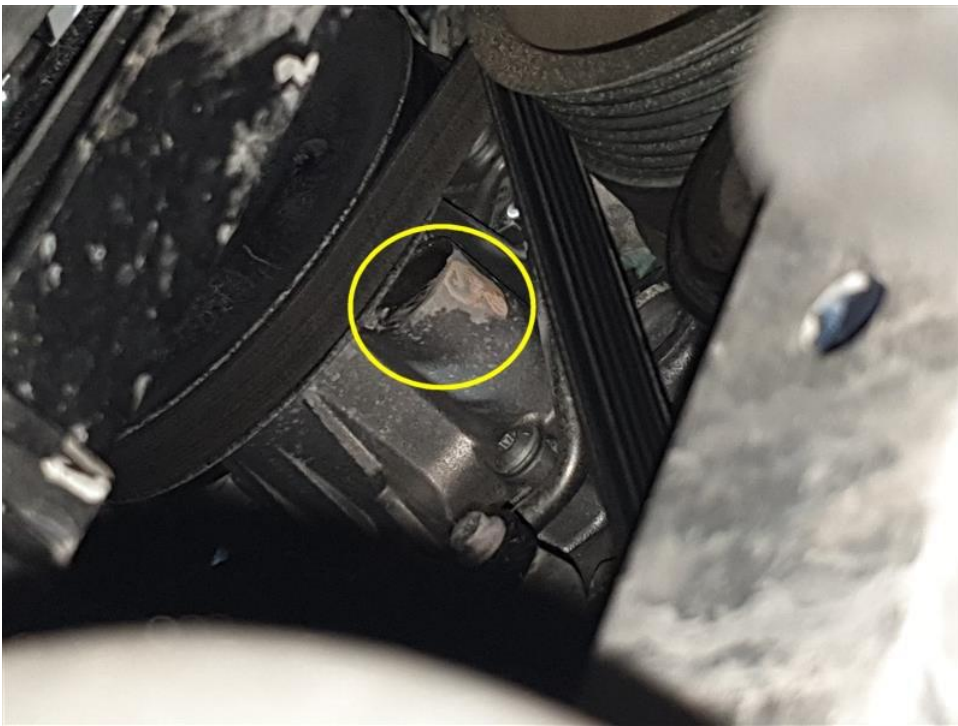
Figure 1

- Refer to the video located within the Bentley Hub reference TPI 2071238/- the video shows an example of a coolant pump with no leak although a small coolant witness mark is evident (Figure 1) in this scenario the coolant witness mark should be cleaned off (using a suitable cleaning agent) to the condition shown in Figure 2
