Technical product information

Topic	Coolant pump leaking (part number 07P 121 008C) - Low coolant warning - Engine overheating - DTC's evident
Market area	Bentley: worldwide (2WBE)
Brand	Bentley
Transaction No.	2071239/2
Level	EH
Status	Approval
Release date

W12 Bentayga - New Continental GT/GTC - New Flying Spur

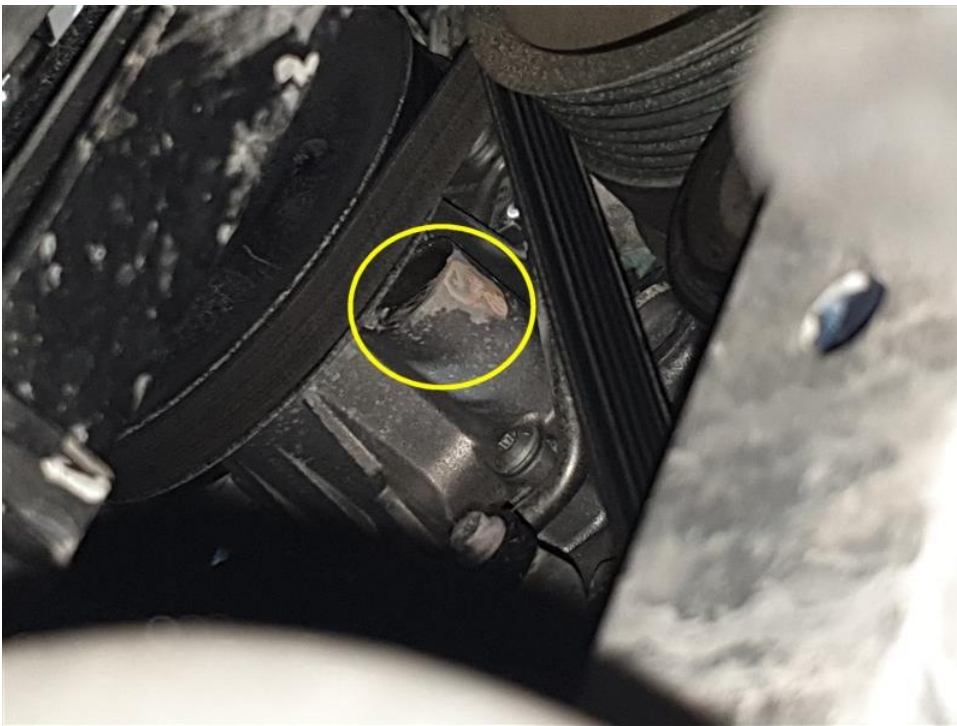
Figure 1

- Refer to the video located within the Bentley Hub reference TPI 2071238/- the video shows an example of a coolant pump with no leak although a small coolant witness mark is evident (Figure 1) in this scenario the coolant witness mark should be cleaned off (using a suitable cleaning agent) to the condition shown in Figure 2

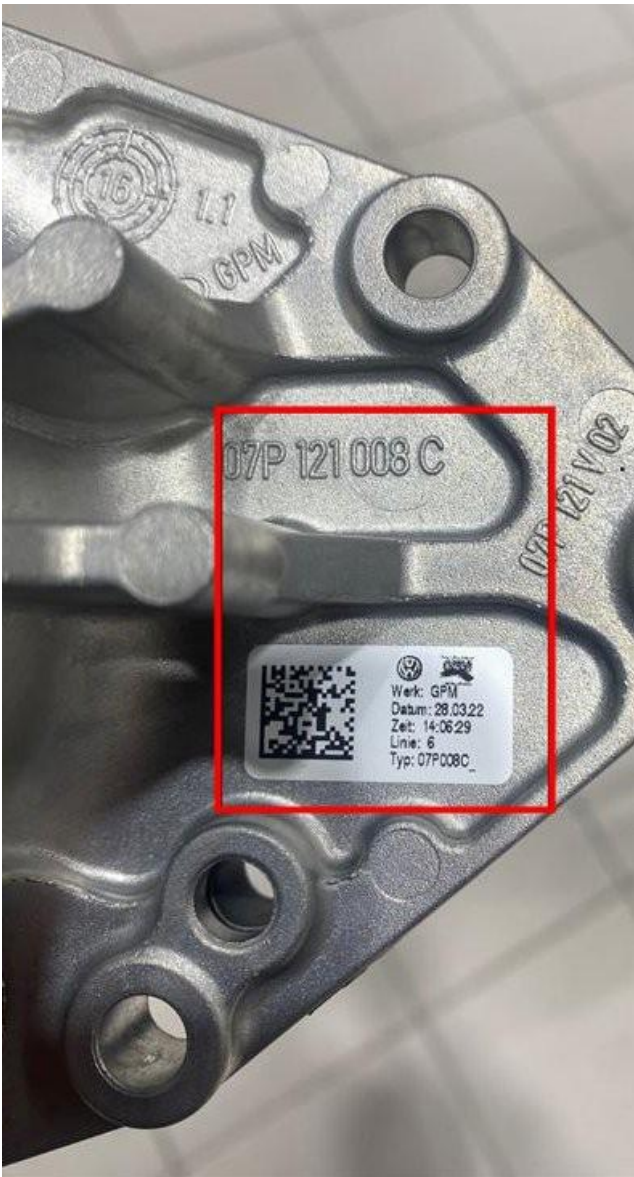
- Clear photo of the coolant level
- Clear photo of the original mechanical coolant pump part number **07P 121 008C** (Figure 4)
- Video of the coolant leak whilst carrying out the pressure test
- Current ODIS log
- Await feedback via DISS before replacing any parts

NOTE: The photo shown in Figure 4 is a C level coolant pump (shown removed from the vehicle for photographic purposes) a borescope may have to be used for photographs of the coolant pump when fitted

6) Once permission has been given via the technical DISS query, replace the following

- Mechanical coolant pump - Rep.Gr 19
- Solenoid for coolant circuit N492 assembly - Rep.Gr 19
