# E316: PACCAR MX-13 EPA21 Main Bearing Cap Bolts

E316

5/20/2024

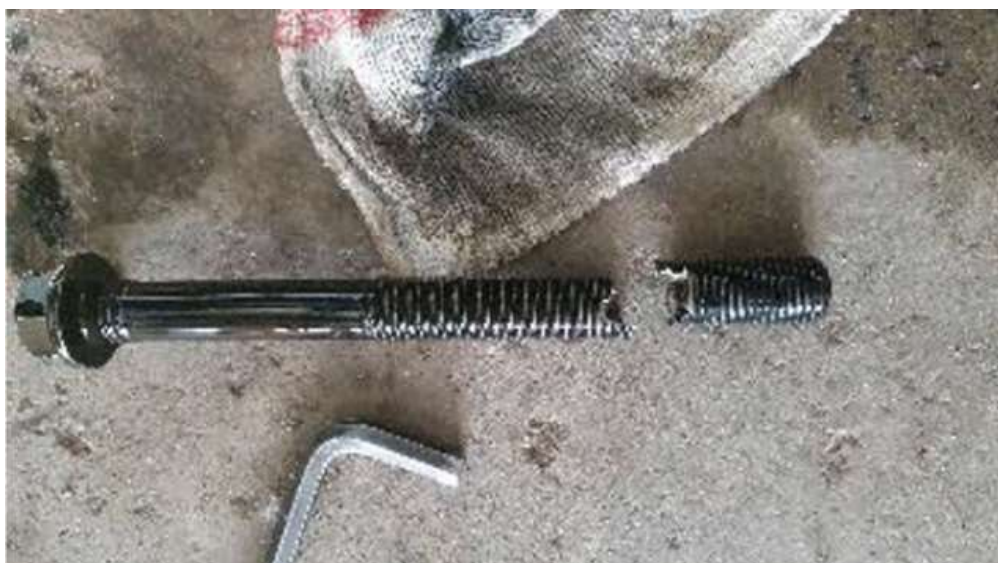
Certain PACCAR MX-13 engines contain bolts for the main bearing caps which may fail under certain conditions.

Dealers will remove and replace all main bearing cap bolts on affected trucks. PACCAR will proactively contact customers with chassis identified in this campaign.
