## SERVICE BULLETIN

**NUMBER:** 16-112-18R

**SUBJECT:** Ignition Key Sticking / Design Change to CVT Shifter / Selector Lever Components

This bulletin announces a design change to the CVT select lever (shifter) mechanism in response to isolated customer concerns of not being able to remove the key from the ignition switch when the vehicle is in Park. The cause is contamination of the Park-Range switch internal components.

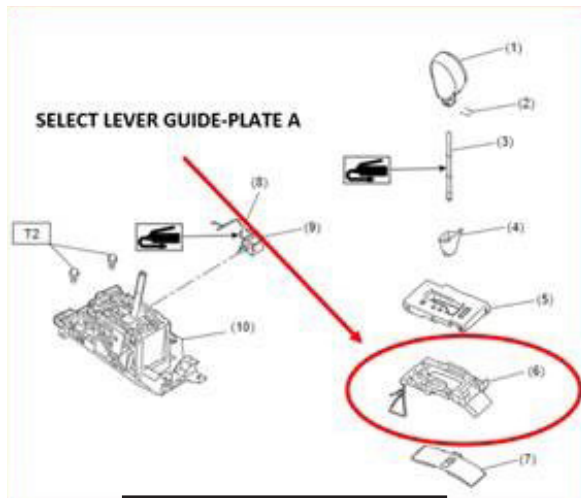
**For Legacy and Outback:**

- The term PLATE-GUIDE B refers to the Park-Range switch which is a serviceable part of the select lever assembly on all models listed above **EXCEPT** Legacy and Outback. See the illustrations provided below for more details.
- For **Legacy and Outback**, the guide plate (GUIDE-PLATE A) must be replaced if the Park-Range switch is found to be faulty.

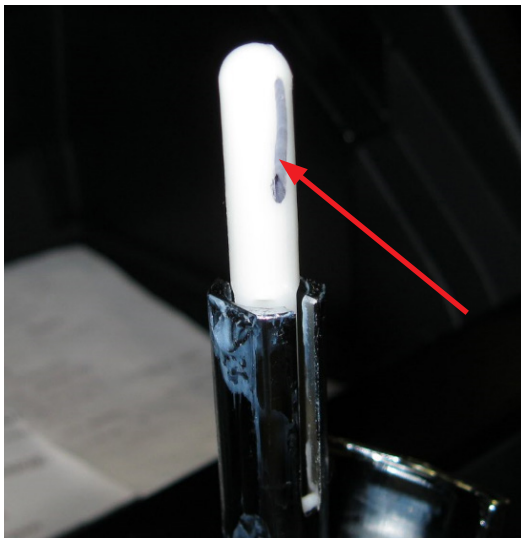
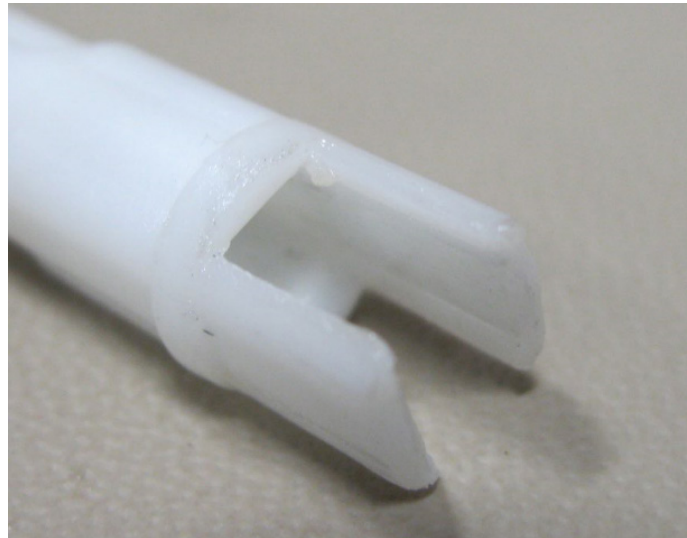
**IMPORTANT TIP:** After removing the shift knob there will be a white plastic rod / plunger protruding from the top of the chrome lever. Use a permanent marker and mark its position as shown in the photo so it can be put back in the same place during reassembly. The bottom end has a notch in it which **must** be in the correct position for proper operation of the mechanism.

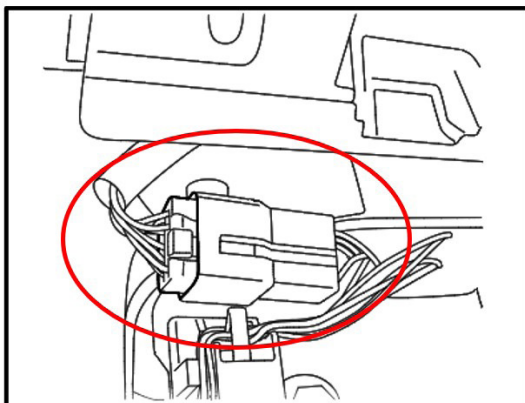
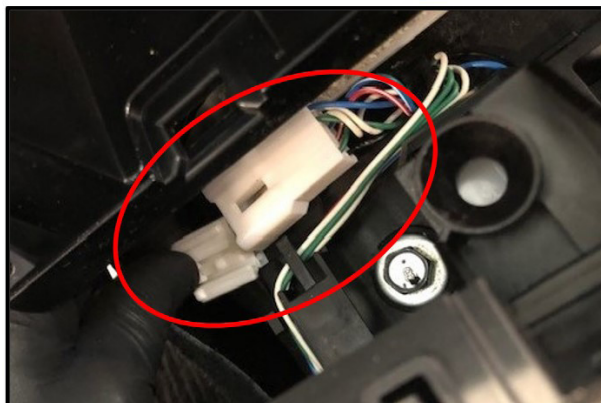
- STEP 3)** Disconnect the harness connector from the gear selector lever.

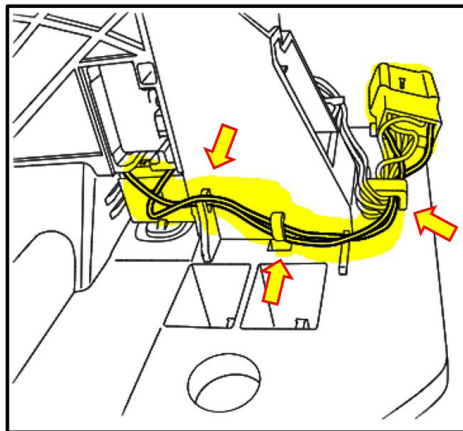
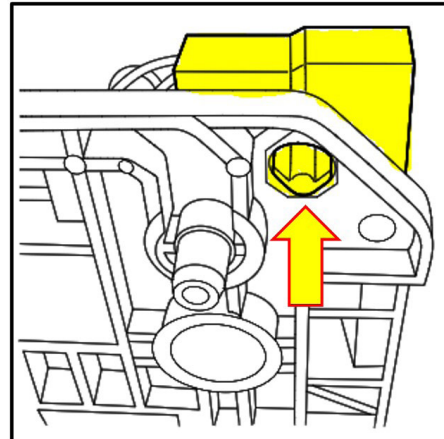
**STEP 4)** Using a plastic trim tool, **CAREFULLY** release the connector mounting tab from the gear selector lever housing. Remove the harness from wiring security loops located on the gear selector lever shown below.

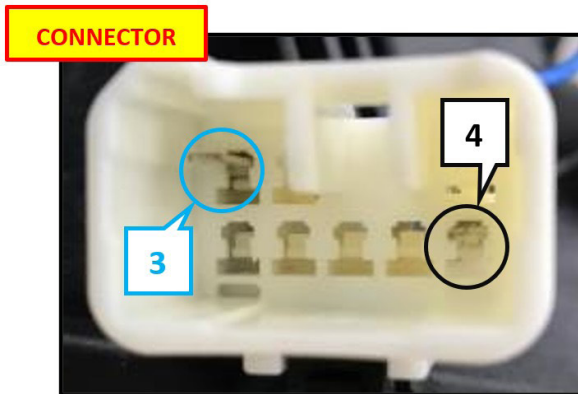
**STEP 5)** **CAREFULLY** release the terminals #3 and #4 of the solenoid unit connector. Insert a suitable terminal removal tool from Snap-on® tool kit #SGTT110 or a flat-blade screwdriver (with a tip width of 1.3mm (0.05in) or less) into the connector and disengage the terminal holding tab while slightly pulling the wires from the connector.

TERMINAL #3 – **BLUE WIRE**  
 TERMINAL #4 – **BLACK WIRE**

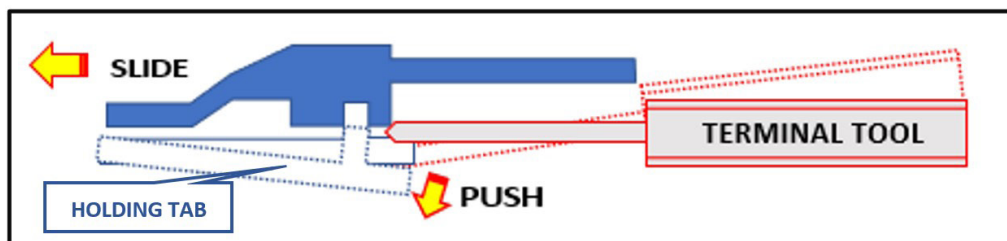
**IMPORTANT NOTE:** Terminal removal shown below.

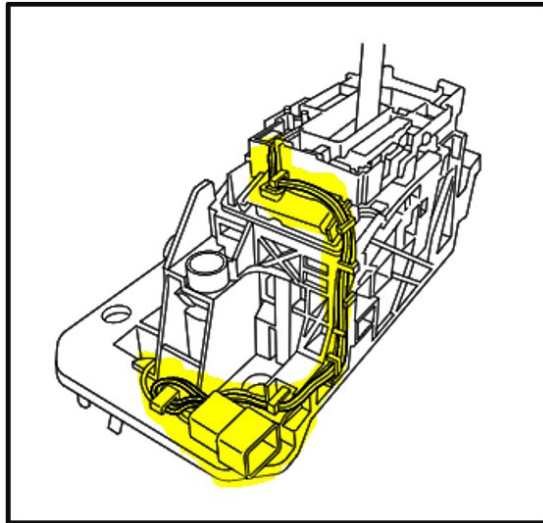
**STEP 6)** Release the harness from wiring security loops located on the gear selector lever shown below.

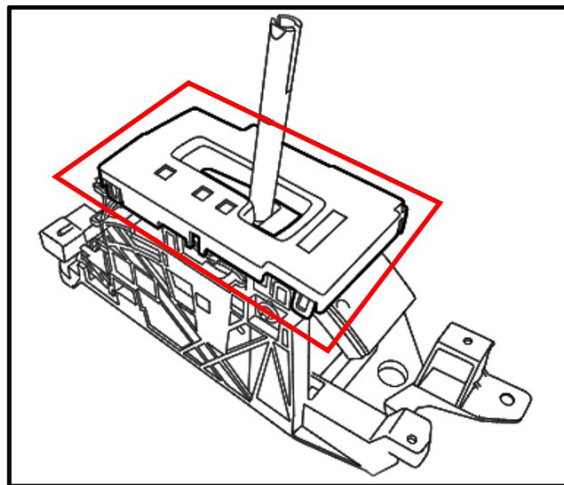
**STEP 7)** **CAREFULLY** remove the indicator cover by releasing the 4 tabs located on the sides. Use **CAUTION** when applying pressure to the tabs to prevent any damage.

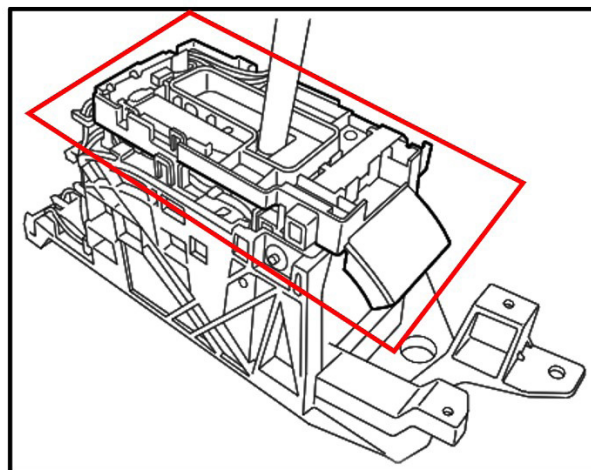
**STEP 8)** **CAREFULLY** remove the blind housing from the gear selector lever. **DO NOT** removed the indicator light terminals.

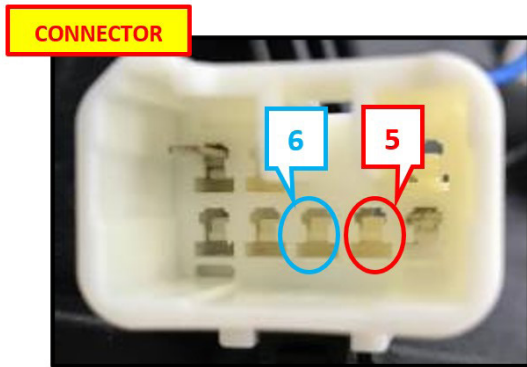
**STEP 9)** CAREFULLY release the terminals #5 and #6 of the indicator light connector. Insert a suitable terminal removal tool from Snap-on® tool kit #SGTT110 or a flat-blade screwdriver (with a tip width of 1.3mm (0.05in) or less) into the connector and disengage the terminal holding tab while slightly pulling the wires from the connector.

TERMINAL #5 – RED & WHITE WIRE  
 TERMINAL #6 – BLUE & WHITE WIRE

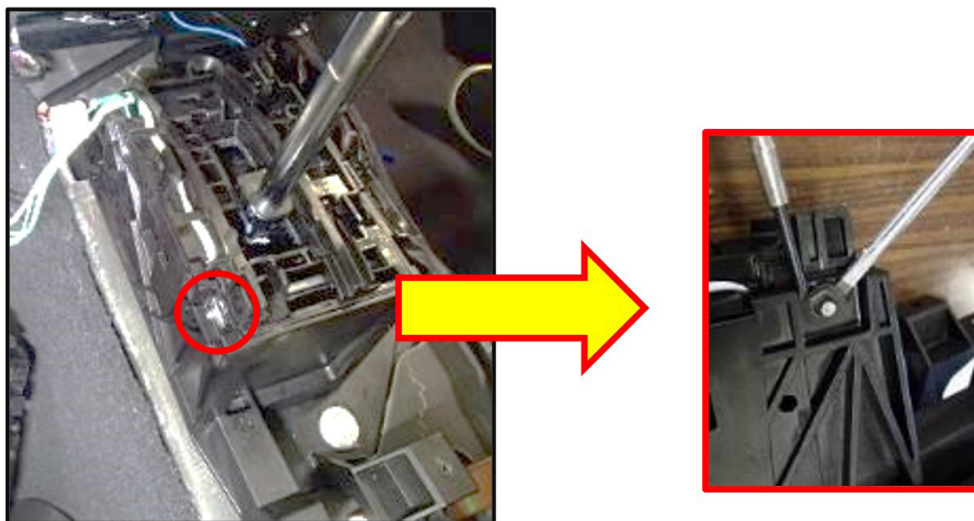
**STEP 10)** Remove the clamp push nut located on the left rear section of the gear selector lever.

**IMPORTANT NOTE:** The clamp push nut is a one-time use part. A new nut MUST be use during assembly.

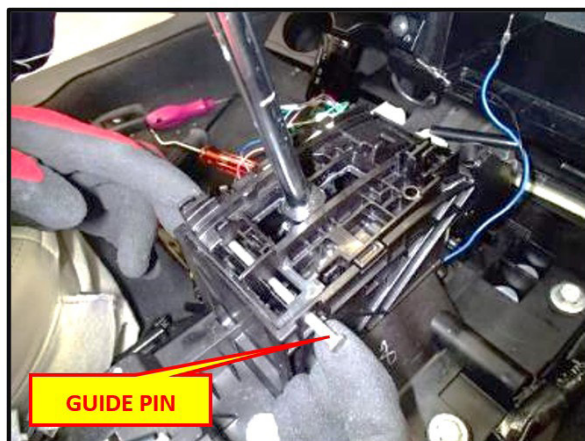
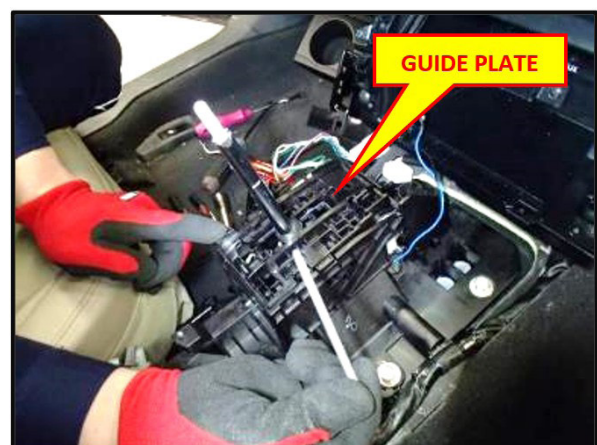
**STEP 11)** Remove the guide pin while applying downforce pressure to the guide plate.

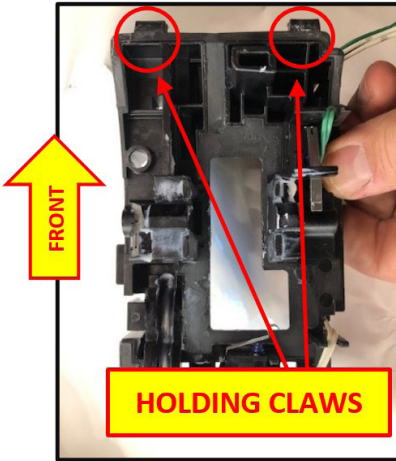
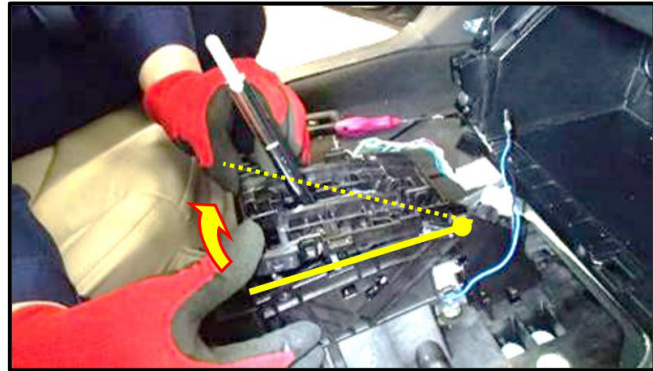
**STEP 12)** Remove the guide plate by raising the rear section to disengage the holding claws located at the front of the plate housing.

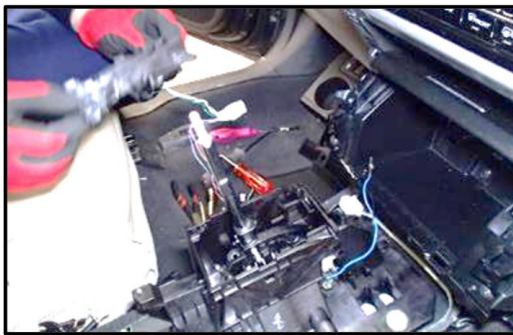
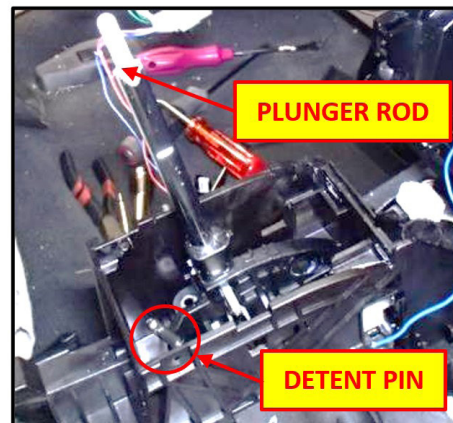
**IMPORTANT NOTE:** Use **CAUTION** to not damage or misplace the plunger rod or detent pin.

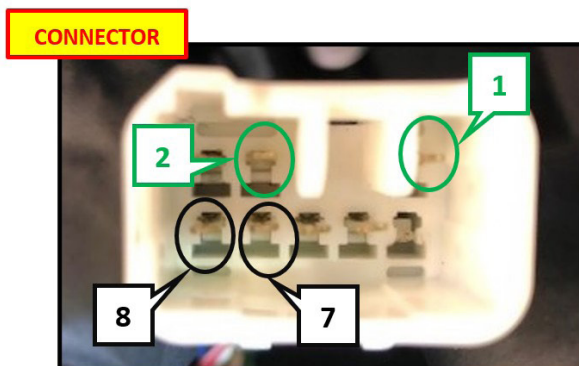
**STEP 13)** **CAREFULLY** release the terminals #1 and #2 of the “manual mode” switch. Release terminals #7 and #8 of the “Parking range” switch. Insert a suitable terminal removal tool from Snap-on® tool kit #SGTT110 or a flat-blade screwdriver (with a tip width of 1.3mm (0.05in) or less) into the connector and disengage the terminal holding tab while slightly pulling the wires from the connector.

**NOTE:** There is no polarity of these terminals. The **MUST STILL** be connected to match the original position to prevent any stress on the wiring.

TERMINALS #1 & #2 – **GREEN WIRES**  
 TERMINALS #7 & #8 – **WHITE WIRES**

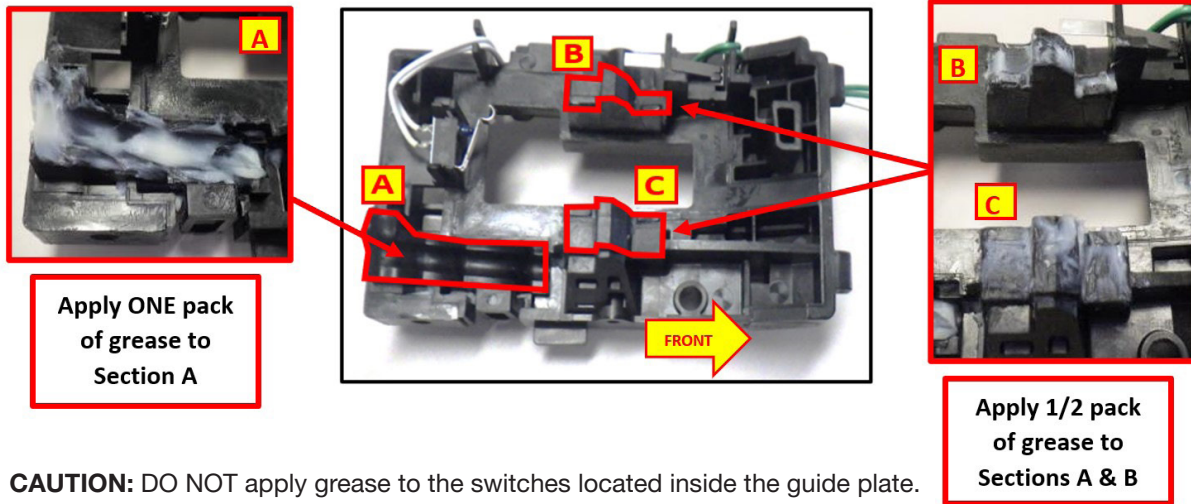
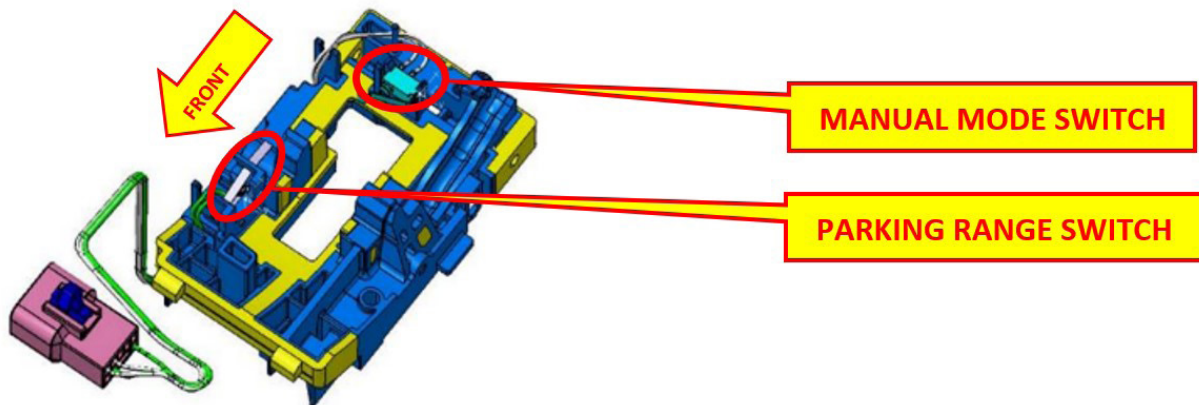
**STEP 1)** Apply the supplied grease to the required areas (A,B, and C) shown below. Apply one pack of grease to section A. Apply ½ pack of grease to sections B and C.

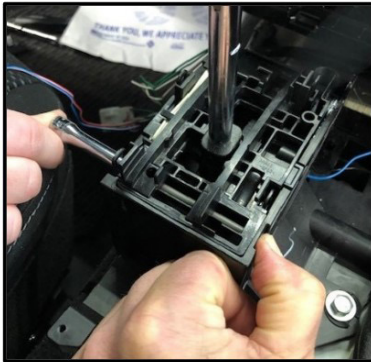
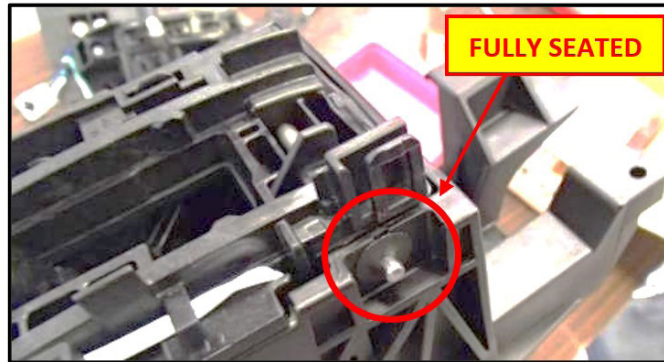
1. Use a deep socket to install the clamp push nut. This will fully seat the clamp push nut against the gear selector lever housing.

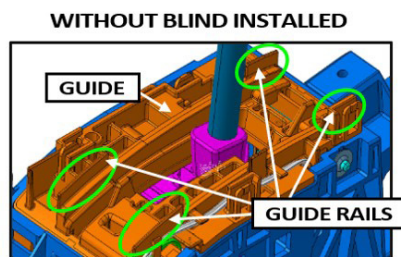
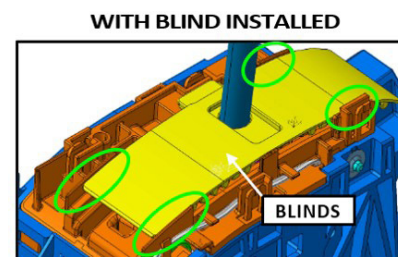
2. Confirm the blind is installed in the correctly within the guide rails.

- Inspect the highlighted areas after the blind is installed to ensure proper alignment.
- Operate the gear selector lever and confirm the indicated gear position matches the actual gear position.
- Confirm the “door open” audio indicator operates when the door is open with the gear selector lever in the “Park” position when the ignition is switched OFF.
