**SERVICE BULLETIN**

**APPLICABILITY:** 2017-20MY Impreza  
 2018-21MY Crosstrek  
**SUBJECT:** Radiator Coolant Seepage

**NUMBER:** 09-73-20R  
**DATE:** 10/27/20  
**REVISED:** 05/14/24

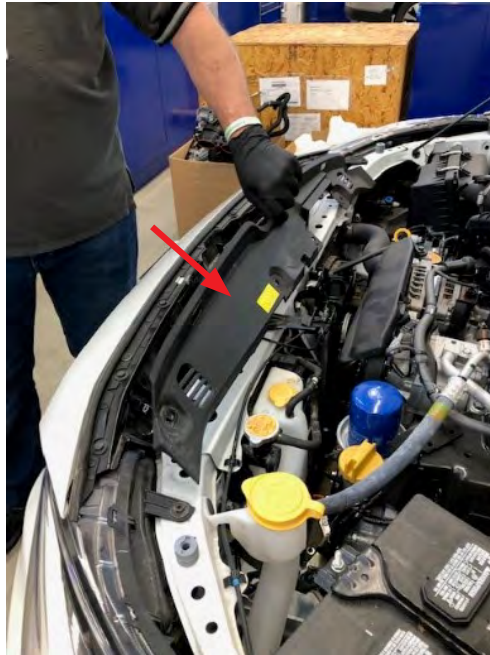
3. Remove the air intake duct leading to the air filter housing.
4. Remove the upper cover.

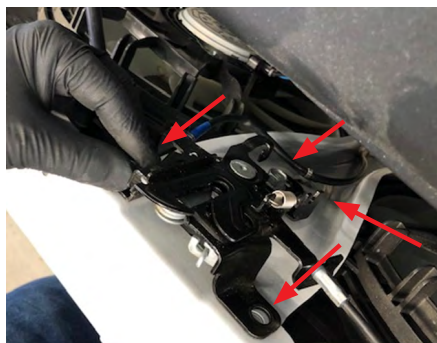
5. Remove all the retaining clips for the related splash shields, upper & lower bumper clips, and the 6 top retaining bracket bolts. **CAREFULLY** disengage the claws securing the bumper cover to the mounting brackets under the headlights to release and remove the bumper cover (fascia) assembly. **NOTE:** To reduce the chances of damage, it is **STRONGLY RECOMMENDED** to use a helper for this step and again during reinstallation. **CAUTION:** While the bumper cover assembly is removed, do not lean on or put any weight against the gray Styrofoam bumper cushion as its retaining tabs are very fragile.
6. Release the hood latch cable (**d**) from the upper radiator frame then remove the latch assembly (3 bolts and a retaining clip at the bottom) from the radiator upper frame and set on the engine as shown (**e**).
