Title: PSI 8.8L Engine Oil Pan Gasket Leaks

Applies To: All PSI 8.8L LPG and Gasoline Engines

The purpose of this article is to provide updated repair guidelines for the engine oil pan leak on all 8.8L gasoline and LPG engines. Engine oil can leak from the rear of the engine oil pan due to an excessive gap in the sealing area between the engine oil pan and the engine block.

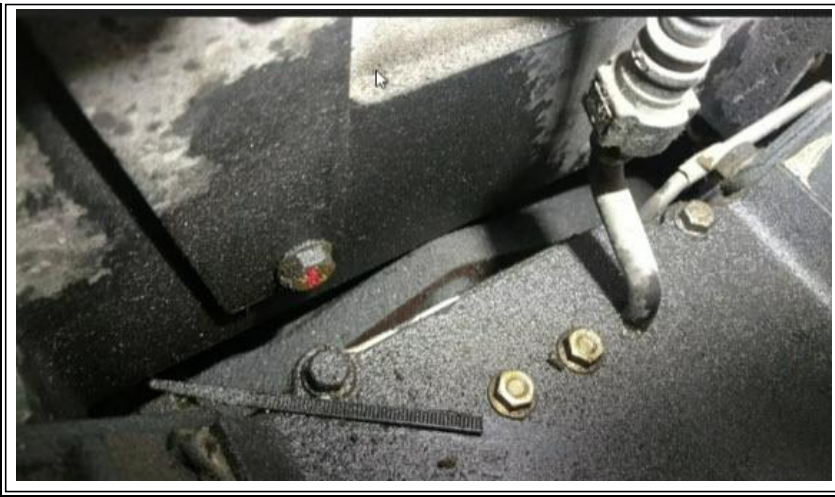
Step	Action	Decision
2	<p>DIAGNOSTIC:</p> <p>Perform a visual inspection of the intake valley plate and confirm it is not leaking causing a false engine oil pan leak. See Figure 1 for an example of an intake valley plate leak.</p>	<p>Yes: Repair engine oil leak at the valley plate. Clean the engine and retest for engine oil leaks.</p>
	<p>**NOTE** The intake manifold DOES NOT need to be removed to inspect the engine valley plate for an oil leak.</p> <p>YES/NO QUESTION?</p> <p>Is the engine valley plate leaking engine oil?</p>	<p>No: Go to step 3</p>

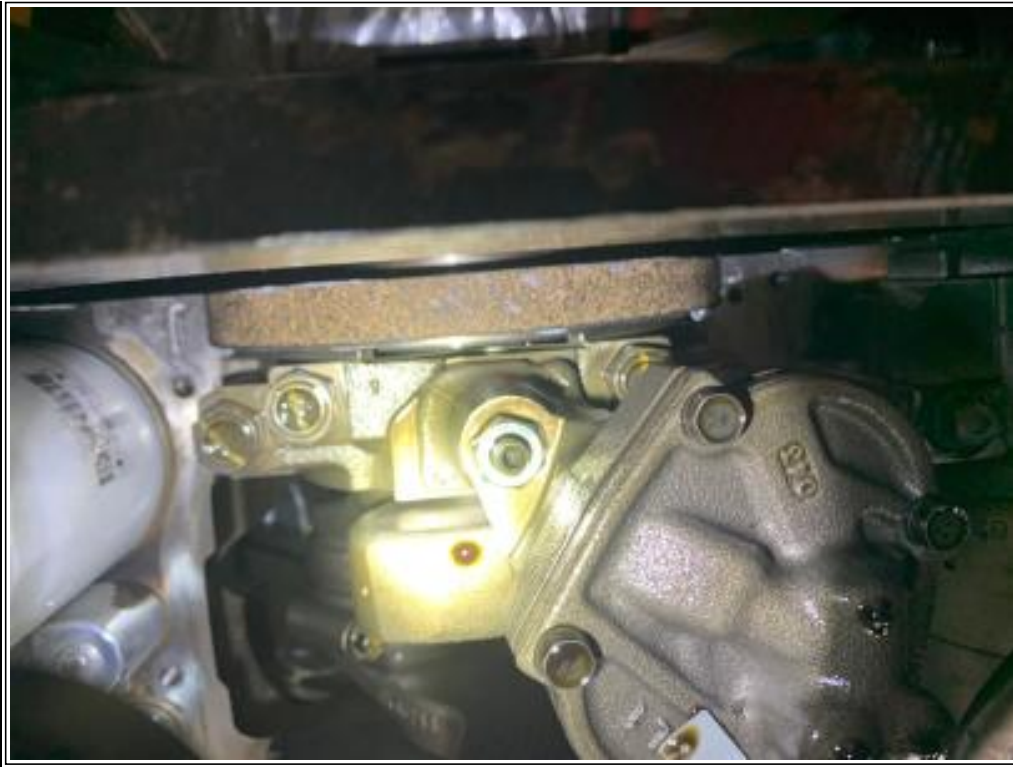
Figure 4 Cork installed with RTV on rear main bearing cap

5. Remove oil pan.
6. Using the measurement from step 4, determine which thickness gasket is needed. (1/8in or 1/16in.)
 1. Cut a strip of 1/8in or 1/16in cork gasket that fits along the rear main cap (**Figure 4**)

2. Apply a Navistar-approved RTV to both sides of the cork gasket, then allow the RTV to become slightly tacky before installing it.
7. Apply RTV to the corners of the engine oil pan and rear main cap mating surfaces. (See service manual for application locations.)
