**HYUNDAI**
Technical Service Bulletin

GROUP DRIVESHAFT & AXLE	NUMBER 24-DS-002H
DATE MAY 2024	MODEL(S) SANTA FE (MX5A) SANTA FE HYBRID (MX5A HEV)

SUBJECT: FUEL TANK HEAT PROTECTOR NOISE INSPECTION AND ADJUSTMENT

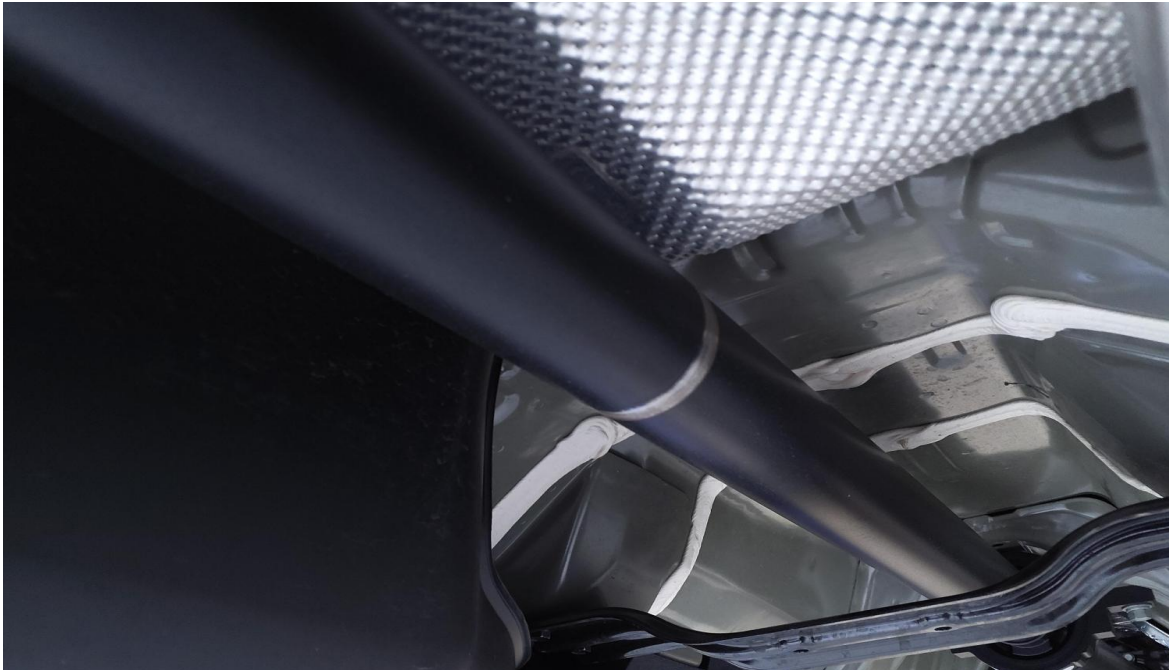
Description: Certain AWD 2024MY Santa Fe (MX5A) and Santa Fe Hybrid (MX5A HEV) vehicles may experience scraping, rubbing, and/or grinding noise coming from underneath and rear of the vehicle under acceleration and turns due to interference between the propeller shaft and fuel tank heat protector.

Follow the procedure outlined below to inspect, adjust the fuel tank heat protector, and apply paint to the affected areas.

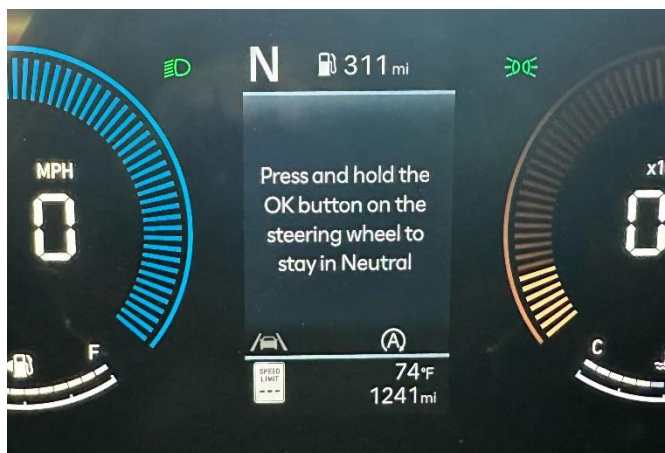
Follow the procedure on the Owners Manual to place the vehicle in Neutral.

- Close the front driver door latch actuator prior to performing the procedure to allow the vehicle to stay in neutral with the driver door slightly open.

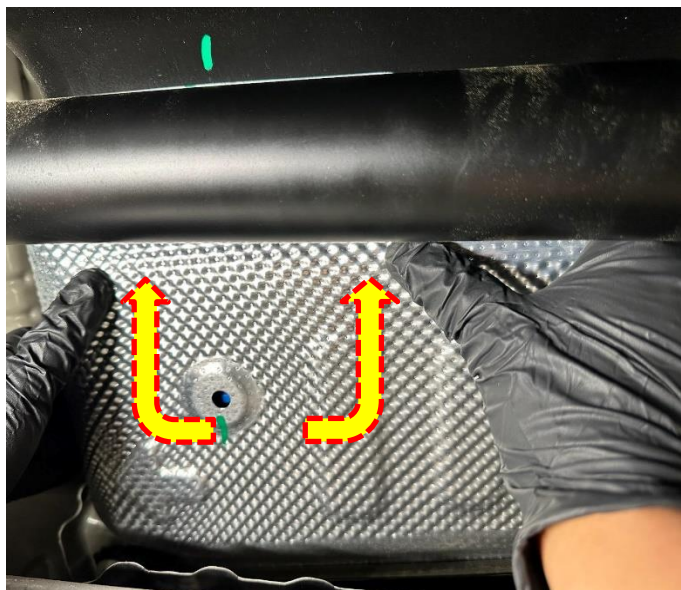
2. Once removed, apply upward force on the affected areas to adjust the heat protector away from the propeller shaft as shown in the picture to the right.

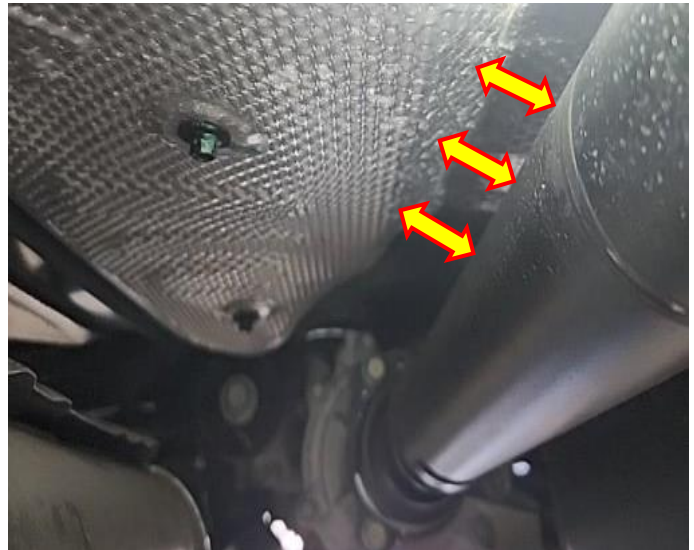
3. Re-attach the heat protector to the fuel tank and verify the minimum clearance using a ruler. Rotate the propeller shaft slowly by hand and verify the noise concern.

**Minimum Clearance Specification:
10 MM or 1 CM**

- If the noise is still **present**, repeat Steps 1 - 2 to re-adjust the fuel tank heat protector.
- If the noise has been eliminated, proceed to **Section C** to apply paint on the affected areas of the propeller shaft.

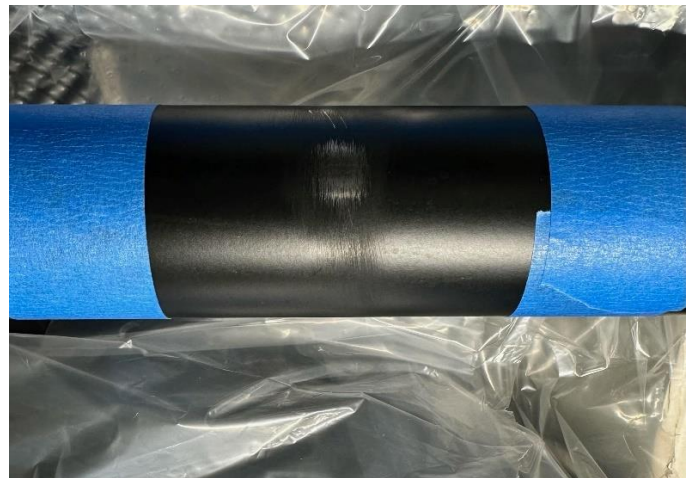
1. Using a damp shop towel, wipe the scuffed areas on the propeller shaft of any debris, dirt, or dust.
2. Apply tape to the area slightly larger than the scuffed area on the propeller shaft, as well as the area behind the the propeller shaft to prevent overspray.
