<b>HYUNDAI</b> <b>Technical Service Bulletin</b>	<b>GROUP</b> <b>CAMPAIGN</b>	<b>NUMBER</b> <b>24-01-042H</b>
	<b>DATE</b> <b>MAY 2024</b>	<b>MODEL(S)</b> <b>ELANTRA N (CN7 N)</b> <b>ELANTRA HYBRID (CN7 HEV)</b>
<b>SUBJECT:</b> TMK SEALANT LEAKAGE INSPECTION/PARTS REPLACEMENT (SERVICE CAMPAIGN TBR)

**Description:** Some 2023MY Elantra N (CN7 N) and 2023-2024MY Elantra Hybrid (CN7 HEV) vehicles may have sealant leakage in the Tire Mobility Kit (TMK). The leakage may contaminate other parts inside or outside of the TMK bag. Follow the procedure in this bulletin to determine if the sealant is leaking and, if necessary, replace any parts that have been contaminated. If the sealant has not leaked, replace only the TMK Sealant Cap.

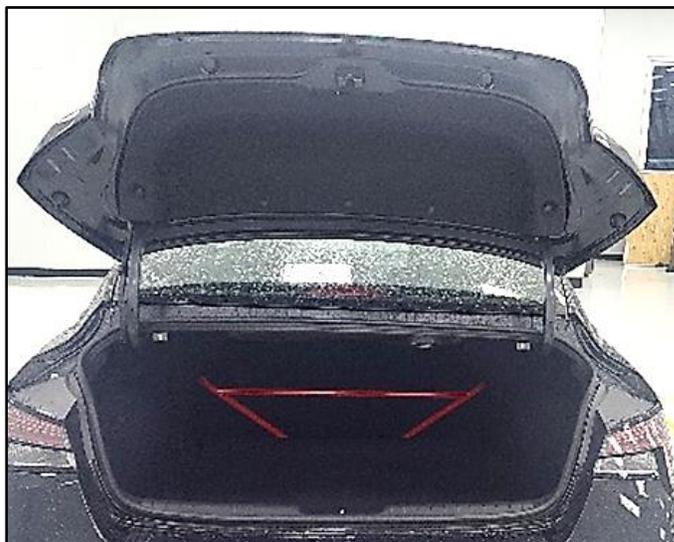
1. Open the rear trunk lid.

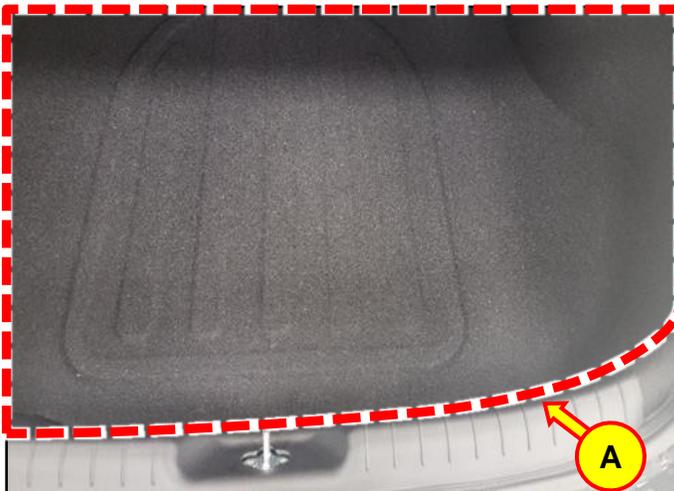
2. Remove the luggage board (A).

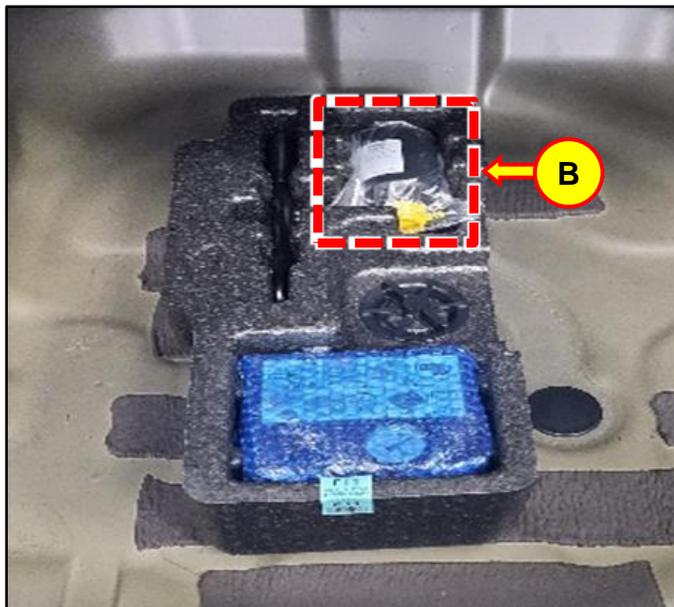
3. Inspect for sealant leakage at the TMK sealant container (B).

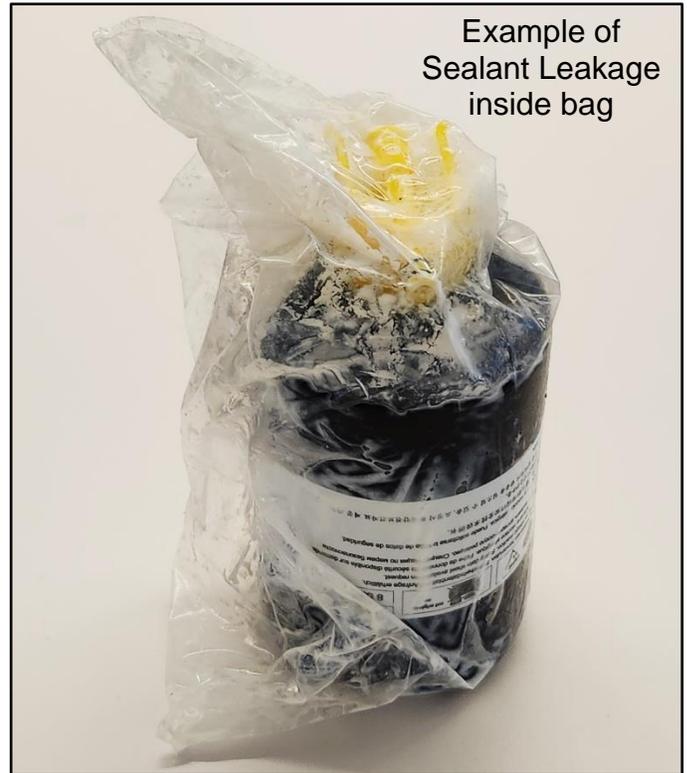
4. If there is sealant leakage inside the plastic bag only (see example), discard the sealant, and replace with new sealant (C).

If sealant leakage is found in the plastic bag, go to [step 5](#).

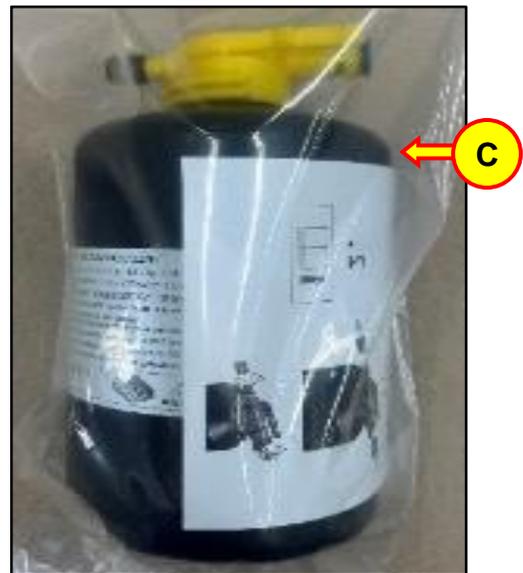
If no sealant leakage is found, proceed to [TMK Sealant Cap Replacement](#) on page 9.

5. If sealant leakage is found outside the sealant plastic bag, go to [step 6](#).

If sealant leakage is only inside the plastic bag, place the new sealant bottle into the existing case, then go to [step 7](#).

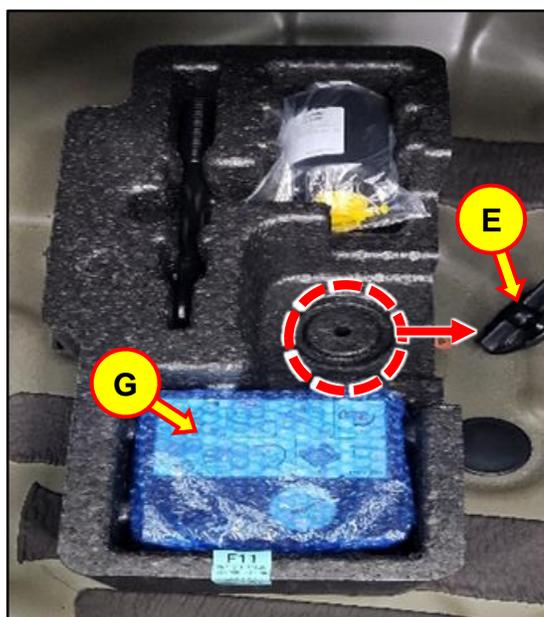
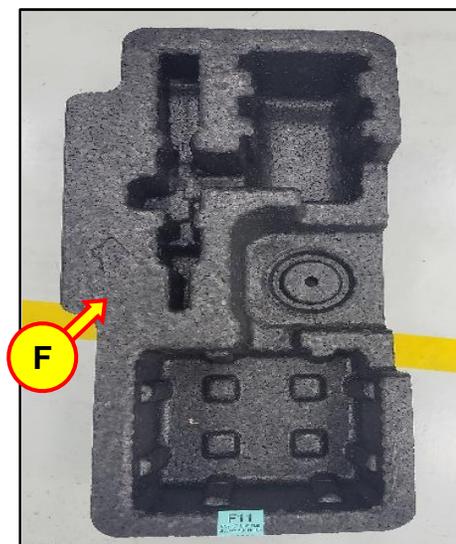
6. If sealant leaked outside the bag, then replace the TMK case with a new one.

- Remove the TMK case attaching handle (E).
- Replace the TMK case with a new one (F).

Do NOT replace the TMK pump (G). Put existing pump into the new case.

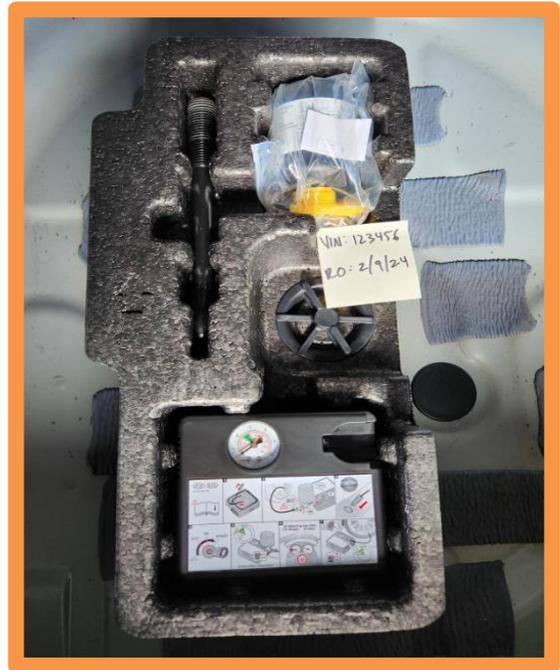
Using STUI, take a photo of the new TMK sealant, and new TMK Kit Case (if replaced), with the last 6 digits of the VIN and the date of repair on a piece of paper.

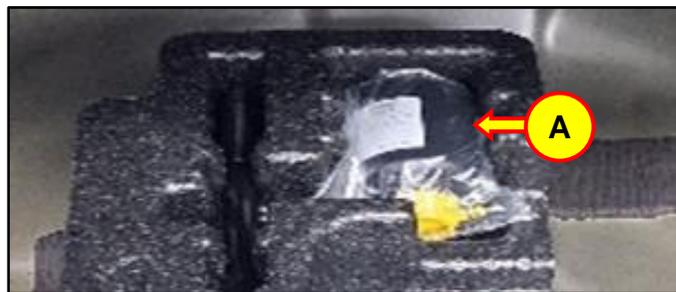
1. Remove the sealant bottle from the bag (A).

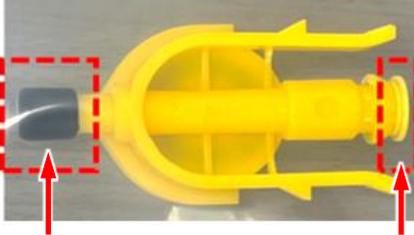
## Comparison of Old and New Sealant Caps

Old Part	New Part

<p data-bbox="412 814 542 848">No Plugs</p>

<p data-bbox="857 835 1122 869">Female Black Plug</p> <p data-bbox="1214 835 1463 869">Male Yellow Plug</p>

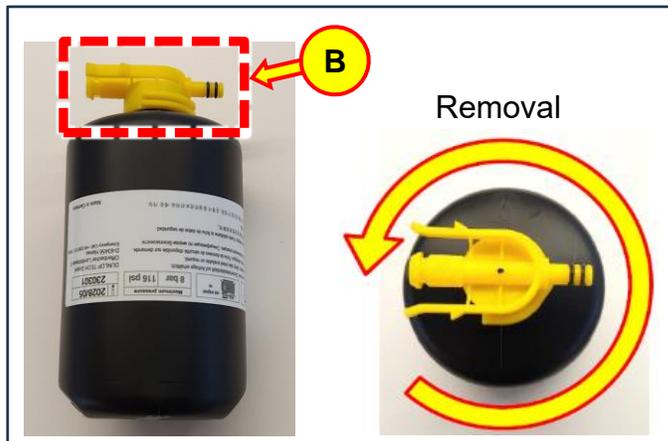
2. Remove the existing sealant cap (B) by slowly turning it counterclockwise to reduce the chance of contents spraying out.

Wear eye protection when removing cap to prevent possible injury from contents suddenly spraying out.

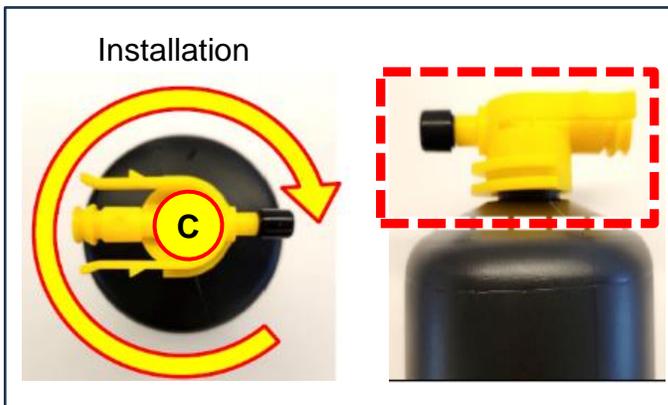
3. Install the new sealant cap (C) by turning it clockwise.

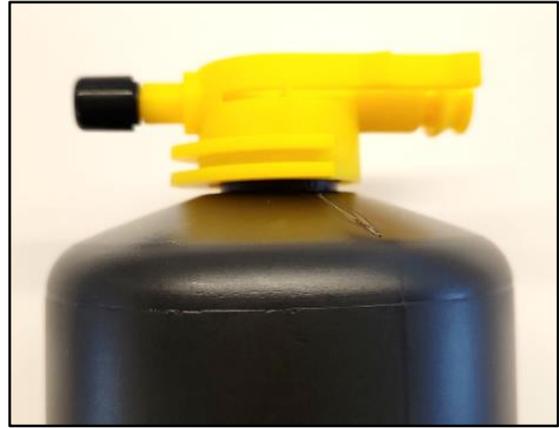
4. After installation, confirm that the cap is tightened properly and securely.
  - Verify cap is not installed crooked.
  - Turn sealant container over and check for leaks.

The ball valve rattle in the sealant cap is normal.

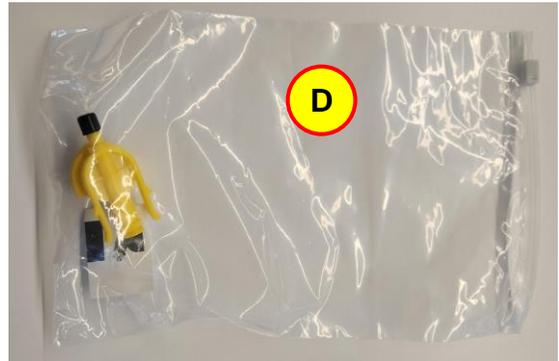
5. Use the zip bag (D) from the sealant cap kit to repackage the sealant bottle.

TMK Sealant Cap Kit  
(PN 09131-N1001QQH)

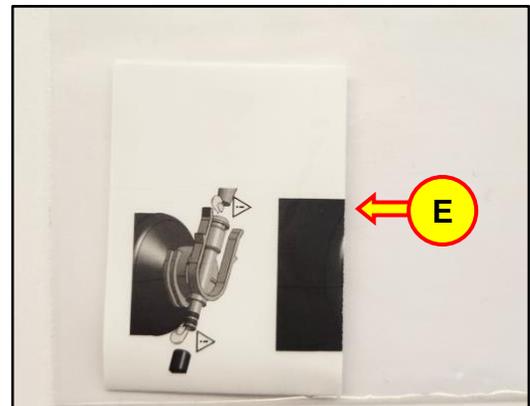
6. Ensure the plug removal instruction pamphlet (E) remains in the bag.

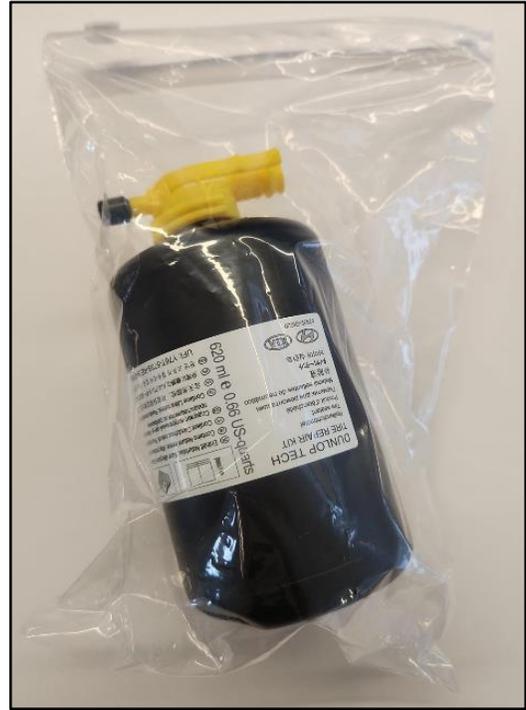
7. Insert the bottle into the zip bag and close it.

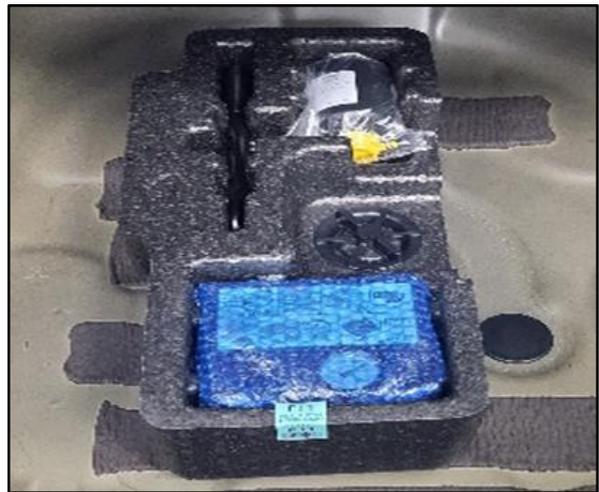
8. Put the repackaged sealant in the TMK Kit Case as shown.

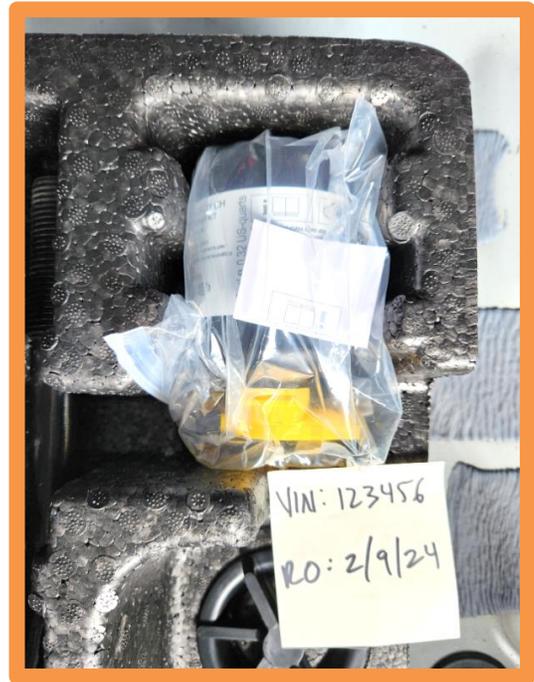
Using STUI, take a photo of the new repackaged TMK Sealant, showing the new cap clearly, with the last 6 digits of the VIN and the date of repair on a piece of paper.
