## STAR ONLINE PUBLICATION

**Case Number:** S2323000015 Rev. B

**Symptom/Vehicle Issue:** Doors Will Not Open From Handle(s)

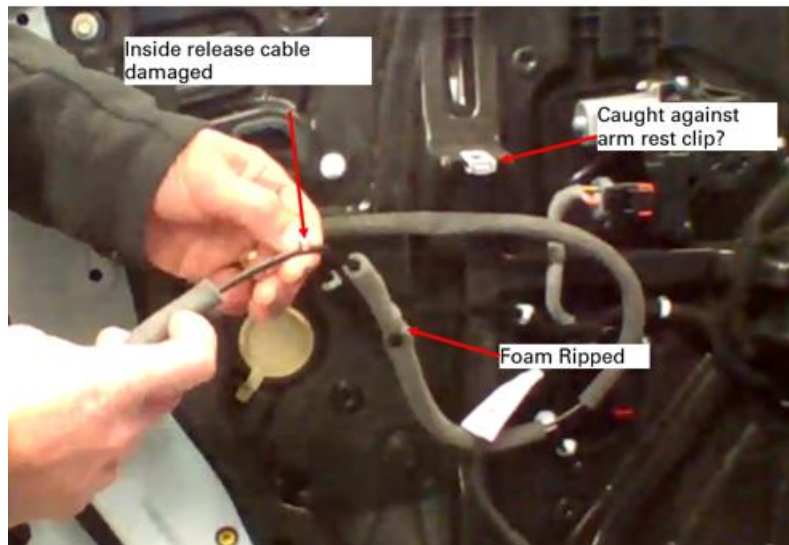
Fig 1

### Condition 1. Door does not open from interior handle.

Open the door from the exterior handle. Remove the door trim. Refer to 23 - Body / Doors – Front (or Rear) / PANEL, Door Trim / Removal and Installation. Inspect the cable routing for routing, rub through, kinking, and pinching. Replace and correct routing of the cable as needed. See Fig 1. Also inspect the interior handle and clip.

Re-assemble the door and test for proper operation.

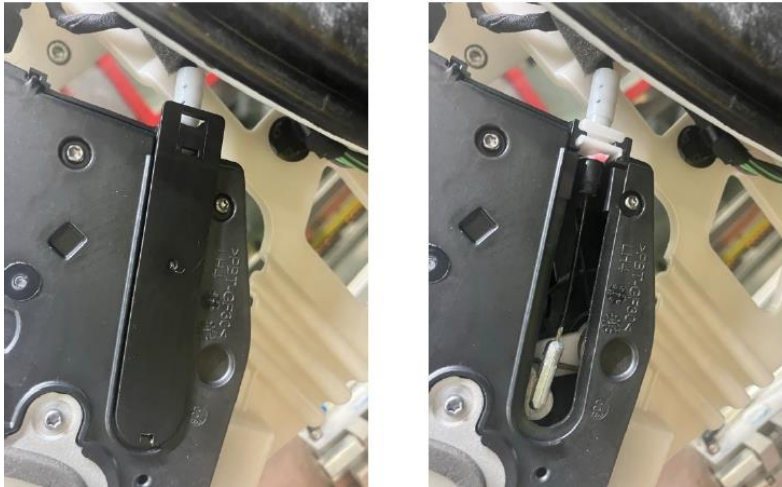
Fig 2

### Condition 2. Door does not open from interior handle. Cable dislodged from latch or interior handle.

1. Review the release cable is properly routed and clipped to the trim panel. If the cable is not properly routed there will be increased release effort and the interior handle will be not able to open the door (see condition 1).
2. Verify if the cable end fitting and the barrel bushing are correctly attached to the interior handle.
3. Remove the dust cover on the latch to verify the proper attachment of the cable cap and the z fitting to the latch release lever (Fig 2).

4. If the cable is not properly routed, remove the cable and install the cable properly.
5. If the barrel bushing or the z fitting are not correctly attached or the core wire is not moving freely into the conduit, remove each and reconnect.
6. Verify the proper function of the interior handle several times.
7. After performing all the steps above and the door still not open by inside, replace the latch.

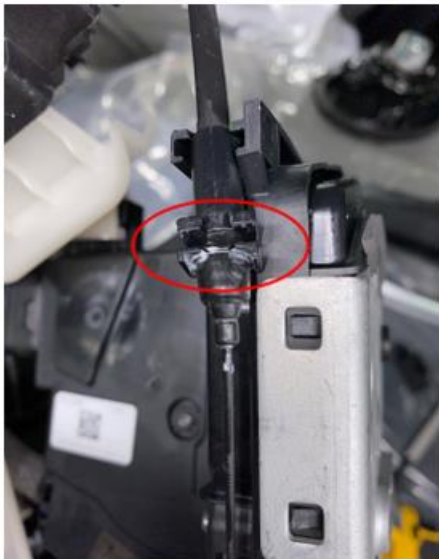
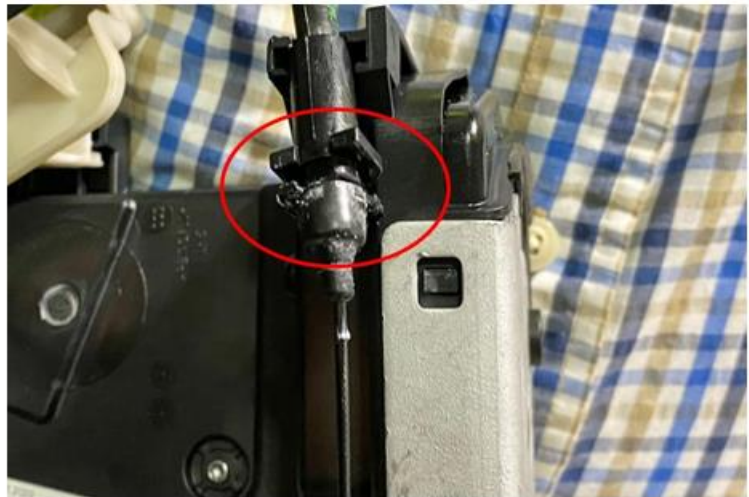
### Condition 3. Door does not open from exterior handle.

Inspection of the exterior handle door cable may require disassembly of the interior side of the door. Follow service information to remove the door panel and carrier plate. Once the area is accessed, inspect the cable caps for proper snap in retention to the door latch and handle. If the cable cap ends show damage such as cracking, bent lock tabs, replace the cable. See Fig 3.

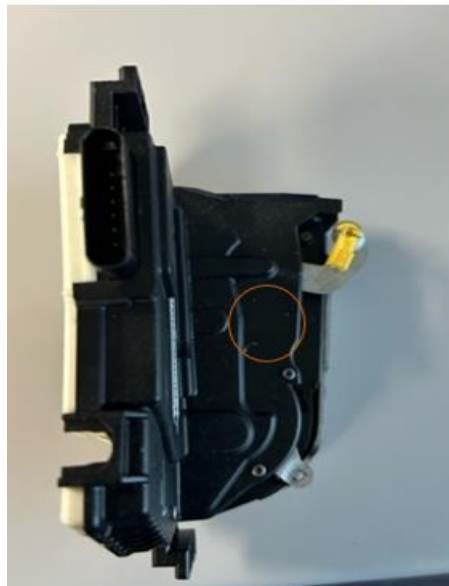
6. Remove the glass run guide for more access to the latch area.
7. Using a small cordless drill, a hole will need to be drilled in the door latch (the door latch will need to be replaced). Use a small hole saw drill with the centering drill removed. See image for approximate location of the hole. See Fig 4. Goal is to open the cavity of the latch to gain access to the levers with just removing the outer layer.

5. Using a cutting tool such as a body saw, cut the carrier plate (you will need to replace the carrier plate after this) to gain access to the door cavity and latch. Use masking tape to protect painted surfaces.

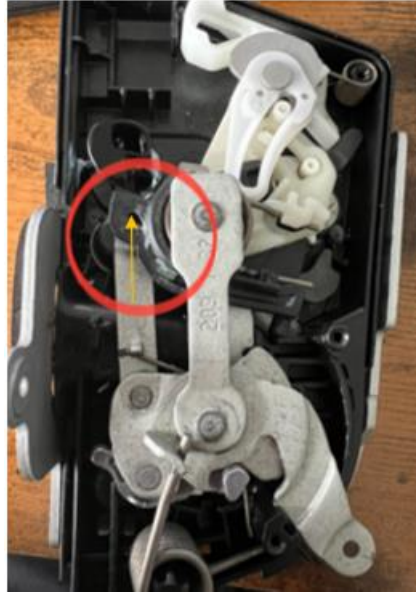
8. After making the hole, push up on the levers using a screwdriver as indicated in Fig 5.

9. Push up on the exterior handle release lever. See Fig 5. The lever is circled in red. This should release the latch. If not, go back to step 8 and try again.
10. >>>**Note**>>> All cut, drilled, and damaged parts will require replacement.

Once door is open clean debris from vehicle and replace damaged parts.  
Assemble the door and check operation.
