## STAR ONLINE PUBLICATION

**Case Number:** S2423000028

**Symptom/Vehicle Issue:** Wheel Hub Cap Installation.

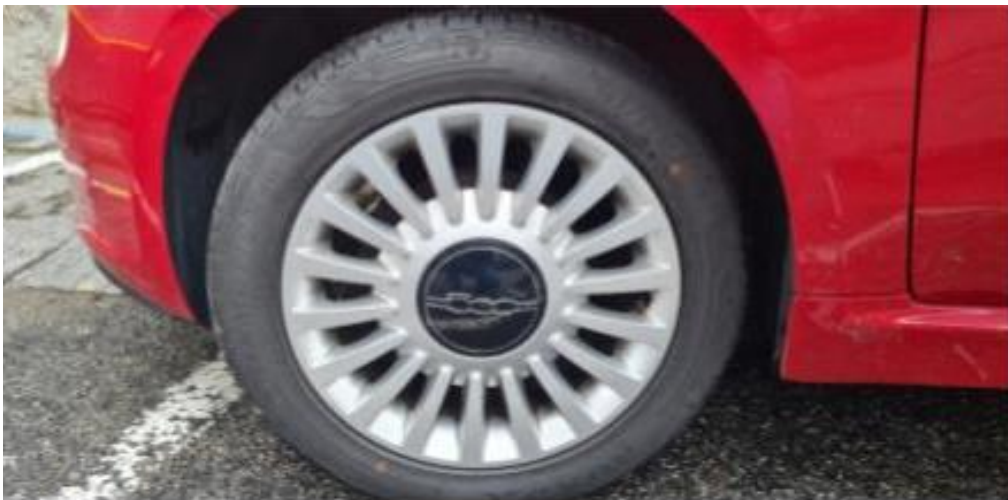
**Discussion:** The wheel center cap attaching fingers or hooks may become damaged if the cap is not snapped in place squarely. Damaged attachment may cause the cap to come loose and be lost. See the below information to ensure the caps are installed properly for wheel service or in pre delivery inspection (PDI).

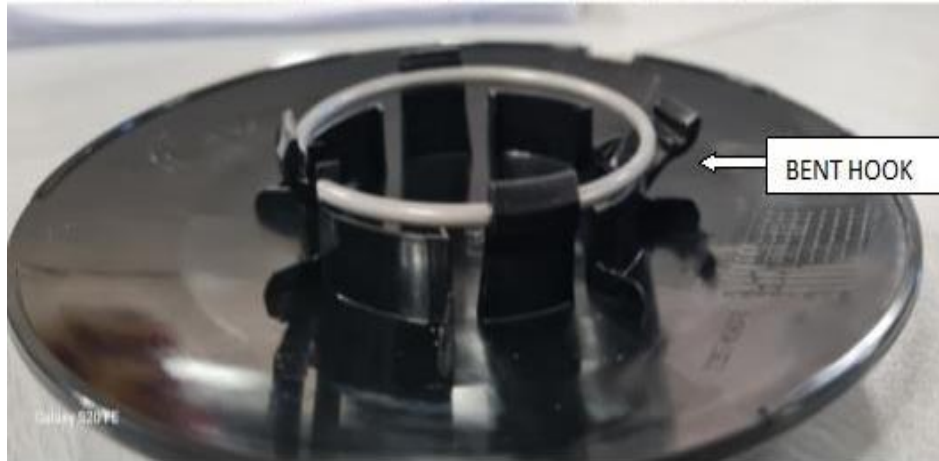
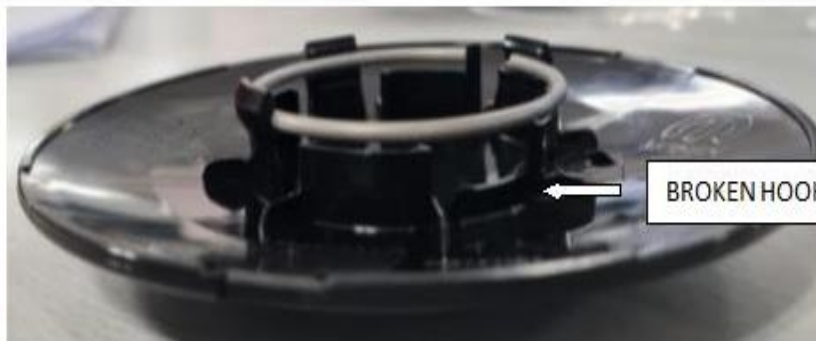
### Examples Of Hub Cap Damage Due To Improper Installation.

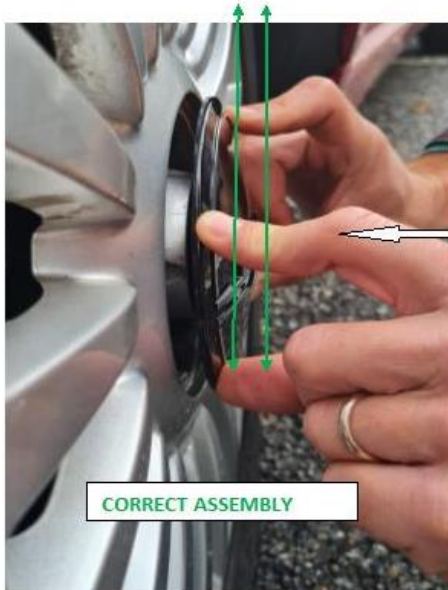
**CORRECT ASSEMBLY**

The pressure exerted is distributed uniformly over the entire surface of the plastic support

**Constant pressure on the support and compliant parallelism between support and wheel seat**

Illustrative picture of the correct assembly of the support inside the wheel

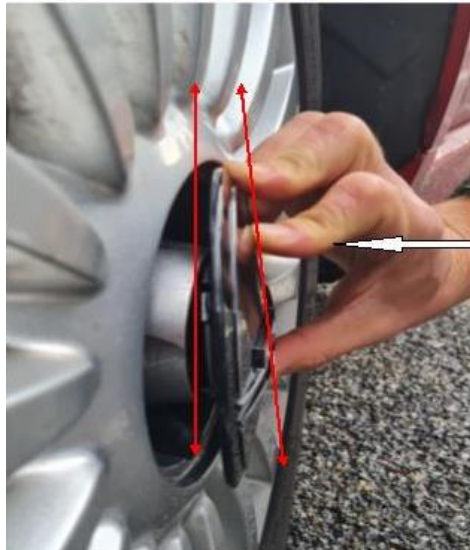
**INCORRECT ASSEMBLY**

The pressure exerted is not distributed uniformly over the entire surface of the plastic support

**Inconstant pressure on the support and non-compliant parallelism between the support and the wheel seat**

Illustrative picture of the incorrect assembly of the support inside the wheel
