Removal of Engine Cover on 5.7L Engines – MY 2024 – Dodge Durango (WD)

Tappet Kit for the PHEV Fuel Door - MY 2024 and Future - Jeep Wrangler (JL)

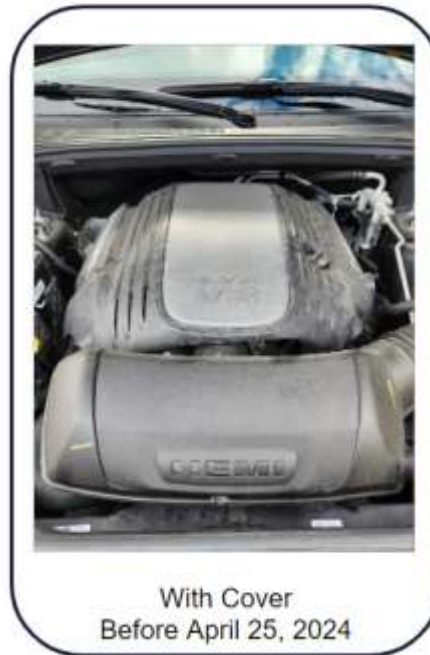
Beginning on April 25th, 2024 (VIN: 1C4SDJCT5RC193718), the 2024 Dodge Durango and all future model years will no longer have the 5.7L engine cover. The engine cover will no longer be available in production.

The engine cover installation is not reimbursable on a shortage and error claim and will be recovered as unsupported claim payment.

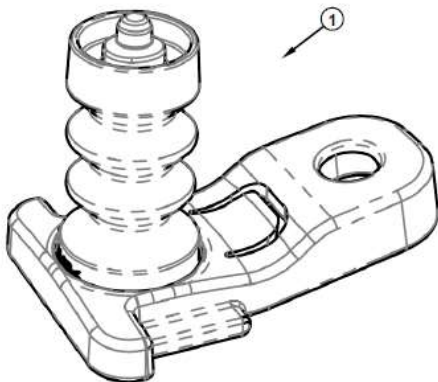
K6856280 - Jeep PHEV Tappet and Base Service kit

Call Out	Description	Quantity	Service Part (Y/N)	Part Number
1	Tappet with Base <i>(new style)</i>	1	Y	68509685AB

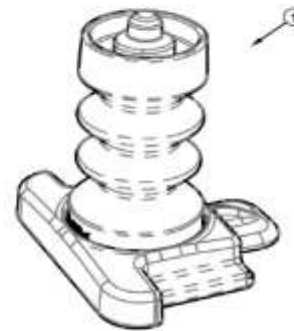
K6856280 - Jeep PHEV Tappet and Base Service kit

Call Out	Description	Quantity	Service Part (Y/N)	Part Number
1	Tappet with Base (old style)	1	Y	68509685AA

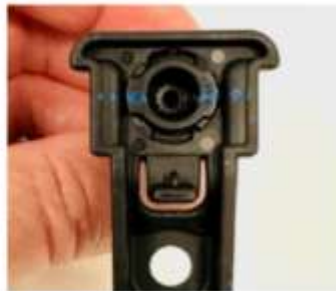
The kit already includes the blue mark (from supplier) across the tappet and tappet base.

Once the correct installation has been verified, apply a blue mark across the back of the tappet and tappet base, using a blue grease pencil.

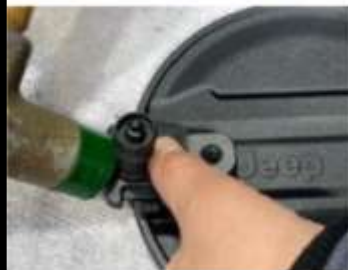
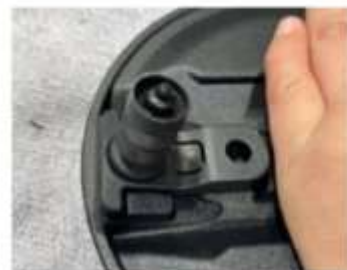
Install the tappet & base assembly onto the cover. It will be necessary to tap the base into location using a mallet.
