CUSTOMER SATISFACTION NOTIFICATION

Swing Gate Air Compressor

Reference: 29B

2023 (JL) Jeep Wrangler

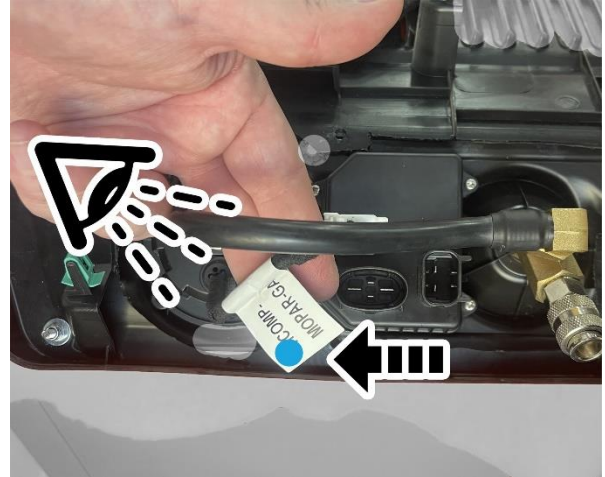
Figure 1 – Blue Dot Location

1. Disconnect the negative battery cable.
2. Remove the spare tire from the swing gate.
3. Remove the swing gate panel.
4. Disconnect the air line from the air compressor.
5. Disconnect the electrical connector.
6. Lay the swing gate panel on a clean protective surface.
7. Inspect for a “Blue Dot” on the wiring harness tag.

➤ Is the Blue Dot present?

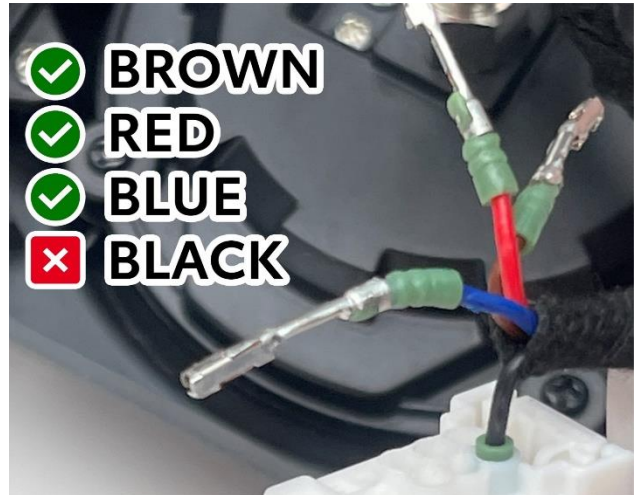
Figure 5 – Wires Removed

13. Insert the pick tool into the connector and release the wire tab and pull out the following wires from the connector (Figure 5).
- Brown
 - Red
 - Blue

NOTE: Do Not Remove the Black wire from the connector.

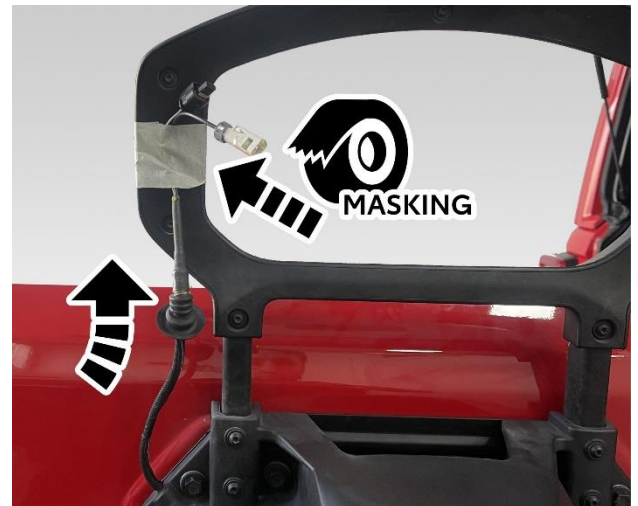
Figure 11 – Wires Tapped

22. Tape the removed wires to the spare tire bracket as shown (Figure 11).

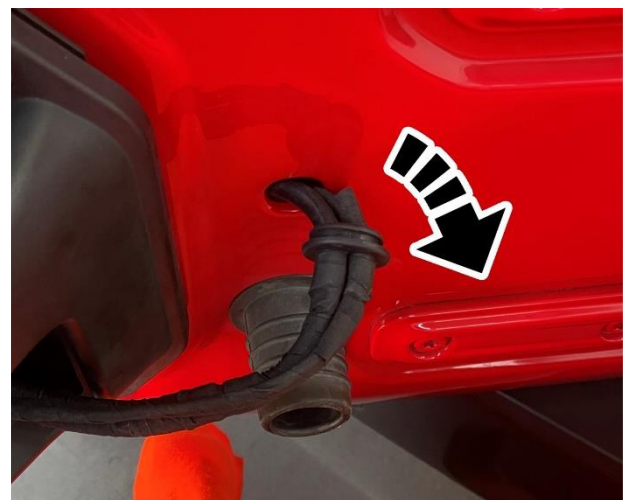
Figure 12 – Rubber Grommet Released

23. Release the rubber grommet on the right side of the spare tire carrier and pull the wires out slightly (Figure 12).

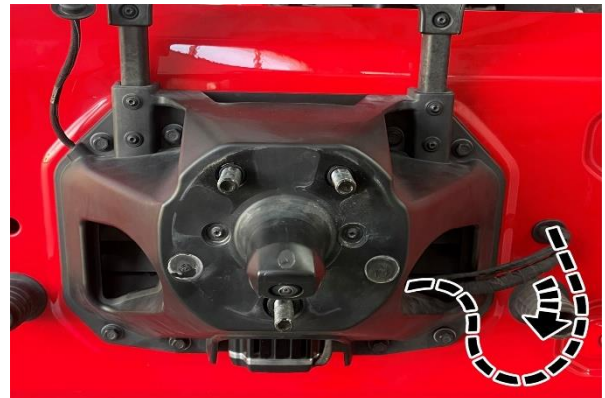
Figure 14 – Hose and Wire Relief

- 25. Pull on the wire and hose to relieve the strain (Figure 14).

37. Push the wire and hose assembly into the swing door grommet hole (Figure 14).

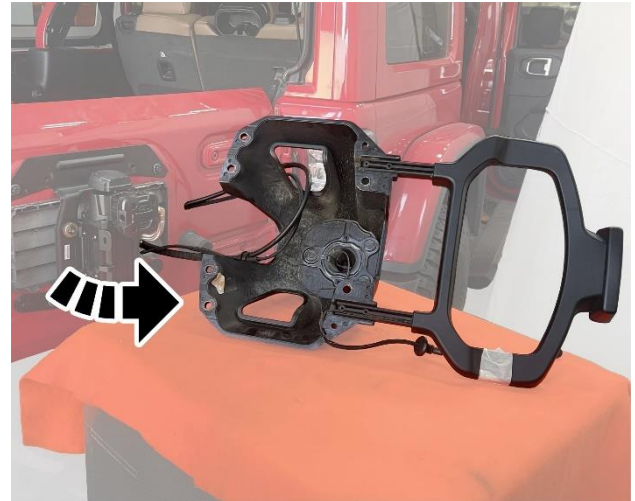
Figure 16 – Removed Bracket

27. Rest the removed bracket on a shop cart (Figure 16).

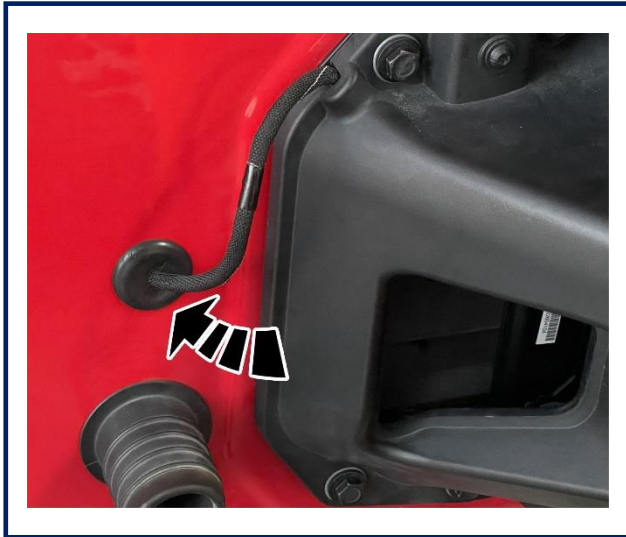
Figure 21 – Swing Gate Wire Routing

- 39. Remove the tape from the tapped wires secured to bracket and insert into the swing gate door hole secure the rubber grommet to the hole (Figure 21).

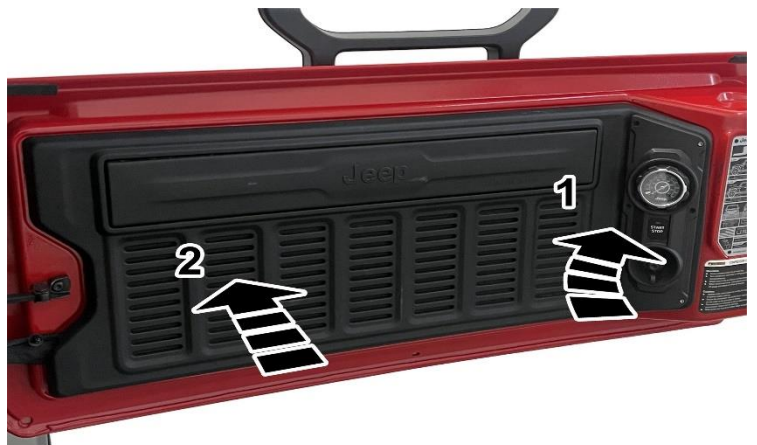
Figure 24 – Panel Installation

42. Align the press on the swing gate panel to engage the clips to the swing gate (Figure 24).

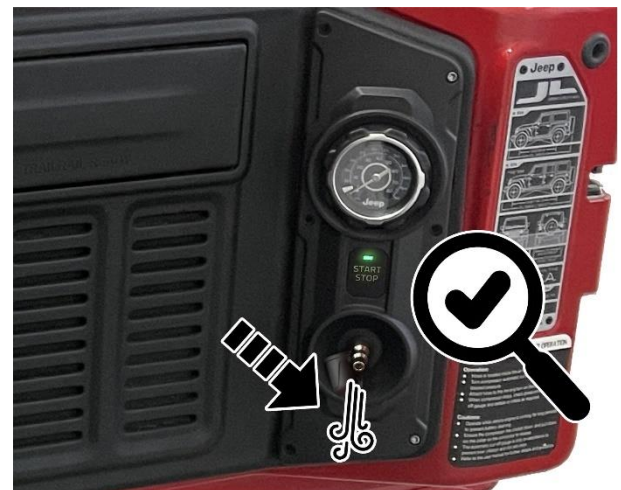
Figure 26 – Air Discharged

- 47. Verify there is air discharged from the hose connection (Figure 26).
- 48. Place finger over the air discharge port and verify the gauge is reading pressure.
- 49. Return the vehicle to the customer.
