CUSTOMER SATISFACTION NOTIFICATION

Front Bumper Anti-theft Label Detachment

Reference: 62B

2024 (FG) Fiat 500E

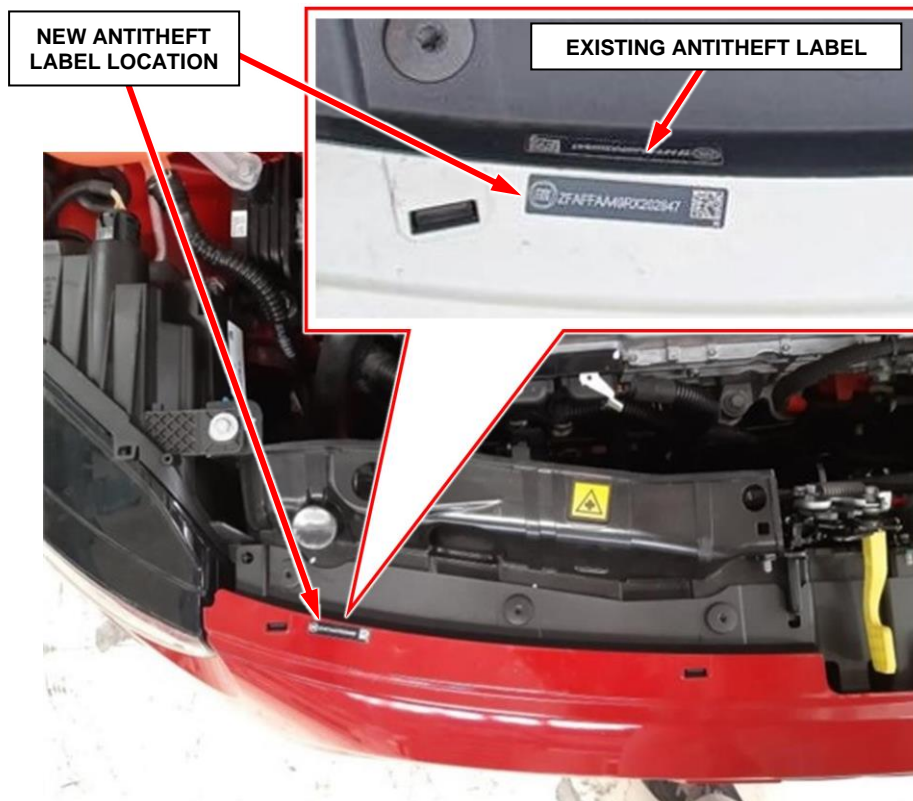
1. Open the vehicle hood and locate the existing antitheft label on the vertical grained black plastic inner surface of the front bumper right (passenger) side of the vehicle as shown in the below image.
2. Obtain the NEW antitheft label for the vehicle and verify the label is appropriate for the vehicle based on vehicle identification number printed on the label.

NOTE: The new antitheft label must be applied on the horizontal painted surface of the front bumper right (passenger) side as close as possible to the location of the existing label as shown in the below image.

3. Use isopropyl alcohol or window cleaner and a clean cloth to remove any wax, oil, dust, and debris from the NEW label application area.
4. Allow the isopropyl alcohol or window cleaner to fully evaporate before applying the NEW antitheft label.
5. Apply the NEW antitheft label using even pressure to the entire surface with firm overlapping strokes removing all wrinkles and air bubbles. Using a tool such as a squeegee is allowed.
6. Close the vehicle hood then return the vehicle to the customer or inventory.

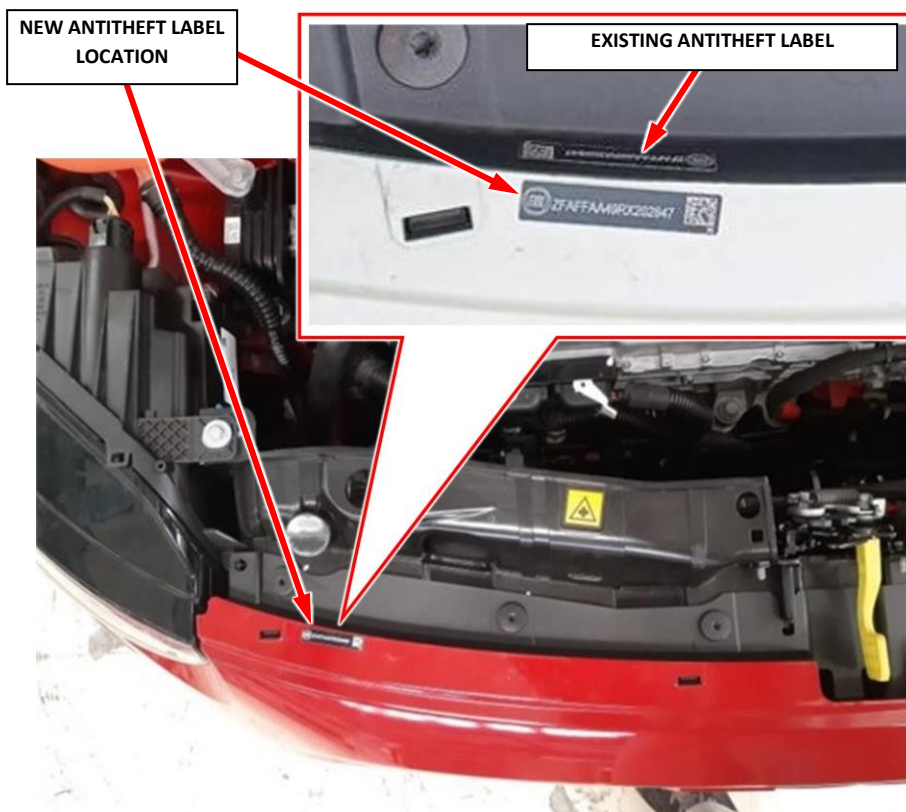
1. Open the vehicle hood and locate the existing antitheft label on the vertical grained black plastic inner surface of the front bumper right (passenger) side of the vehicle as shown in the below image.
2. Obtain the NEW antitheft label for the vehicle and verify the label is appropriate for the vehicle based on vehicle identification number printed on the label.

NOTE: The new antitheft label must be applied on the horizontal painted surface of the front bumper right (passenger) side as close as possible to the location of the existing label as shown in the below image.

3. Use isopropyl alcohol or window cleaner and a clean cloth to remove any wax, oil, dust, and debris from the NEW label application area.
4. Allow the isopropyl alcohol or window cleaner to fully evaporate before applying the NEW antitheft label.
5. Apply the NEW antitheft label using even pressure to the entire surface with firm overlapping strokes removing all wrinkles and air bubbles. Using a tool such as a squeegee is allowed.
6. Close the vehicle hood.
