EGR Valve Diagnosis and Cleaning Procedure using TU-  
NAP 926® on 906, 907 Sprinter with OM642 Diesel Engine

| Topic number | LI14.20-N-073867 |
| Function group | 14.20 - Exhaust gas recirculation |
| Validity | 906, 907 Sprinter with OM642 V6 Diesel Engine |

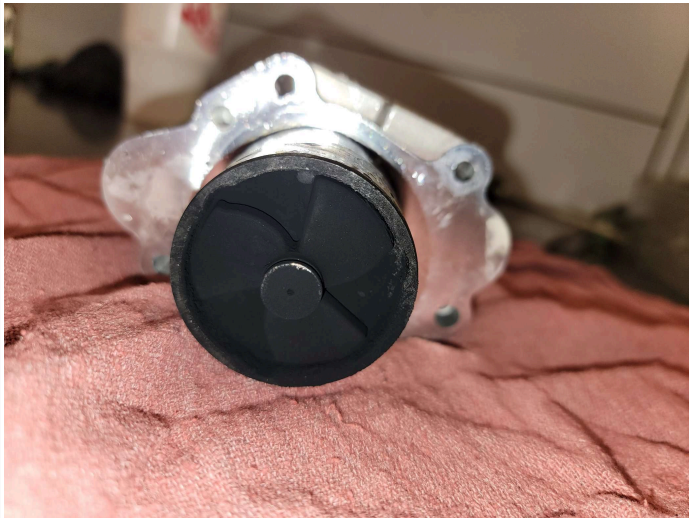
| File | Description |
|---|---|
| <a href="#">OM642 EGR Valve before 1.jpeg</a> | Bottom of sooted EGR Valve. |

Soot deposits between the EGR Valve blade and seat leading to the EGR Valve no longer being able to meet the desired target of the EGR Valve position controller.

Clean the EGR Valve with TUNAP 926® (BQ6670128) by performing the following steps:

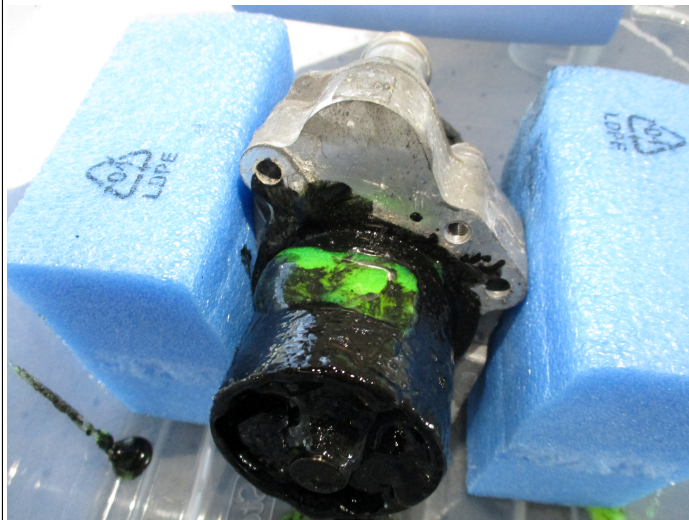
EGR Valve Cleaner Application.JPG

EGR Valve with cavity filled, and blades covered in cleaner.

2. Position EGR Valve so open cavity is facing upward. Fill cavity with cleaner, and then proceed to apply cleaner to blades from the outside. Additionally, apply cleaner to outside where additional soot is found.
