TECHNICAL SERVICE BULLETIN

| Classification: DA18-033C | Reference: NTB18-076C | Date: April 17, 2024 |

2018-2019 KICKS; REAR SONAR DOES NOT WORK WITH HEADLAMPS AND/OR PARKING LAMPS ON

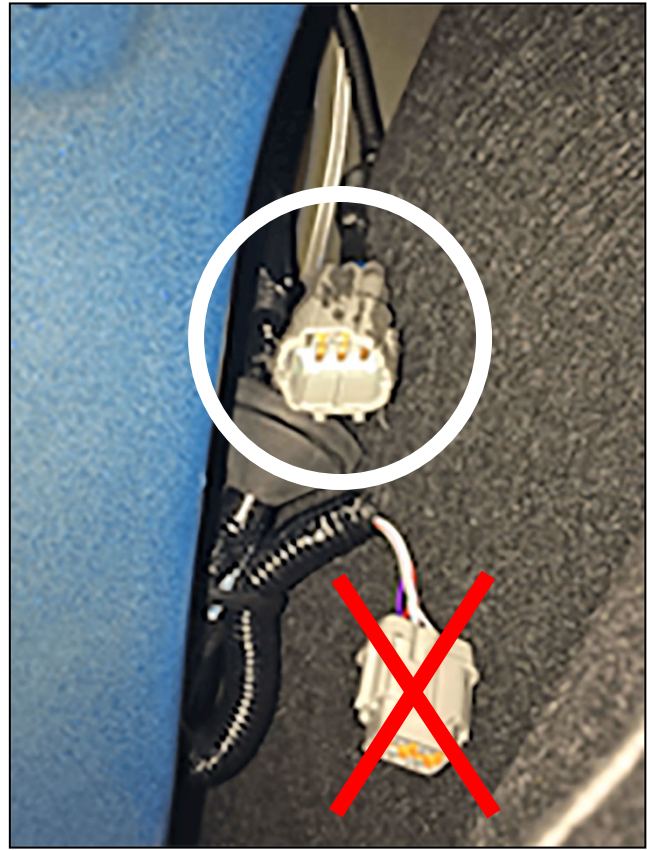
Figure 15

- Perform repairs to the circled connector, not the one with the red "X" (see Figure 15).

19. Disconnect the connector.
