Technical Service Bulletin (TSB)
Left Rear Door Trim Panel Defective

REFERENCE:	TSB: 23-032-24 GROUP: 23 - Body	Date:	May 10, 2024	REVISION:	–
VEHICLES AFFECTED:	2024 (WS) Wagoneer / Grand Wagoneer This bulletin applies to vehicles built on or after January 17, 2024 (MDH 0117XX) and on or before February 21, 2024 (MDH 0221XX).			MARKET APPLICABILITY:	
				<input checked="" type="checkbox"/> NA	<input type="checkbox"/> CH
				<input type="checkbox"/> EE	<input type="checkbox"/> IAP
				<input type="checkbox"/> SA	<input type="checkbox"/> MEA
CUSTOMER SYMPTOM:	Customers may experience the following: <ul style="list-style-type: none"> • Rear left hand door panel might show broken plastic on the bottom of the door or nearby the map pocket. • Rear left hand door panel to door attachments or component attachments may break. 				
CAUSE:	Excessive amount of colorant on the door panels Fig. 1 .

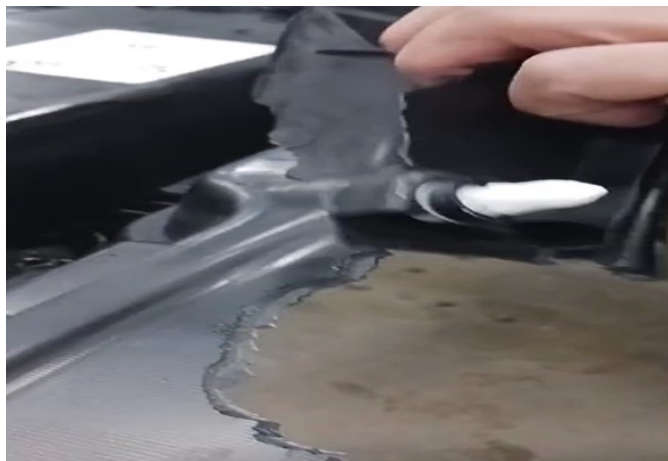
Fig. 1
Brittle Door Panel Pulling Apart

This bulletin involves replacing the rear left hand door panel.

1. Replace the left hand rear door trim panel. Refer to the detailed service procedures available in DealerCONNECT/Service Library under: Service Info> 23 - Body / Doors - Rear / Panel, Rear Door Trim / Removal and Installation.
