GENERAL MOTORS
DCS6913
URGENT - DISTRIBUTE IMMEDIATELY

Subject: N242445280 - Special Coverage
Front Exhaust Pipe

Models: 2022 Buick Enclave
2022 Chevrolet Traverse

N242445280 Front Exhaust Pipe

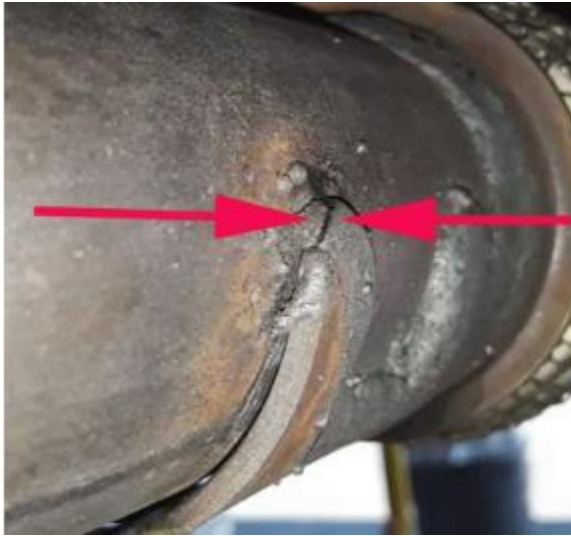
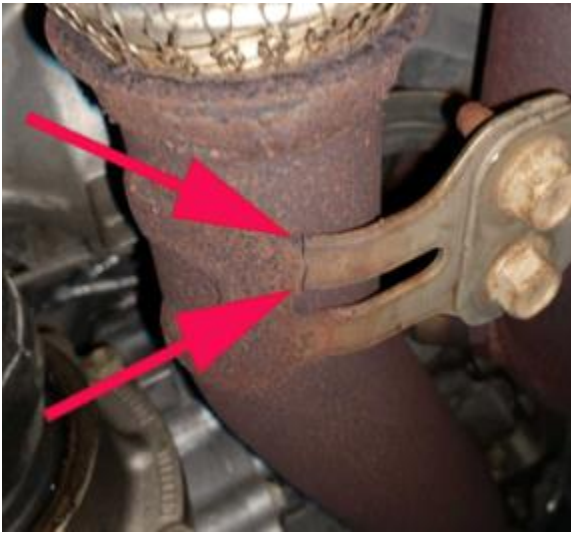
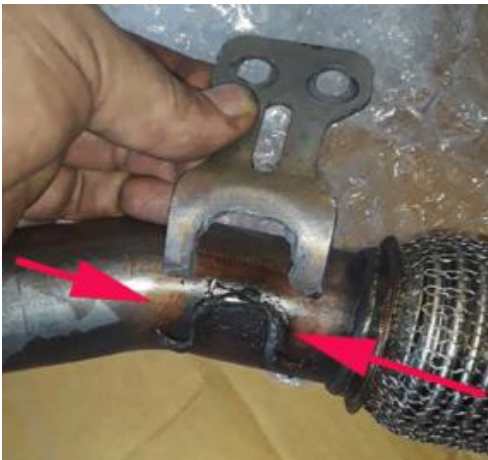
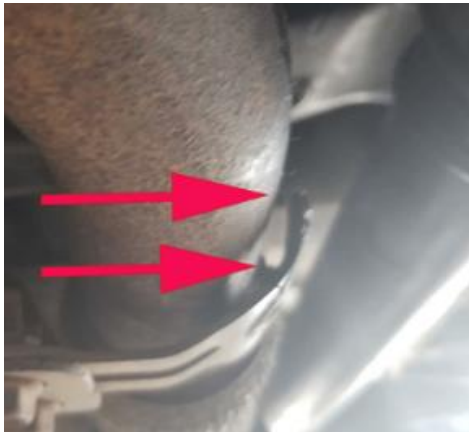
Condition	Certain 2022 model year Buick Enclave and Chevrolet Traverse vehicles may have a condition that could cause the mounting bracket on the front exhaust pipe to separate from the pipe. If this condition occurs, a hole may develop in the exhaust pipe at the bracket location, and a rattling or increased exhaust noise may be heard.
Special Coverage Adjustment	<p>This special coverage covers the condition described above for a period of 15 years or 150,000 miles (240,000 km), whichever occurs first, from the date the vehicle was originally placed in service, regardless of ownership.</p> <p>For vehicles covered by Vehicle Service Contracts, all eligible claims with repair orders on or after June 12, 2024, are covered by this special coverage and must be submitted using the labor operation codes provided with this bulletin. Claims with repair orders prior to June 12, 2024, must be submitted to the Service Contract provider.</p> <p>Vehicle owners or lessees who paid for repairs referenced in this Special Coverage ("Customers") are eligible for reimbursement of their reasonable and customary expenses in accordance with the procedures specified below. The conditional right to reimbursement is provided by GM solely in the interest of customer satisfaction and is personal to Customers. <i>Customers may not assign and GM does not consent to any assignment of any Customer's right to submit reimbursement claims, or to receive reimbursement, or any other rights granted by this Special Coverage to any third party, including but not limited to service contract providers, and this Special Coverage is not intended to and does not confer any third party beneficiary, subrogation or contribution rights, or any other rights to reimbursement, against GM, whether in law, equity or otherwise, on any third parties.</i></p>

2. Inspect the front exhaust pipe (the one that has the flex section built in) for damaged, cracked, or broken welds as shown in the photos above.
 - a. If no damage is found, no further action is required.
 - b. If damage is found, replace the damaged exhaust section. Refer to *Exhaust Front Pipe* Replacement in SI.

Correction	Dealers are to replace the front exhaust pipe as necessary. The repairs will be made at no charge to the customer.
