## STAR ONLINE PUBLICATION

**Case Number:** S2419000001

**Symptom/Vehicle Issue:** Low Pressure Power Steering Line Servicing For Leak Concerns.

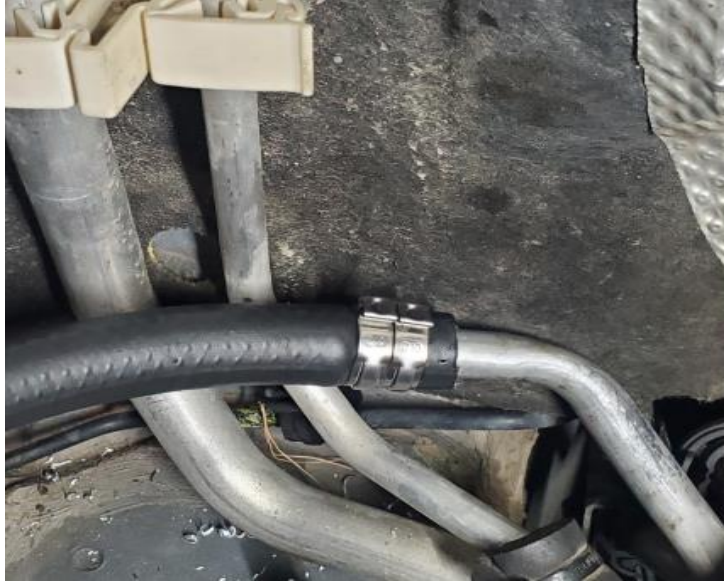
Crimp style hose clamps. High pressure fuel clamps are also acceptable.

**Discussion:** Parts supply constraints have led to a shortage of low-pressure power steering hose service parts. Most hose replacements are due to leak at clamps or in the flex hose. In the interest of customer satisfaction and “up time” for these vehicles it may be necessary to repair the low-pressure hose and secure it in a safe manner until a MOPAR service hose assembly is available. For flex hose leaks use bulk hose rated for use with oils and designed for use with low side power steering pressures available through a local supplier. The clamps used to attach the bulk hose to the metal line should be compression crimp style or high-pressure fuel injection worm clamps also available at a local parts supplier. If a rub through condition is found on the metal portion of the line, it may be necessary to cut that portion off and use a flare tool to create a factory style raised lip flare for hose retention once its clamped. Once the repair is made, use cable or zip ties to retain the hose in its original location. See the below images for reference.

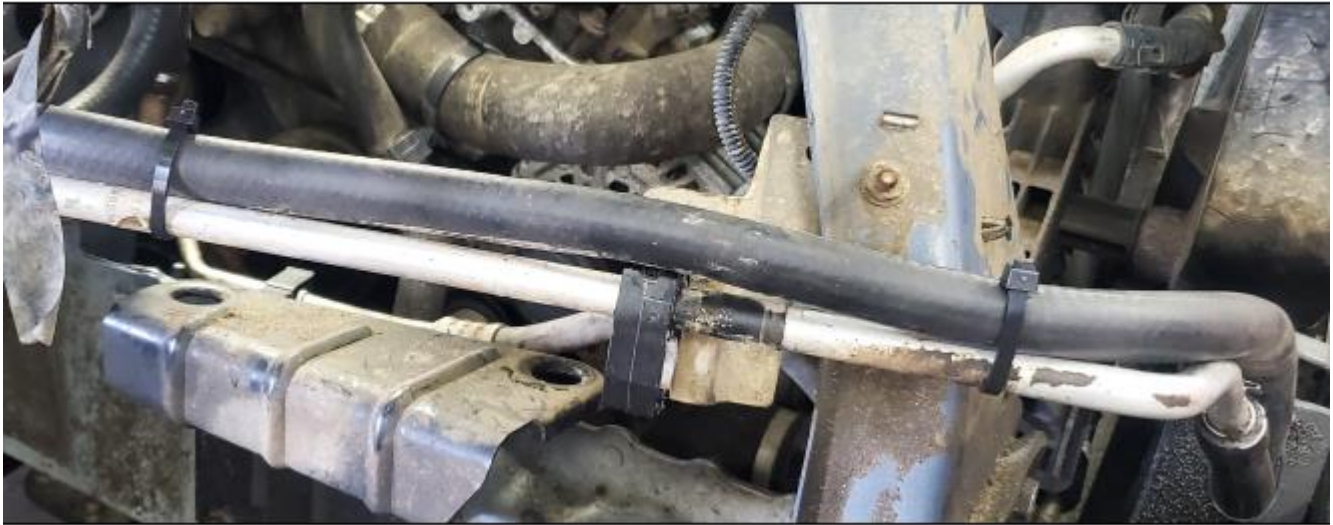
Cable ties used to secure routing of the repaired hose.
