Diagnostic Sheet

Grecale –Axle shaft Clicking Noise - Tech Tip

DATE: June 6, 2024

MODELS: M182 Grecale (All MY).

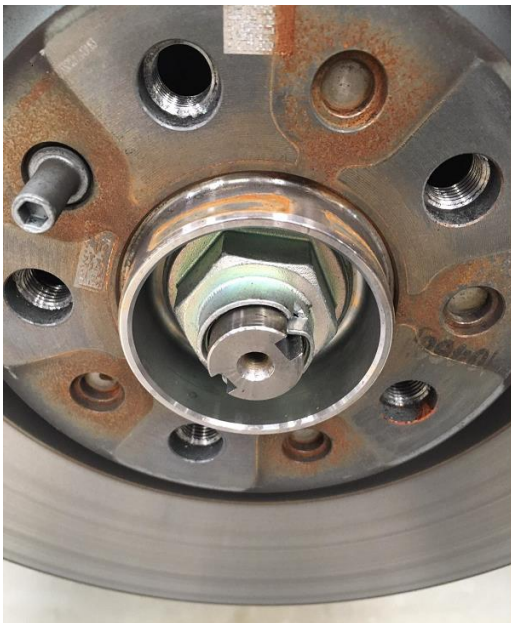
Picture 1

CONCERN: Front/rear clicking noise while maneuvering the vehicle

1. Remove the M24 axle nut (Pic.1) and thoroughly clean the grooves and hub thread with brake cleaner (Pic. 2).
2. Apply Molykote copper paste as illustrated – (Pic.3)
3. Replace the axle nut (component #12 in spare parts table 03.22-2 FRONT WHEELS TRANSMISSION)
4. Perform axle shaft nut tightening procedure as indicated in the workshop manual
