Diagnostic Sheet

Grecale - Noise From Door Speakers

MODELS: M182 Grecale (All MY).

SUBJECT: Abnormal noise (humming/buzzing) coming from the door speakers during audio playback.

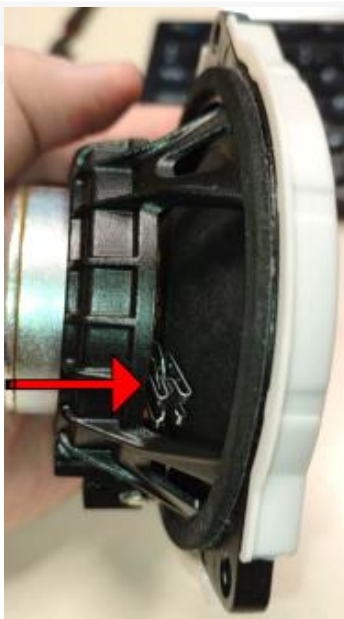
1. Save a complete scan report of the control units in the vehicle.
2. Verify the repeatability of the customer's complaint. If confirmed, record a video that clearly shows the problem. Identify and note the position of the speaker affected by the anomaly.
3. Remove the speaker in question from its seat, leaving it electrically connected. Under these conditions, record a video of the speaker operating.
4. Check for a metal clip on the back of the speaker. Example photo below. If present, remove it.

6. Reassemble the speaker in its seat and carry out a functional test. Record a video.
7. Open a BOL as "factory information", reporting all the data collected during the diagnosis. If the information attached in the BOL proves that the problem persists, even after the checks have been carried out, proceed with replacing the speaker.

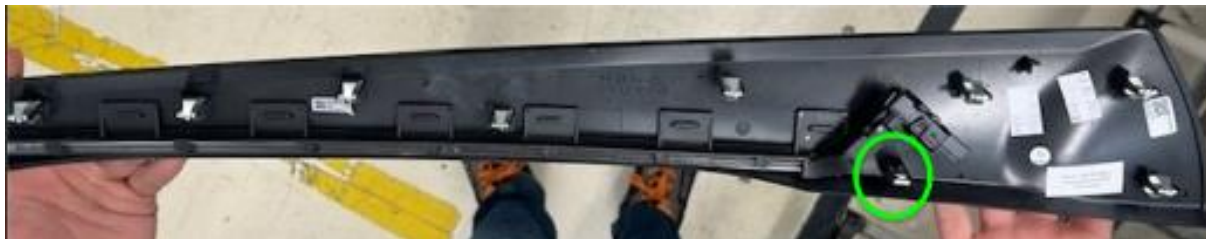
5. Check whether the trim of the corresponding door panel has any missing clips. Example photo below. If so, reset the clip positioning.
