# Technical Service Bulletin

## 66 Exterior black optic trim peeling / spotted

66 24 07 2074058/1 May 28, 2024.

Model(s)	Year	VIN Range	Vehicle-Specific Equipment
A3, S3, and RS 3	2022 - 2025	All	Black optic trim
Q4 e-tron, Q4 Sportback e-tron, e-tron GT, and RS e-tron GT	2022 - 2024

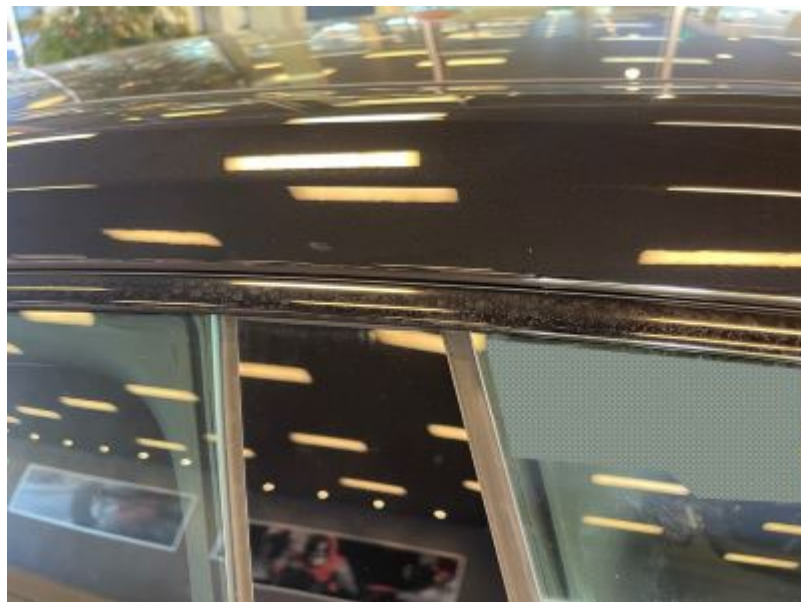
The finish on the black optic exterior trim is peeling or spotted.

*Figure 1. Typical spotting on black optic trim.*

Various degrees of damage to the trim finish are confirmed.

The affected trim will need to be replaced in these cases however, due to the nature of the root cause of the failure of the trim finish having been determined as chemical contamination, trim replacement under warranty is prohibited.

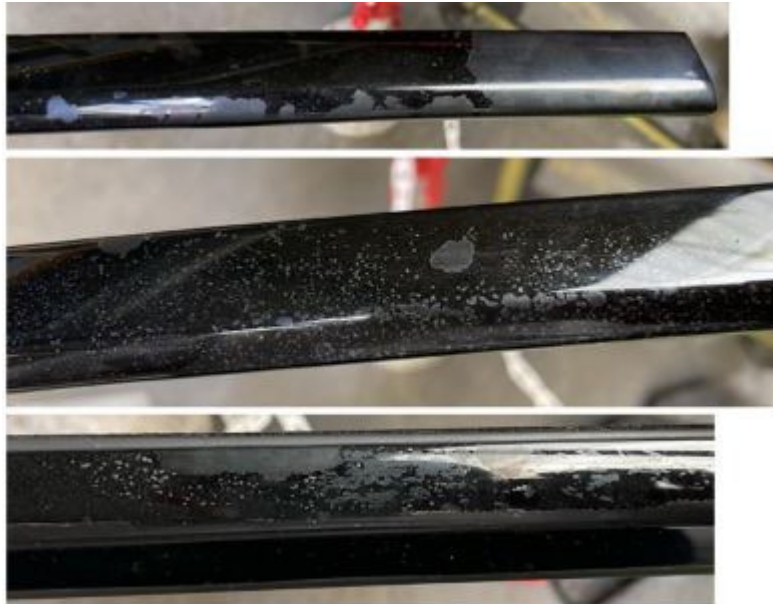
1. Figure 2 shows varying degrees of peeling finish.

**Figure 2.** Black optic trim peeling.

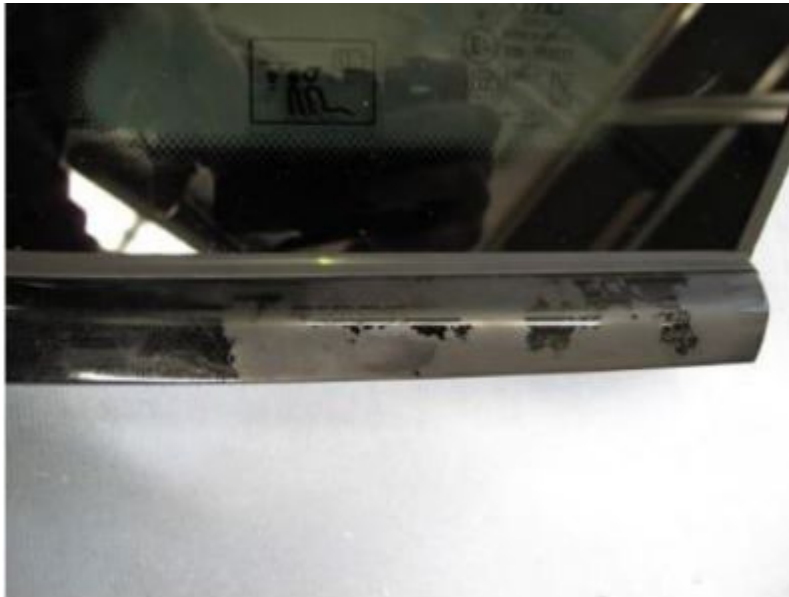
2. Figure 3 shows the black optic door trim with a peeling condition.

**Figure 3.** Black optic door trim peeling.

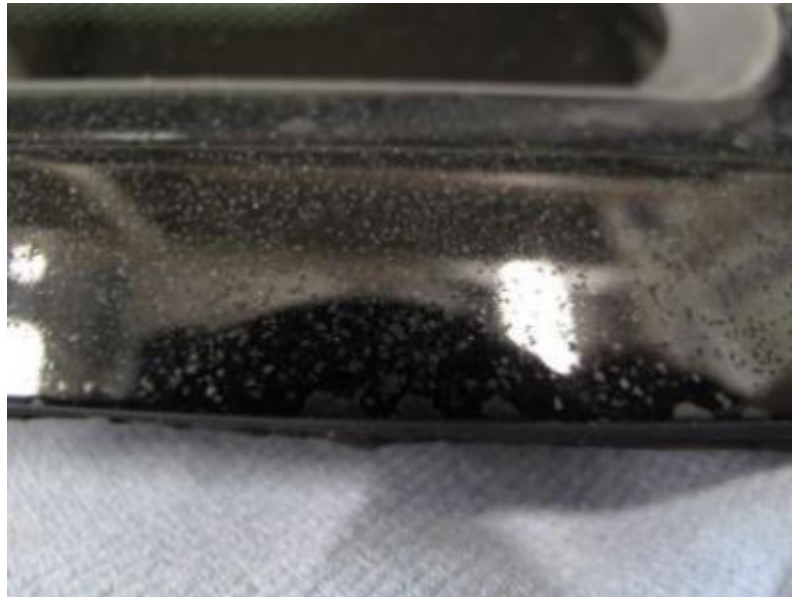
3. Figure 4 shows finish delamination in a droplet pattern.

**Figure 4.** Droplet patterned finish adhesion failure.

4. The droplet pattern is indicative of the trim having been sprayed with a caustic cleaner. The cleaner has compromised the finish and the droplets are also found on the adjacent rubber strip.

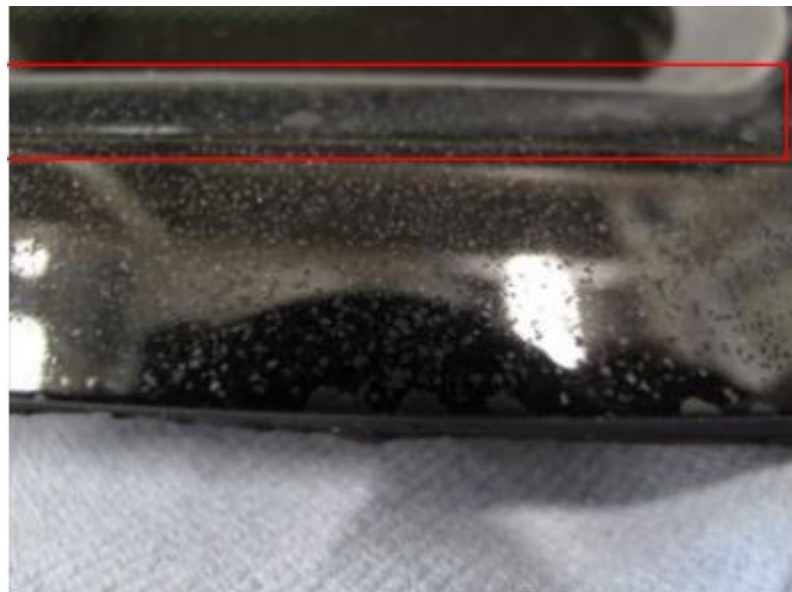
**Figure 5.** Droplet pattern migration to adjacent rubber strip.

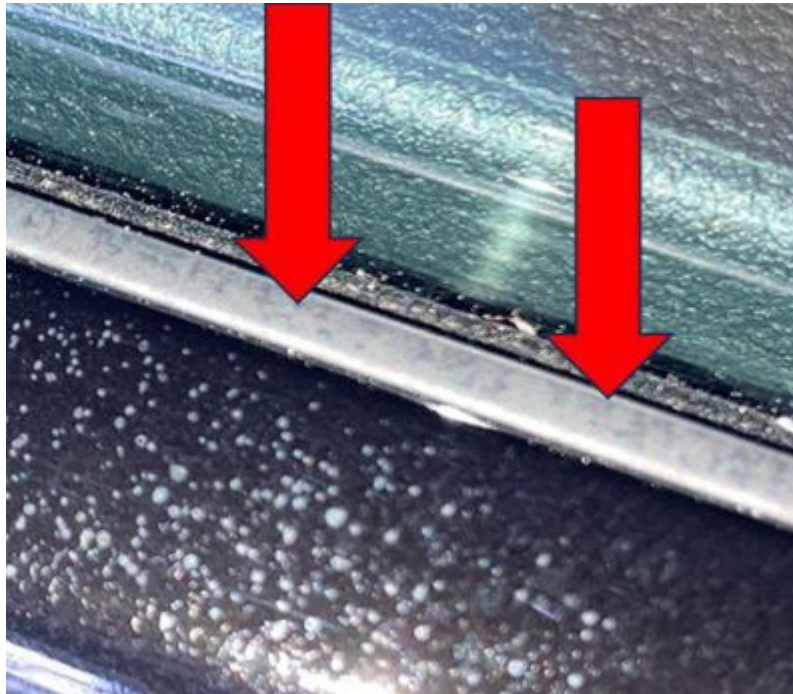
5. Various rubber components adjacent to the damaged black optic trim show the droplet pattern as well.

**Figure 6.** Droplet pattern migration to adjacent rubber components.

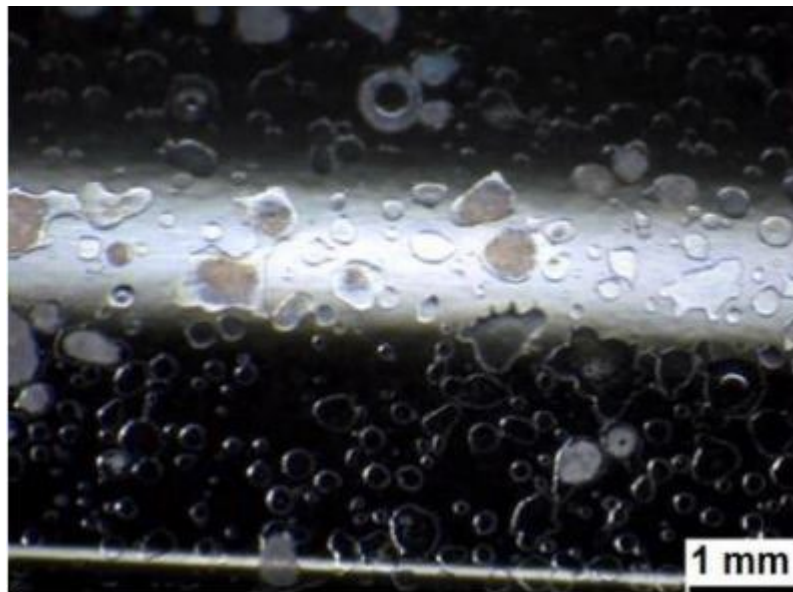
6. Figure 7 shows the delamination blisters under magnification.

**Figure 7.** Magnified view of blistering that results from contact with caustic cleaners.

7. After laboratory analysis traces of Fluorine and Phosphorus were detected on the analyzed trim components. These elements are not present in the manufacturing process of the trim components in production. These elements are commonly found in more aggressive cleaning agents. As a result, the root cause of the damage to the trim described in this TSB is due to contact with aggressive cleaning

agents. These cleaning materials include but are not limited to insect removers or wheel cleaners. These materials attack the black optic finish and cause delamination. Additionally, the use of high-pressure washers accelerates the extent to which the trim finish is damaged. The damage is irreversible and cannot be repaired.
