Technical Service Bulletin

70 Noises from door trim panel(s)

70 24 90 2064546/7 May 14, 2024. Supersedes Technical Service Bulletin Group 70 number 23-84 dated June 29, 2023 for reasons listed below.

Model(s)	Year	VIN Range	Vehicle-Specific Equipment
e-tron GT, and RS e-tron GT	2022 - 2024	All	Not Applicable

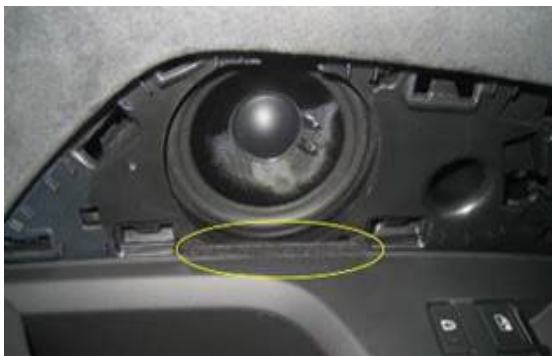
Figure 1. Felt strip section applied to opening in door panel.

- Remove the midrange speaker trim. Using felt tape (533867910A), apply a section to the lower part of the opening for the trim in the door panel.
- Ensure that this section of felt will not be visible when the speaker trim is reinstalled (Figure 1).

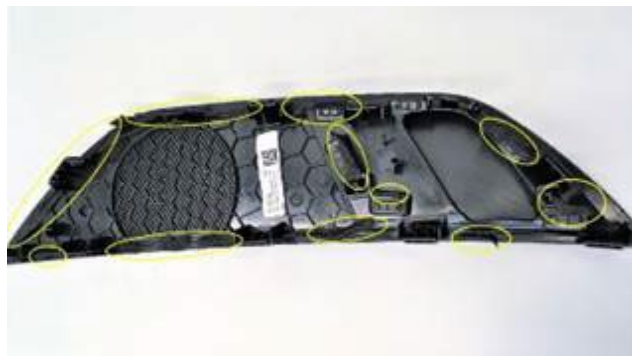
Figure 2. All tabs on the midrange speaker trim that require felt tape.

All of the tabs on the speaker trim that engage the opening in the door panel will need to have felt tape applied to each of them (Figure 2).

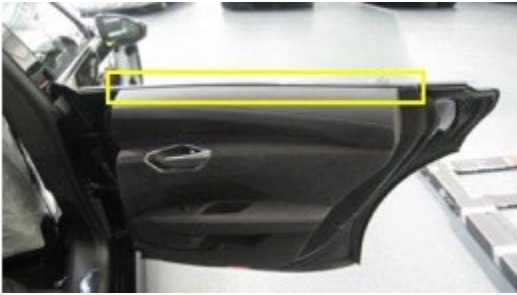
Figure 3. Apply fleece tape to the trim panel mounting strip.

- Bond fleece tape (D373125A2) into mounting strip. To do so, position fleece tape at edge of fastening strip and fold it over towards inside. Then press it on across entire surface (Figures 3-5).

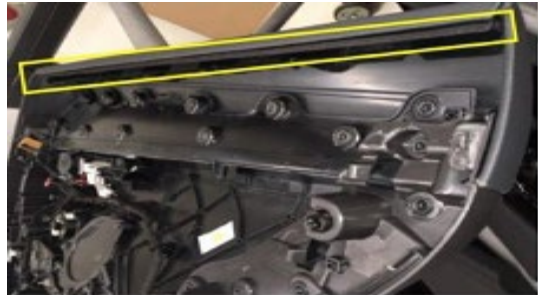
Figure 4. Fleece tape applied to mounting strip.

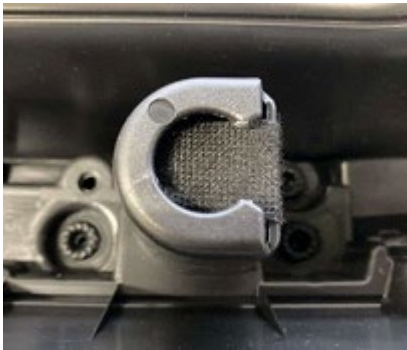
Figure 6. Door clip with fleece tape applied.

- Apply fleece tape (D373125A2) to door trim panel clips and to body mounting points to reduce play (Figures 6-7).

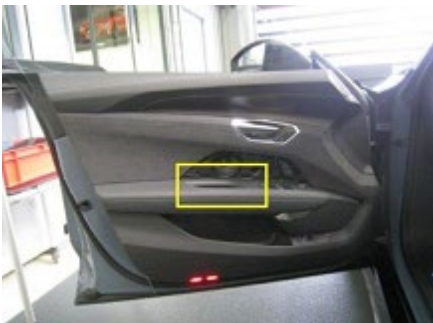
Figure 8. Isolate pull handle from armrest.

- Isolate the door trim panel pull handle from the armrest by applying fleece tape (D373125A2) or special lubricant (G052172A1) in the areas of contact (Figures 8-9).

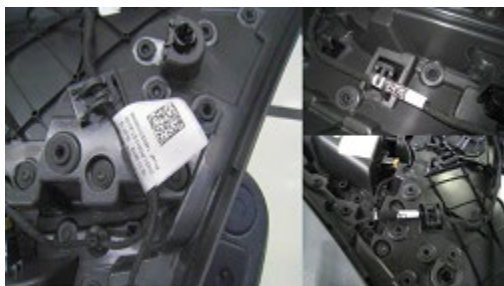
Figure 10. Repositioned part label.

- Secure the door wire harness and/or part labels by repositioning them and/or applying fleece tape (D373125A2) (Figures 10-13).

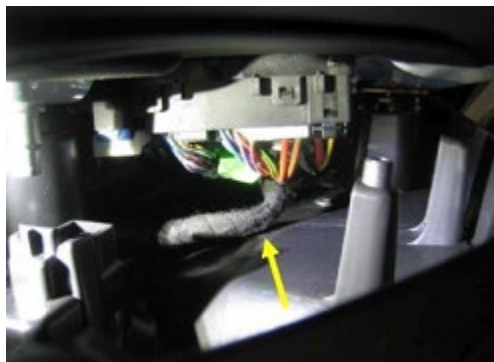
Figure 11. Wire harness contacting door trim panel.

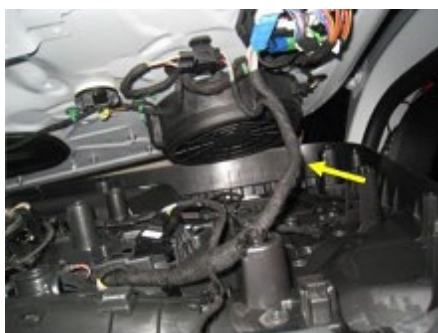
Figure 12. Wire harness not secured properly.

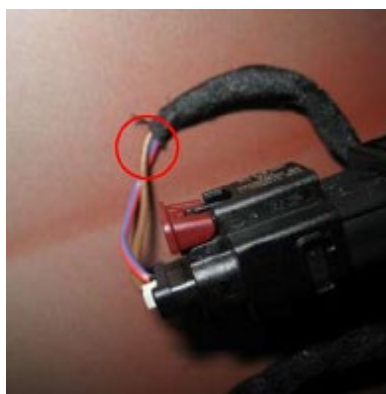
Figure 13. Wire harness contacting body.

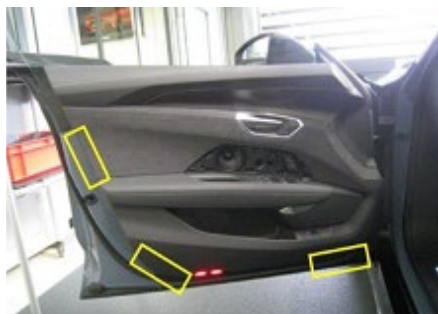
Figure 14: Apply felt tape to edge of trim panel.

- Apply felt tape (533867910A) to edge of door trim panel or on the existing piping strip in area of close contact. (Figures 14-15).

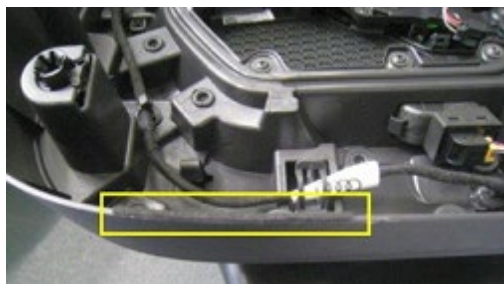
Figure 15. Felt tape installed on trim panel.

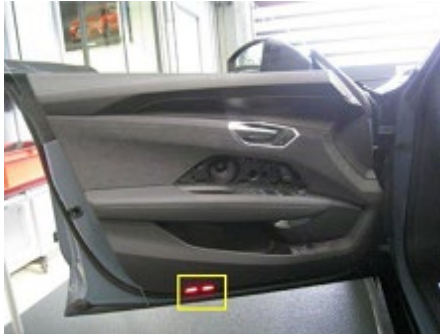
Figure 16. Apply fleece tape to trim panel light and wiring.

- Wrap cable for door trim panel light assembly with fleece tape (D373125A2) as far as to the connector. Also apply fleece tape to light assembly to reduce play in mounting (Figures 16-18).

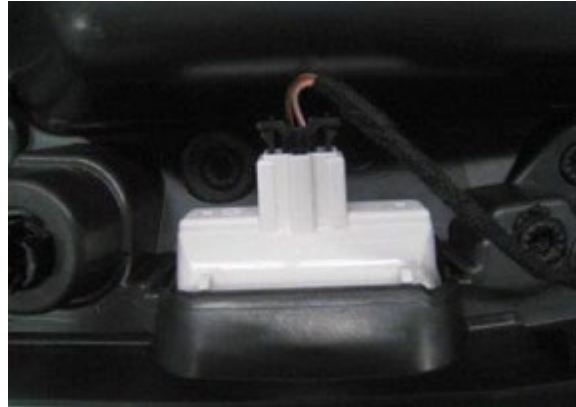
Figure 17. Wrapping light wire harness with fleece tape.

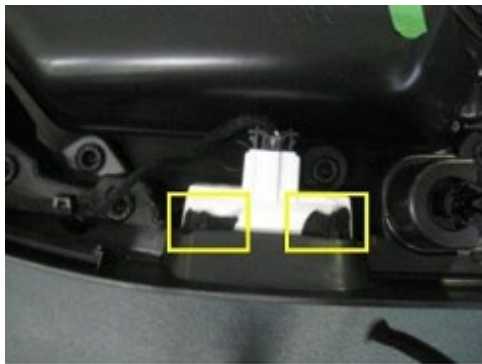
Figure 18. Fleece tape applied to light assembly.

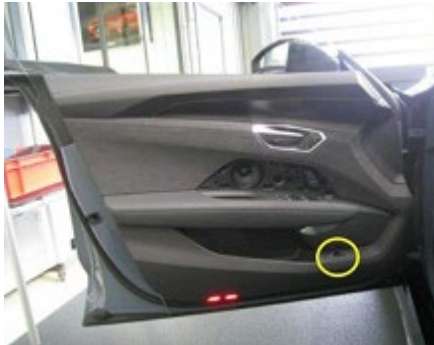
Figure 19. Bend retaining tab of power rear lid switch.

- Carefully bend open retaining tab of power rear lid switch for a more secure fit (Figures 19-20).

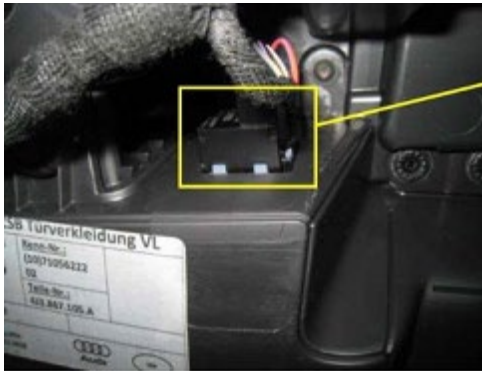
Figure 21. Apply fleece tape to pocket lighting.

- Apply fleece tape (D373125A2) to the retaining tabs of the diffuser of the door pocket lighting (Figures 21-22).
