Service Action

Code: 82C9

Subject	Electric Passenger Compartment High-Voltage (HV) Heater														
Document History	<table border="1"> <thead> <tr> <th style="background-color: #c00000; color: white;">Date</th> <th style="background-color: #c00000; color: white;">Summary</th> </tr> </thead> <tbody> <tr> <td>05/10/2024</td> <td>Updated work procedure</td> </tr> <tr> <td>01/24/2024</td> <td>Updated parts information and work procedure</td> </tr> <tr> <td>10/26/2023</td> <td>Original publication</td> </tr> </tbody> </table>	Date	Summary	05/10/2024	Updated work procedure	01/24/2024	Updated parts information and work procedure	10/26/2023	Original publication						
Date	Summary														
05/10/2024	Updated work procedure														
01/24/2024	Updated parts information and work procedure														
10/26/2023	Original publication														
Affected Vehicles	<table border="1"> <thead> <tr> <th style="background-color: #c00000; color: white;">Country</th> <th style="background-color: #c00000; color: white;">Beginning Model Year</th> <th style="background-color: #c00000; color: white;">Ending Model Year</th> <th style="background-color: #c00000; color: white;">Vehicle</t

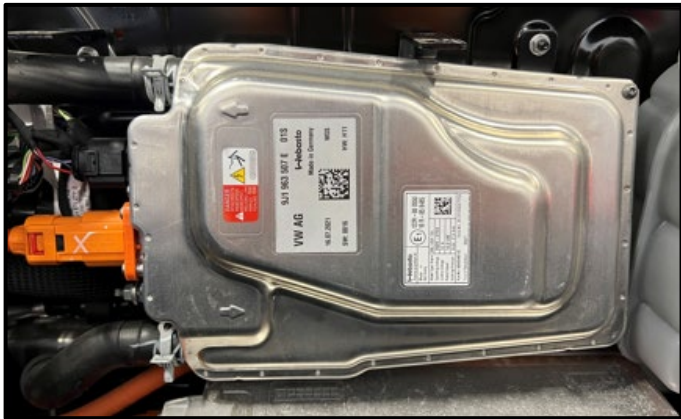
Repair Overview

- Inspect the Z189 high-voltage in-line heater.
- Replace if necessary.

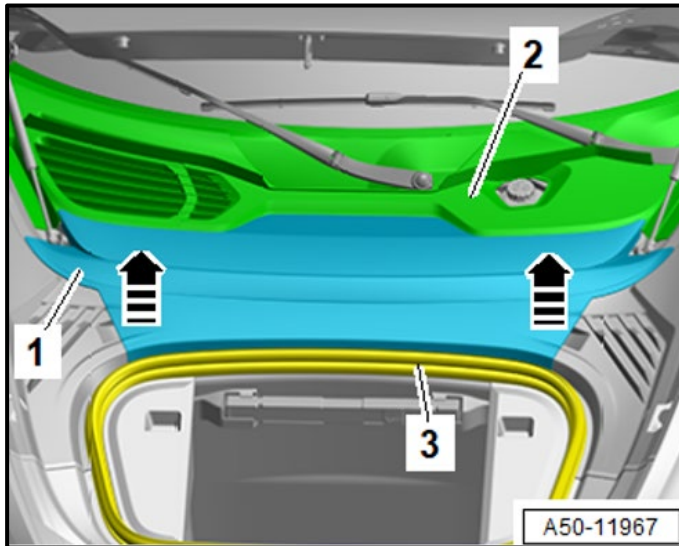
Remove the front plenum chamber:

- Loosen the plenum chamber cover <1> from the retainers <arrows> and remove from the luggage compartment seal <3>.
- Remove the plenum chamber cover <1> toward the front of the vehicle.
- Remove any remaining clips using the Omega Clip Tool -T40280-.

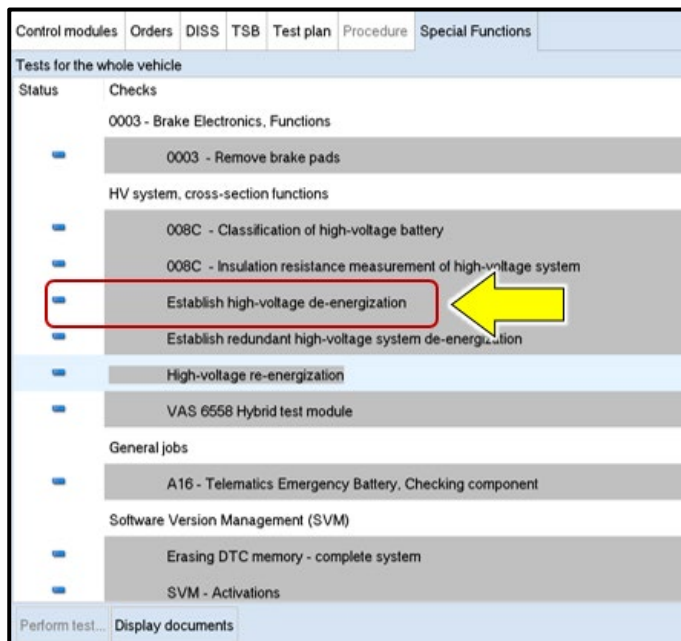
De-energize the high-voltage system:

- Attach a 12V battery maintainer/charger.
- Under the special functions tab, select the test plan for “Establish high-voltage de-energization”.
- Follow the test plan steps until the high-voltage system is successfully de-energized.
- Also, reference the ELSA repair manual when de-energizing the high-voltage system: *Repair manual > Motor > Electric Drive Motor 0EG > 93 Electric drive > High-Voltage System, De-Energizing.*

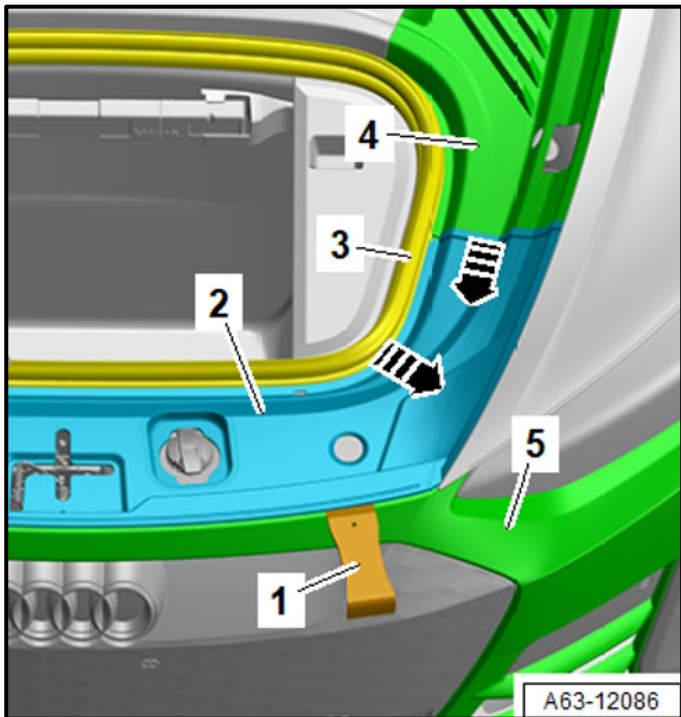
Remove the front lock carrier cover:

- Using Removal Wedge -T40233- <1>, release the retainers for the lock carrier <2> at the bumper cover <5>.
- Release the retainers at the fender using the trim removal wedge.
- Disengage the lock carrier cover <2> from the luggage compartment seal <3> and the cover <4> in the direction indicated <arrows> and remove.

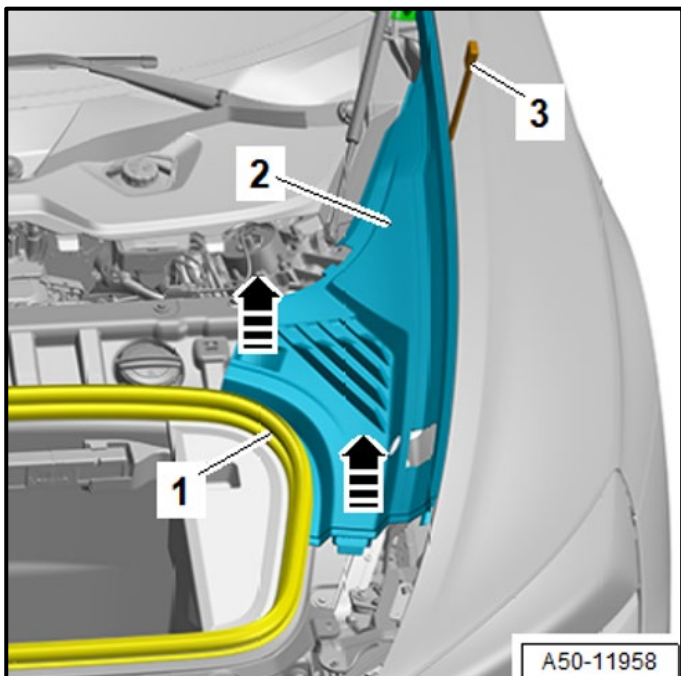
Remove the fender covers:

- Loosen the fender cover <2> using scraper number 3 from the Scraper Set -VAS6845- <3>.
- Loosen the cover from the catches <arrows>, disengage the cover from the luggage compartment seal <1>, and remove.

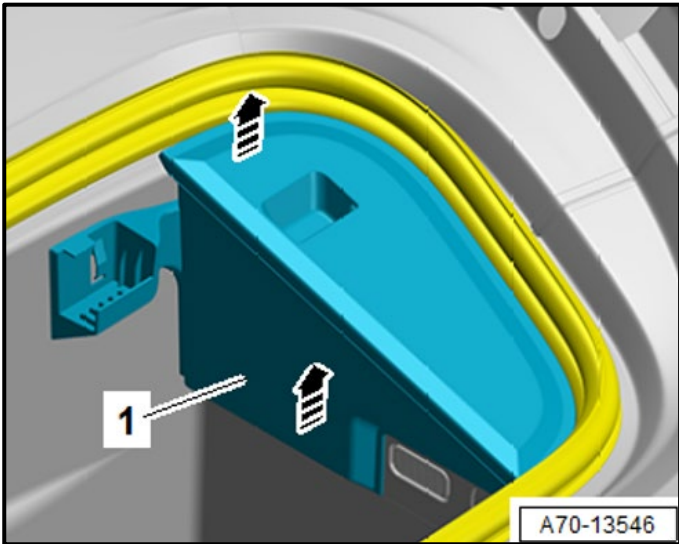
Remove the front luggage compartment lamp and emergency release button:

- Remove the driver's side storage compartment <1> from the luggage compartment liner mounts in the direction indicated <arrows>.

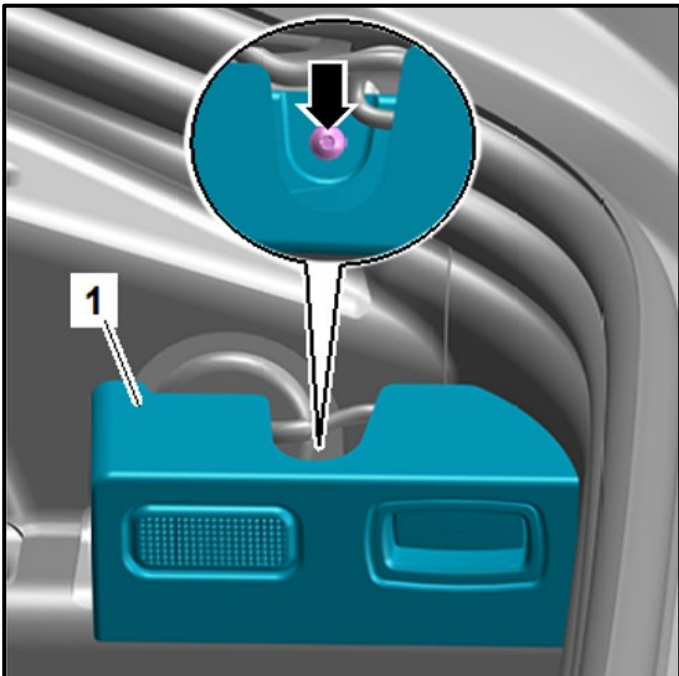
- Remove the bolt <arrow> from the cover <1>.

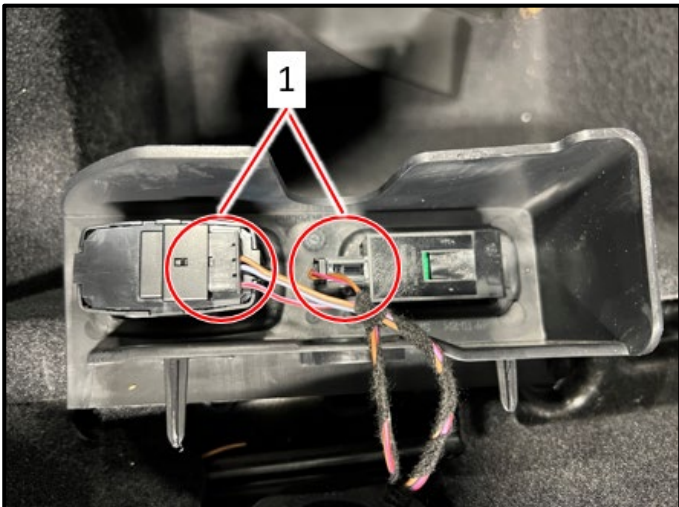
- Disconnect the connectors <1> and remove the cover.

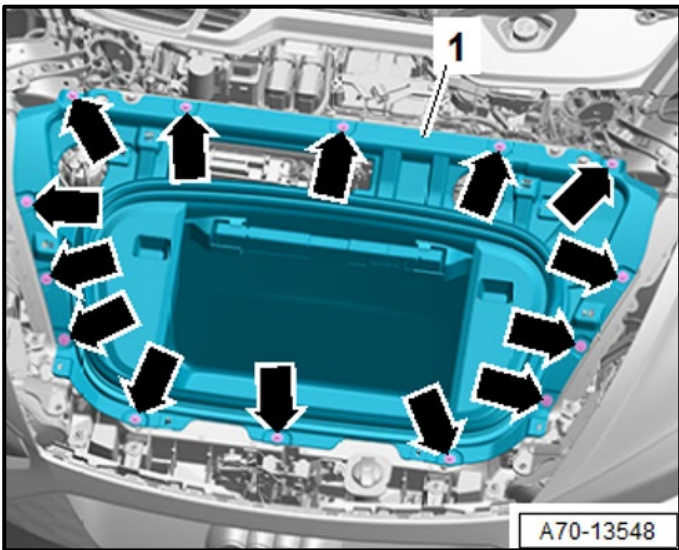
Remove the front luggage compartment liner:

- Remove the bolts <arrows>.

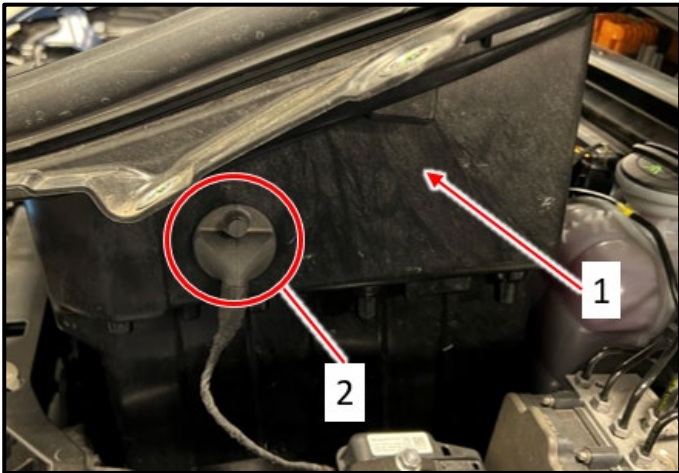
- Slightly lift the driver's side of the luggage compartment liner <1>
- Remove the rubber grommet <2> from the luggage compartment liner <1>.
- Remove the luggage compartment liner <1> from the vehicle.

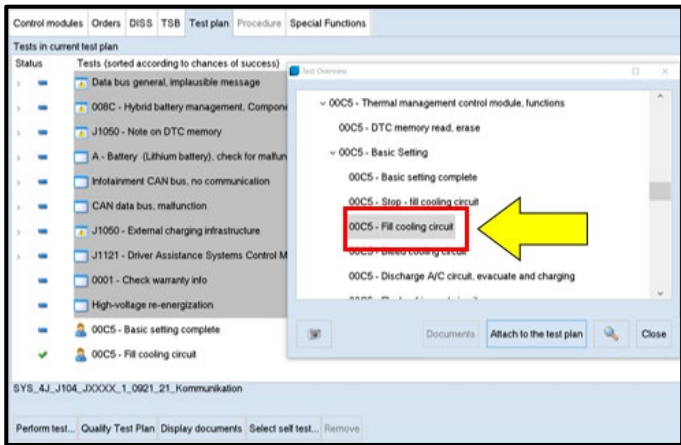
When looking under guided functions for the thermal management module, Diagnostic Address 00C5, there will not be a specific test plan for opening the coolant valves.

- In ODIS under the Diagnosis tab: *Select the test plan tab > select self test > Diagnostic capable systems > 00C5 - Thermal management control module > Thermal management control module, functions > 00C5 - Basic settings > 00C5 - Fill cooling circuit > Attach to the test plan.*
- Perform the test plan and follow the steps.
- Continue with draining the cooling system per the ELSA repair manual once the valves have been opened.

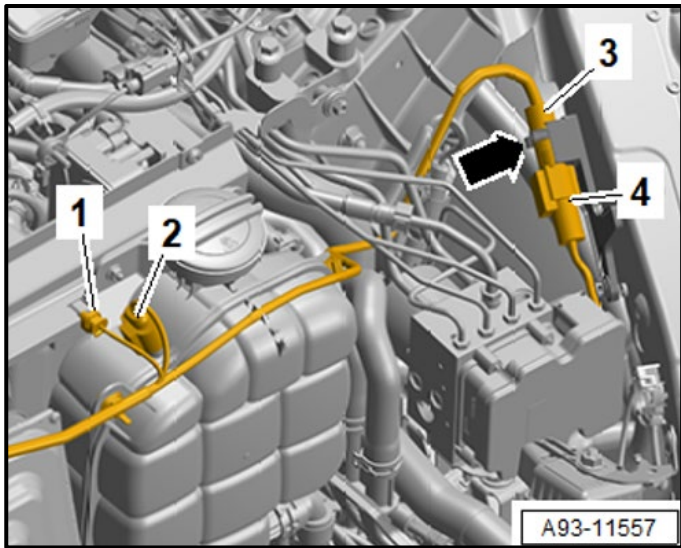
Loosen the under hood E-box:

- Remove the connector housing <3> from the retainer <arrow>.
- Disconnect the connectors <1>, <2>, and <4>.

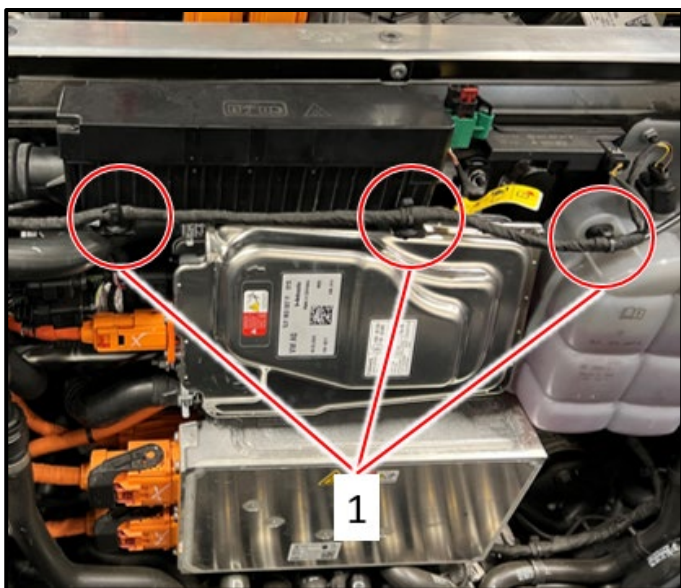
- Loosen the wiring harness by releasing the retaining clips <1>.

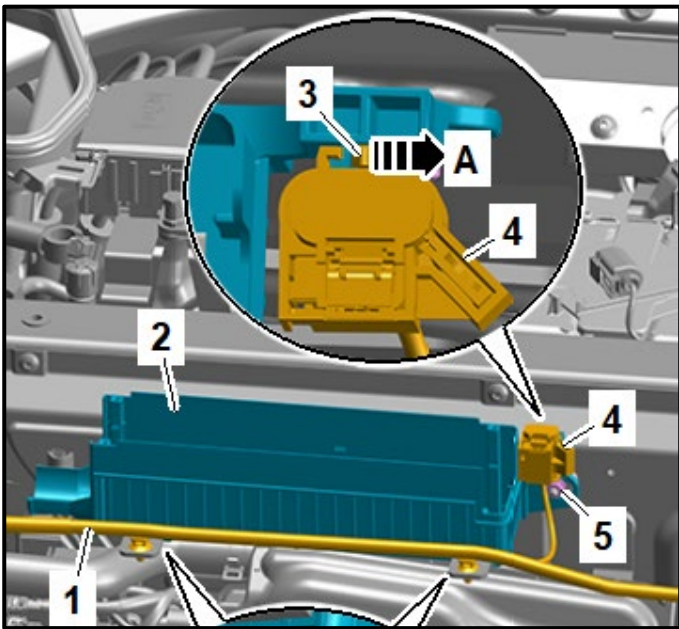
- Release the tab <3> in the direction indicated <arrow A> and slide the High-Voltage System Maintenance Connector housing -TW- <4> down to remove it.
- Move the harness <1> to the side.

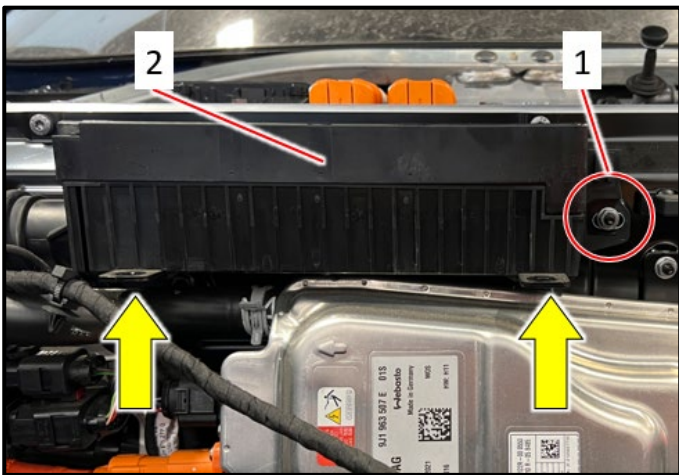
- Remove the nut <1>.
- Release the retaining tabs under the E-box using a suitable tool <arrows>.
- Remove the E-box <2> from the bracket towards the front of the vehicle, and carefully lay to the side.

A long 90° pick tool works well for releasing the retaining tabs.

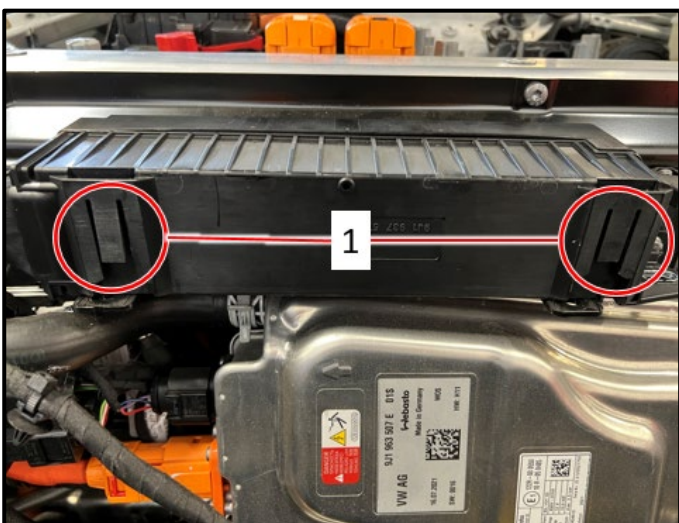
E-box retaining tabs <1> shown with the E-box removed for clarity.

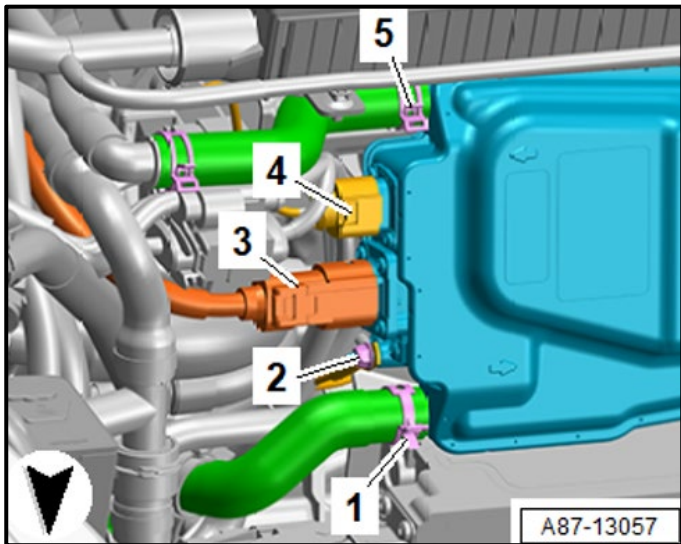
Replace the Z189 high-voltage in-line heater:

- Disconnect the connector <4> and secure to the side.
- Disconnect the high-voltage cable <3> and secure to the side.
- Place lint free cloths under the coolant hoses to catch any residual coolant.
- Loosen the hose clamps <1> and <5> and remove the coolant hoses.
- Remove the nut <2> and the potential equalization cable.
- Remove the nuts <3>.
- Disengage and move the coolant expansion tank <4> to the side until the nut <2> is accessible.

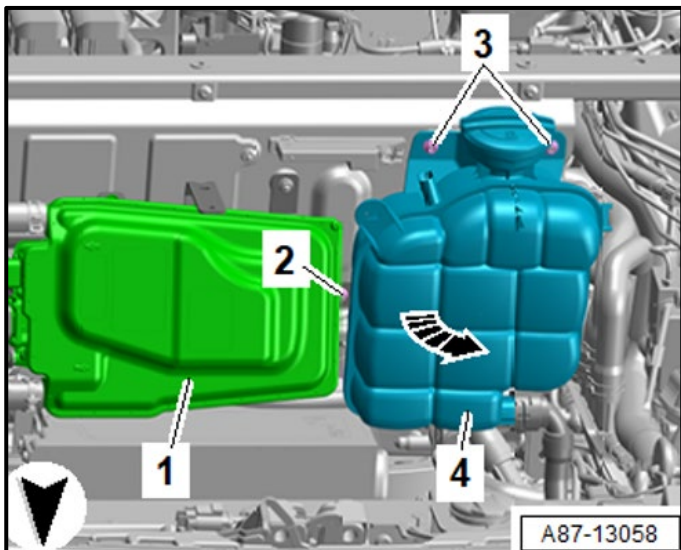
- Remove the nuts <3>.
- Remove the High-Voltage In-Line Heater -Z189- <1> with the bracket <2>.

Some versions of the securing bracket <2> have a bolt in the lower right corner instead of a nut.

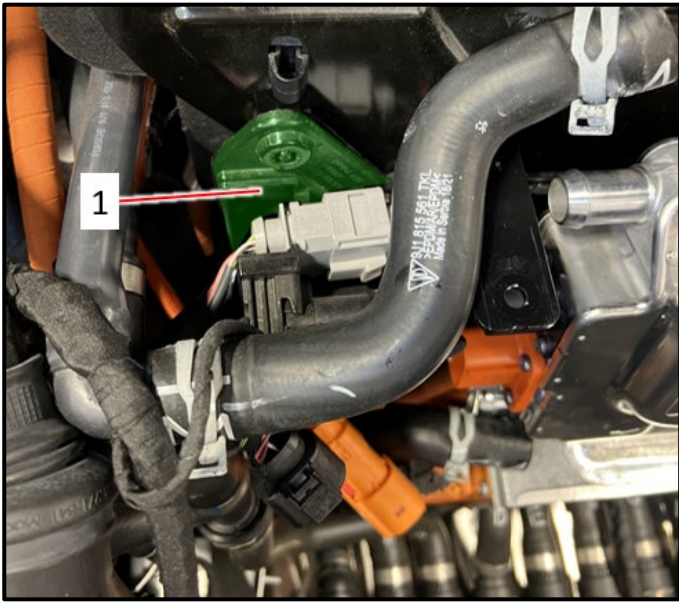
The wiring harness bracket <1> can be loosened to allow for better access to the -Z189- bracket fasteners.

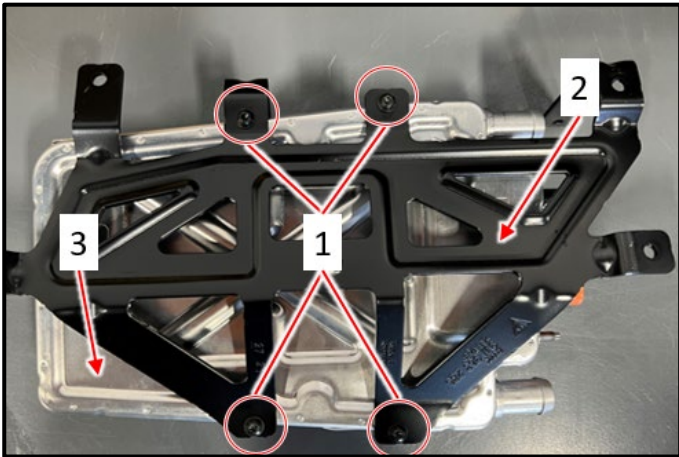
- Remove the screws <1>.
- Transfer the bracket <2> to the new High-Voltage In-Line Heater -Z189- <3>.
- Tighten the screws <1> to 4 Nm.

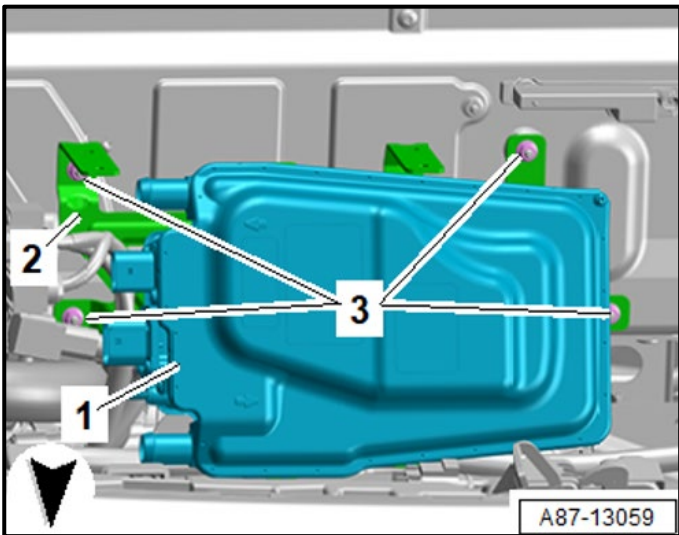
Install the Z189 high-voltage in-line heater:

- Install the high-voltage heater <1> with the bracket.
- Replace the nuts <3>.
- Tighten the nuts <3> to 8 Nm.

Versions of the bracket with a bolt in the lower right corner: The bolt does not require replacement.

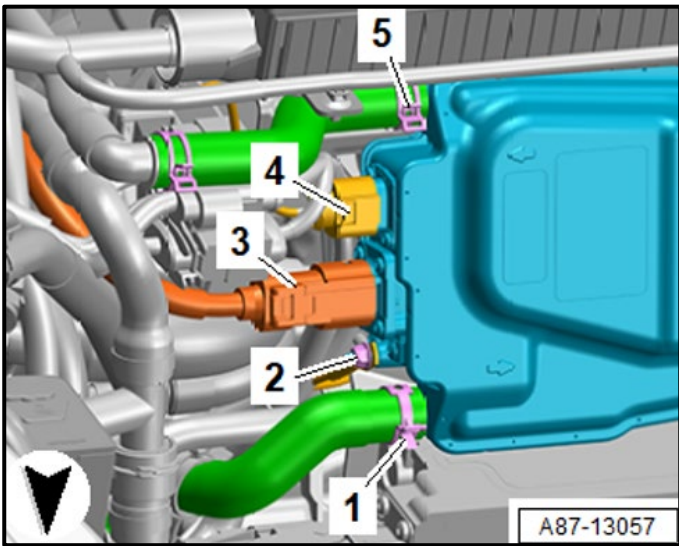
- Connect the potential equalization cable and tighten the nut <2> to 8 Nm.

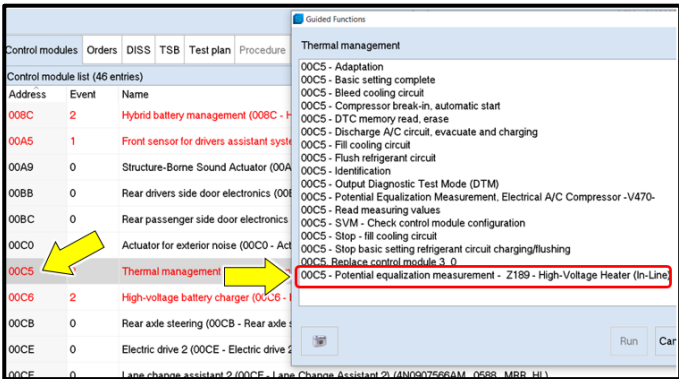
Perform the potential equalization measurement:

- In ODIS: *Select Diagnosis > Select DA 00C5 (Thermal Management) > Guided functions > perform “Potential Equalization Measurement – Z189 – High-Voltage Heater (In-Line)”.*
- Follow the steps listed by the test plan.

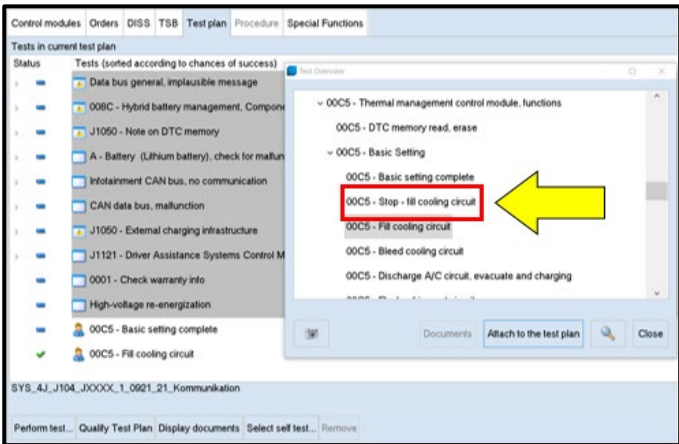
When looking under guided functions for the thermal management module, Diagnostic Address 00C5, there will not be a specific test plan for closing the coolant valves after filling.

- In ODIS under the Diagnosis tab: *Select the test plan tab > select self test > Diagnostic capable systems > 00C5 - Thermal management control module > Thermal management control module, functions > 00C5 - Basic settings > 00C5 - Stop - fill cooling circuit > Attach to the test plan.*
- Perform the test plan and follow the steps.
- Continue with the steps in the ELSA repair manual once the valves have been closed after filling.
- Bleed the cooling system per the ELSA repair manual: *Repair manual > Motor > 19 Cooling System > Cooling System/Coolant > Cooling System, Bleeding.*

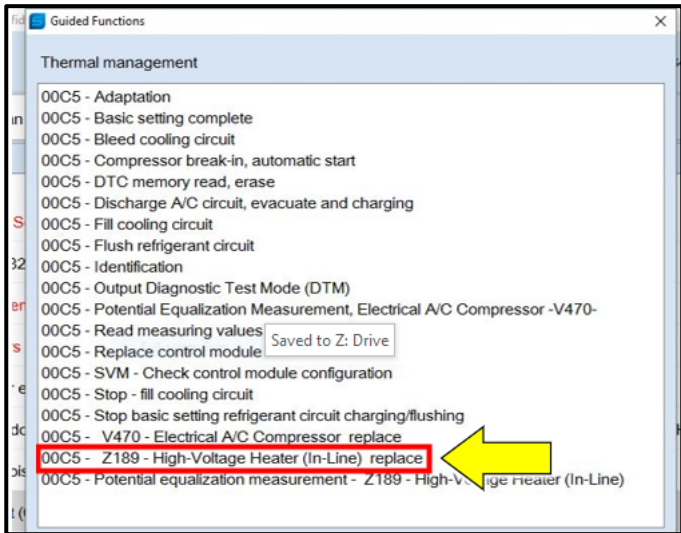
Perform Z189 replacement test plan:

- In ODIS: *Select Diagnosis > Select DA 00C5 (Thermal Management) > Guided functions > 00C5 - Z189 - High - Voltage Heater (In - Line) replace.*
- Follow the steps listed by the test plan.
