June 2024  
SF691 A

## Subject: M2 Plus Work Brake

**Models Affected: Specific model years 2024-2025 Business Class  
M2 vehicles manufactured between March 23, 202, through April 9, 2024.**

The parameters that control the work brake function do not operate properly.

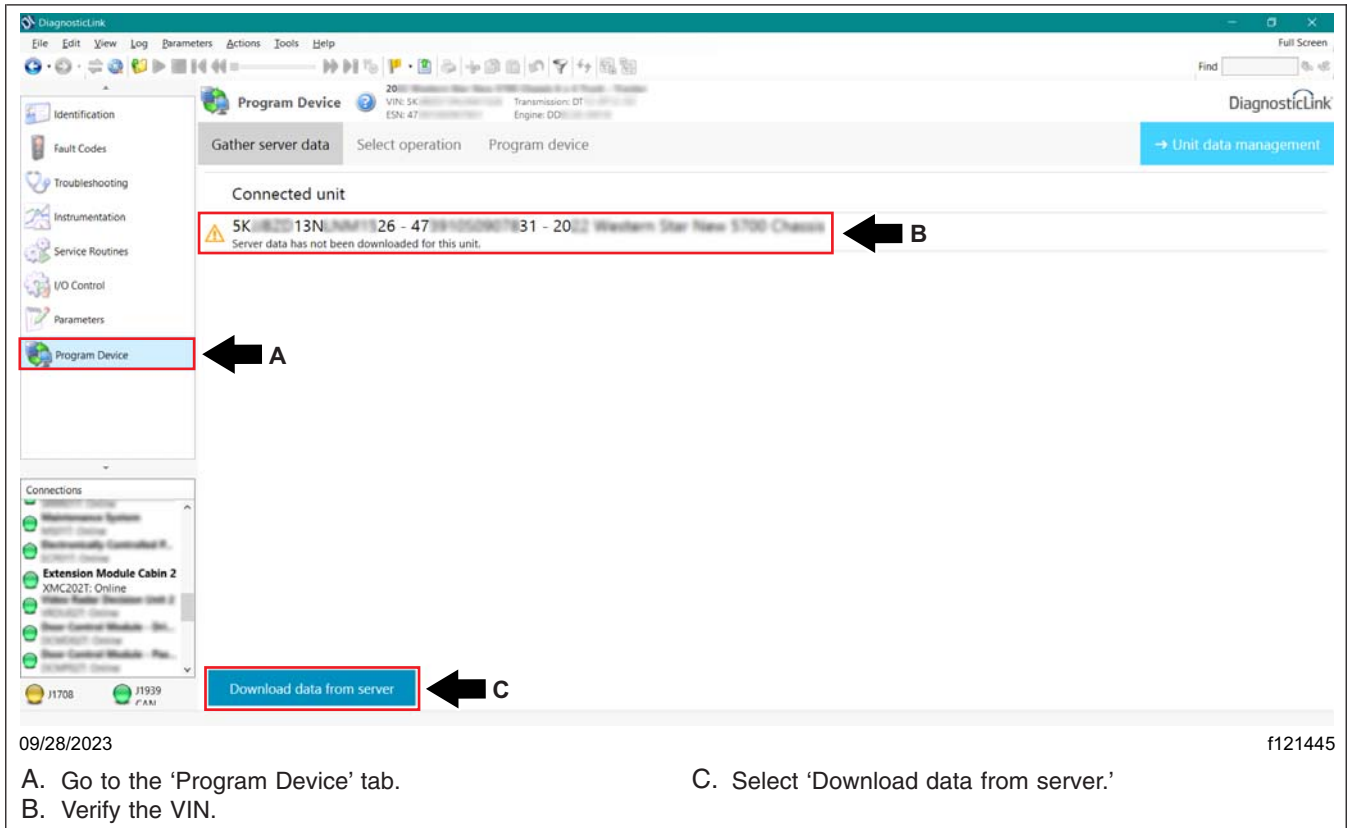
**Fig. 1, Downloading Data from the Server**

- Go to the 'Program Device' tab, and make sure that the vehicle identification number (VIN) that appears is correct. Select 'Download data from server.' See Fig. 1.

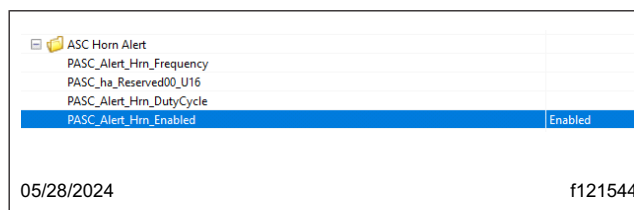
**Fig. 2, PASC\_Alert\_Hrn\_Enabled Parameter Value Set to Enabled**

- After the server data download is complete, go to the 'Parameters' tab.
- Select and expand the 'SSAM02T – Single SAM' folder.
- Select and expand the 'ASC Horn Alert' sub-folder.
- Select the 'PASC\_Alert\_Hrn\_Enabled' parameter, and make sure the parameter value is already set to 'Enabled,' as shown in Fig. 2.

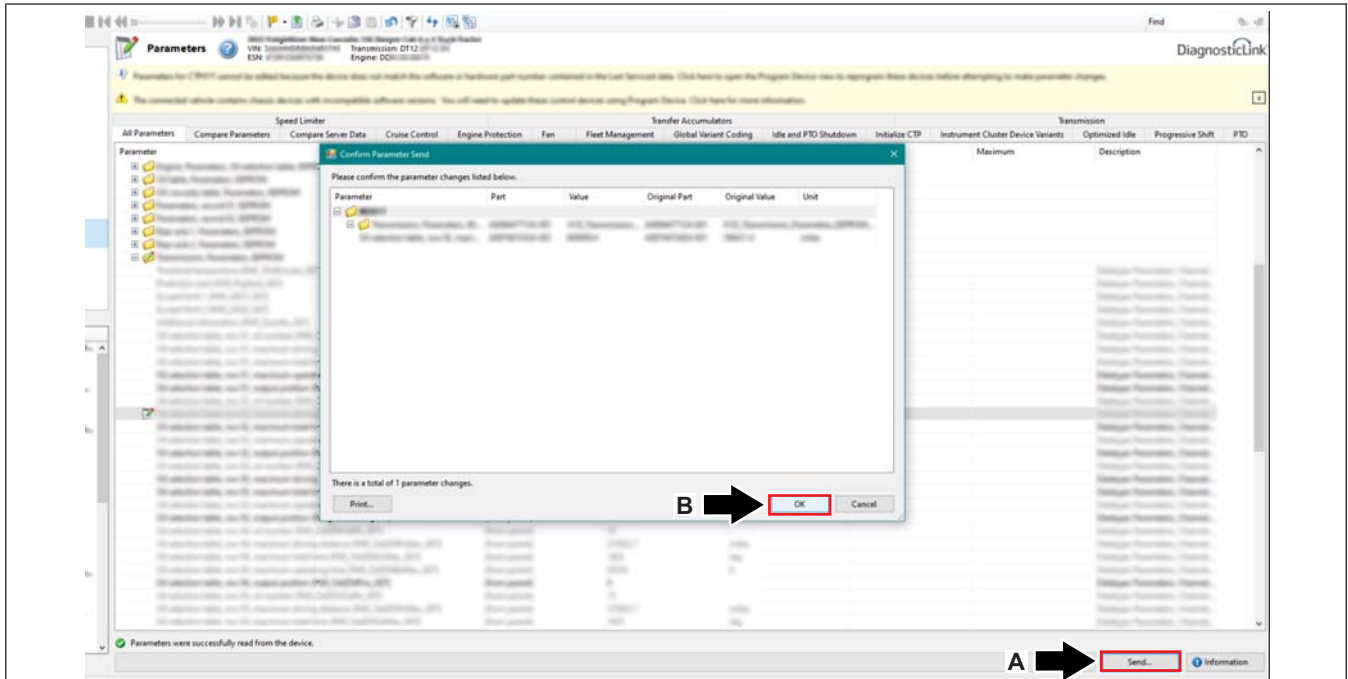
Fig. 6, Writing the Parameter Changes to the Vehicle

18. Select the 'Send' button to write the parameter changes to the SSAM02T and XMC02T electronic control units (ECUs) in the vehicle. A pop-up window appears asking to confirm the parameter changes. Select 'OK.' See Fig. 6.

A. Select the 'Send' button.

B. Select 'OK' to confirm the parameter changes.

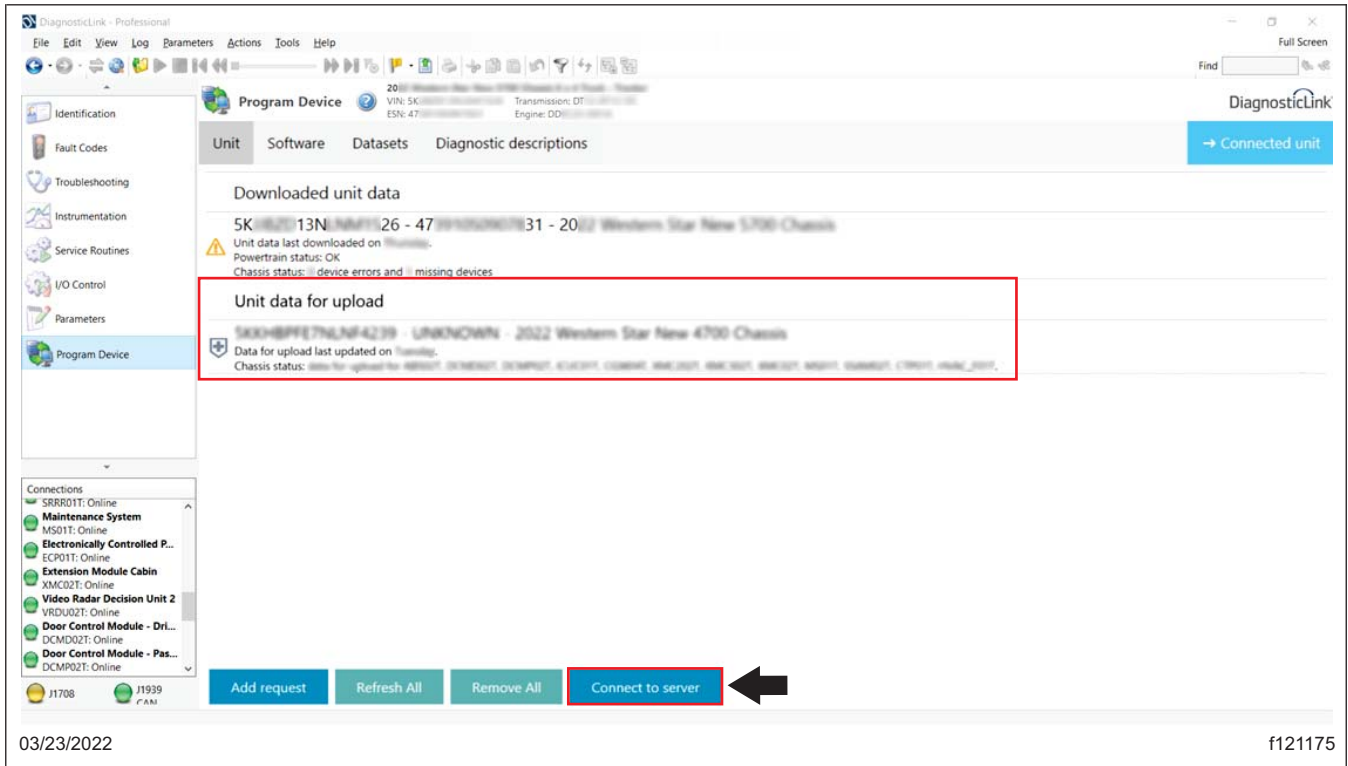
Fig. 8, Uploading the New Parameters

- The information corresponding to the VIN should appear under the 'Unit data for upload.' Select 'Connect to server' to upload the new parameters. See [Fig. 8](#).

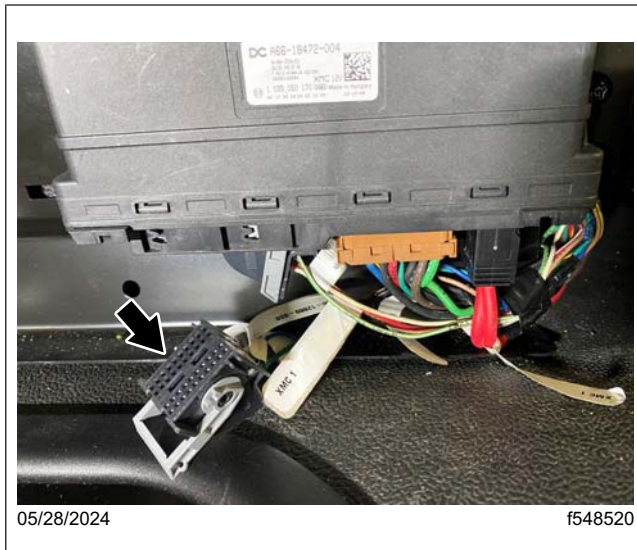
**Fig. 9, XMC1 X1 Connector**

2. Use the pin removal tool (DK10CHA17002-2 or DK10CHA17002-4) to remove the wire from pin 38 of the XMC1 X1 connector and insert into pin 1 of the same connector. See [Fig. 9](#) and [Fig. 10](#).

NOTE: If some other wire is already inserted into pin 1 of the XMC1 X1 connector, both the wires have to be spliced together.

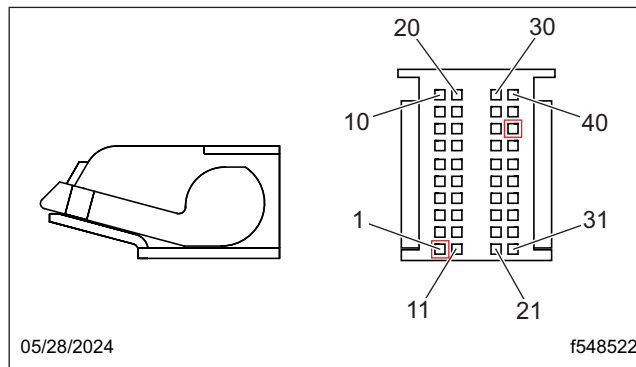
**Fig. 11, XMC1 X1 Connector Pin Layout**

[Figure 11](#) shows the XMC1 X1 connector pin layout.

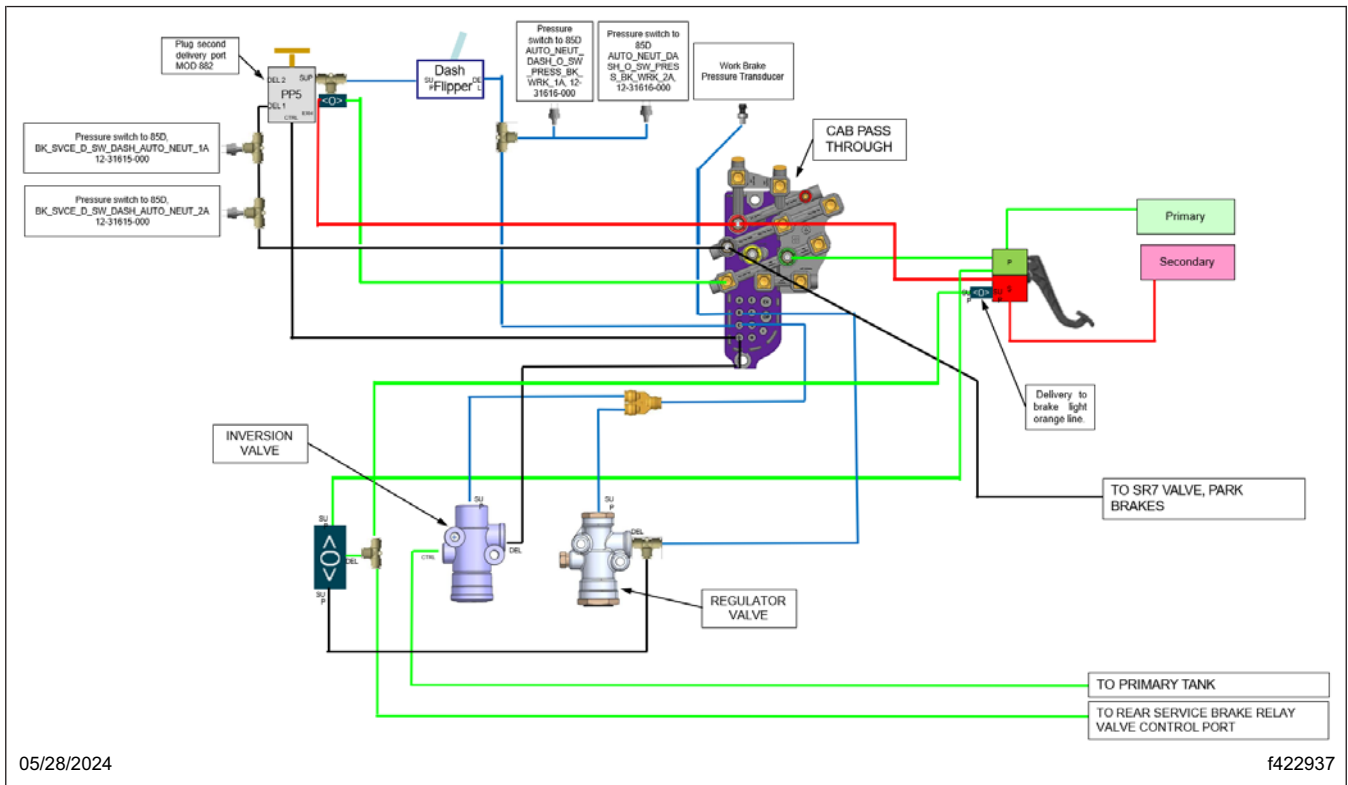
**Fig. 13, Work Brake Schematic**

1. The parking brake sets when the work brake is activated.
  - Check the plumbing for an incorrectly plumbed inversion valve. [Figure 13](#) shows the work brake schematic.
  - The inversion valve and the regulator valve are mounted together and can be incorrectly-plumbed.

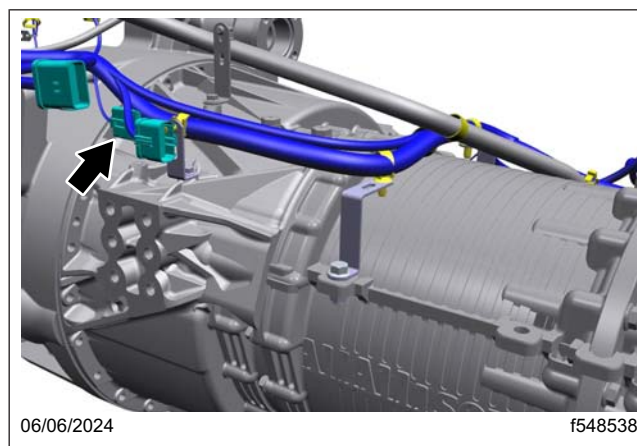
**Fig. 14, Transmission Harness Connector**

2. The transmission does not go to neutral.
  - Ensure the transmission harness connector is plugged in, as shown in [Fig. 14](#).
