### **Technical Service Bulletin SB-72 Repair Instructions**

**Models Involved:** 2023 – 2024 Convoy motorhomes and 2023 Tiffin GH1 motorhomes built between March 21, 2023, and April 8, 2024.

**Purpose:** To provide instructions on how to drain the Aqua-Hot Hydronic Heating System of the improper coolant, flush and fill system with the proper coolant.

### SB-72 2023-2024 Convoy & 2023-2024 Tiffin GH1 Aqua Hot Incorrect Coolant

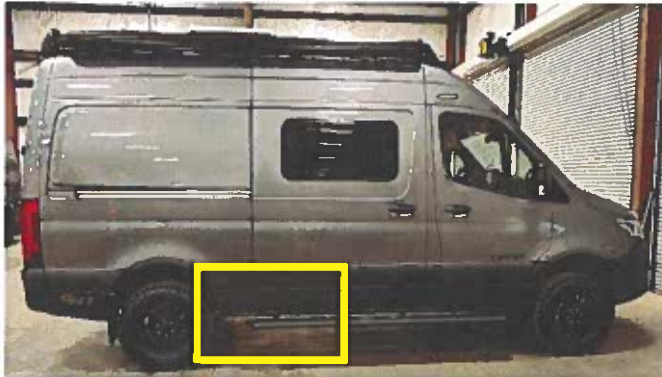
**Figure 1**

1. Locate the Aqua-Hot Under Chassis Circulation Pump Assembly underneath the Van. The Pump is approximately in the center of the Van, in line with the rectangle pictured below in figure 1.

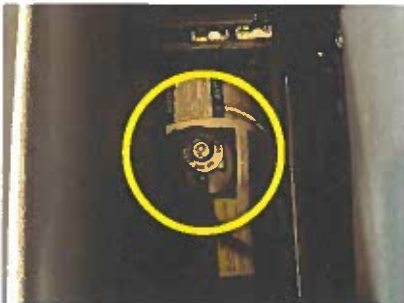
Figure 4a

6. Remove the Aqua-Hot access panel by pulling up (it is attached with Velcro). Push down on radiator cap (figure 4a) and turn counterclockwise to remove the radiator cap from the top of the tank (figure 4b).

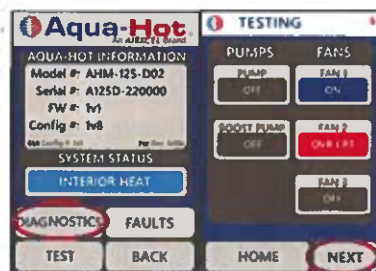
Figure 5a

7. At the LCD screen tap the three lines icon -> Diagnostics -> Test -> Next (figure 5a). Tap the 3-Way Valve button until it says "Int heat" (figure 5b). Listen for the valve to stop moving. There is a window on the top of the valve showing a red line. This indicates the position of the valve and can be used to visually check when the valve has stopped moving. Tap "Back" and tap the pump button to on (figure 5c). You should hear the pump turn on. The icon may say "UNDER CRT". This will stop once water or coolant is poured into the tank.

9. Tap the 3-way valve button again until it displays "Int Heat."
10. Let the pump circulate water for 10 minutes. The Test screen will time out after 5 minutes and the pump will have to be re-engaged.

14. At the LCD screen in the Test menu tap the 3-way valve again until it displays "Hot Water". You should hear some bubbles being released.
15. Tap the 3-way valve button again until it displays "Int Heat".
