**June 19, 2024**

Version 3

## A/C Compressor Shaft Seal Leak

Supersedes 23-050, dated January 25, 2024 to revise the information.

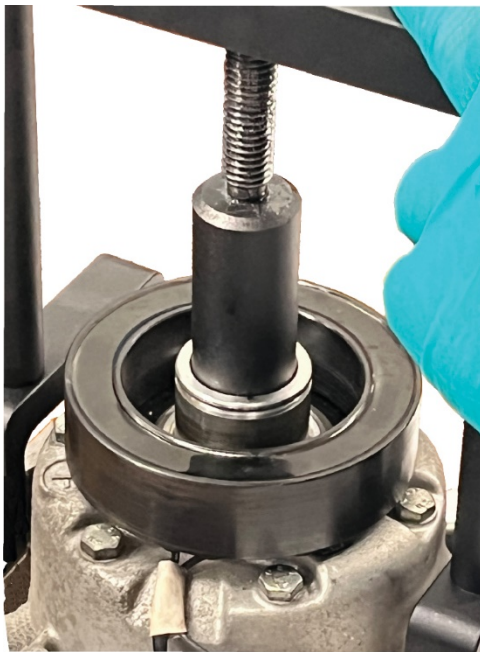
22. Tighten the press until there is no clearance, then **3/4 turn (270°)**.

- The purpose of this step is to break the compressor shaft seal loose.
- Turning the handle more than **3/4 turn (270 degrees)** can damage the tool and seal making it difficult to remove the compressor shaft seal.

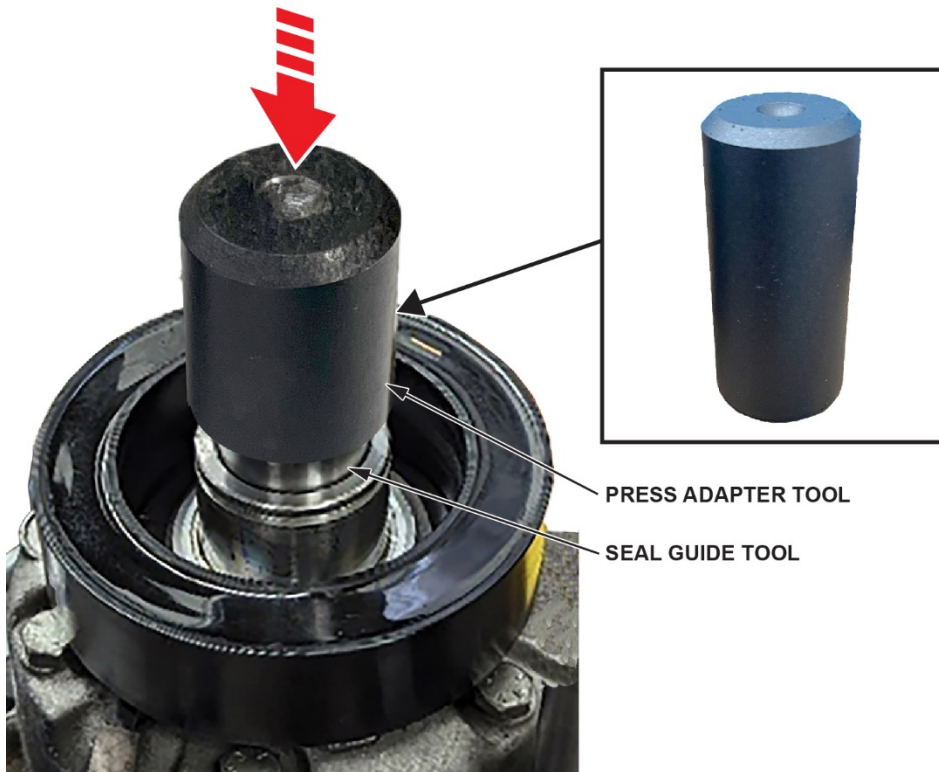
34. Insert the press adapter tool over the seal guide. By hand, press down to seat the new seal about **5 mm** below the top edge of the bore and remove the press adapter.

Push down.
