## SERVICE BULLETIN

**APPLICABILITY:** 2019-24MY Forester

**NUMBER:** 07-218-23R

**SUBJECT:** Genuine Alternative Battery Replacement

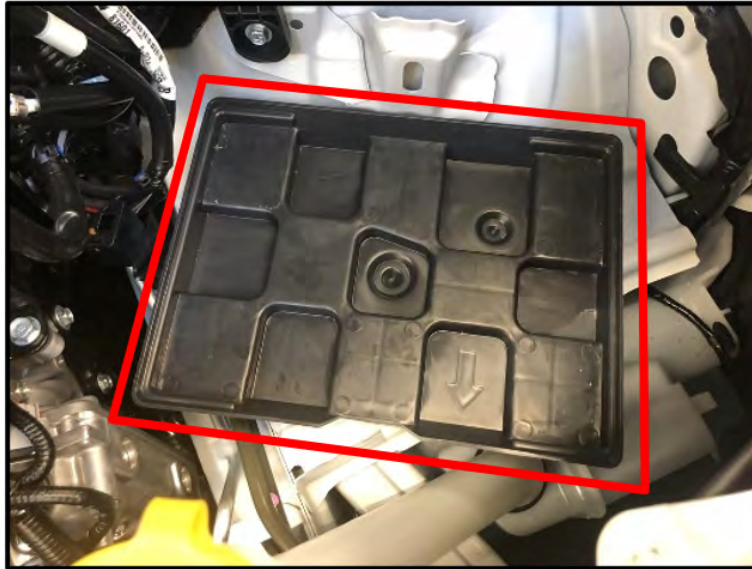
**STEP 3:** Replace the battery tray with the new part (p.n. 82190AN000).

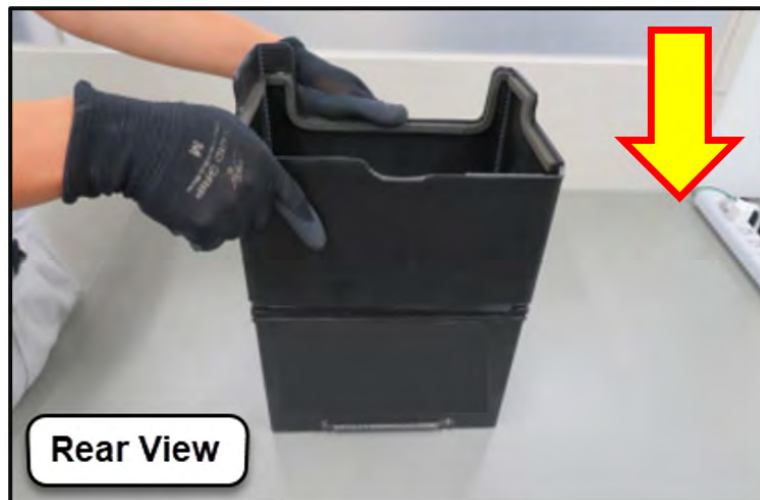
**STEP 4:** Install the NEW battery cover (p.n. 82123AN000) to the alternative replacement battery. Confirm the bottom of the cover is aligned flush with the bottom of the battery.
