June 19, 2024

Version 4

## 2019-20 MDX A/C Compressor Shaft Seal Leak

Supersedes 23-024, dated January 24, 2024, to revise the information highlighted in yellow.

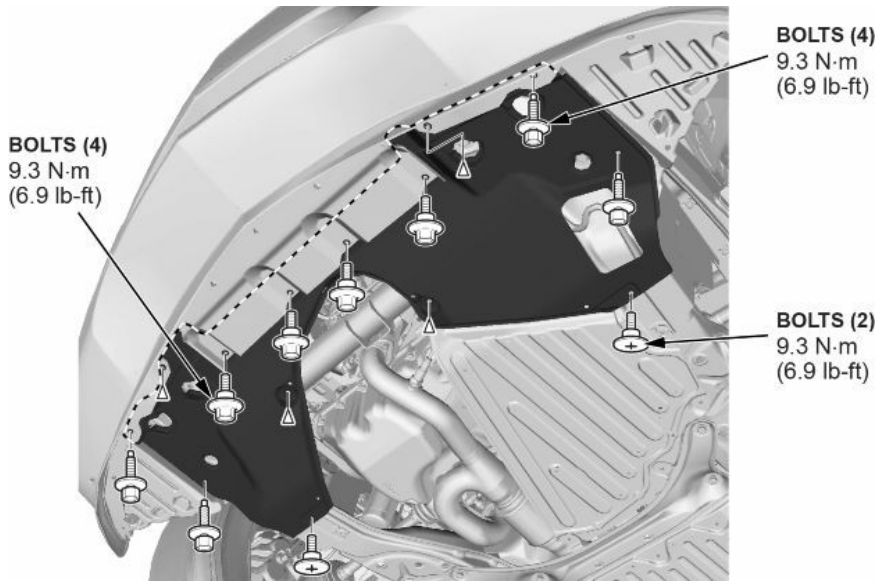
1. Remove the right-front tire.
2. Remove the engine undercover.

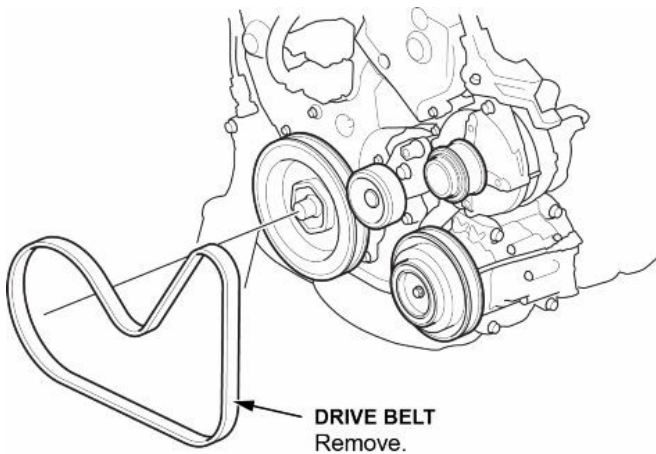
3. Remove the drive belt.

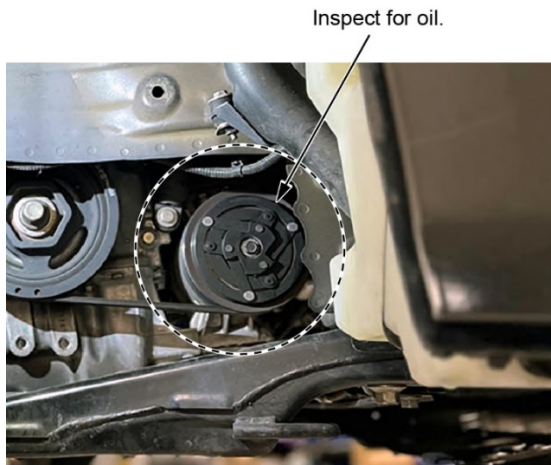
4. Inspect for oil on the armature plate surface of the compressor.

NOTE: If any oil is stuck to the armature plate surface of the compressor, then proceed to the repair procedure.

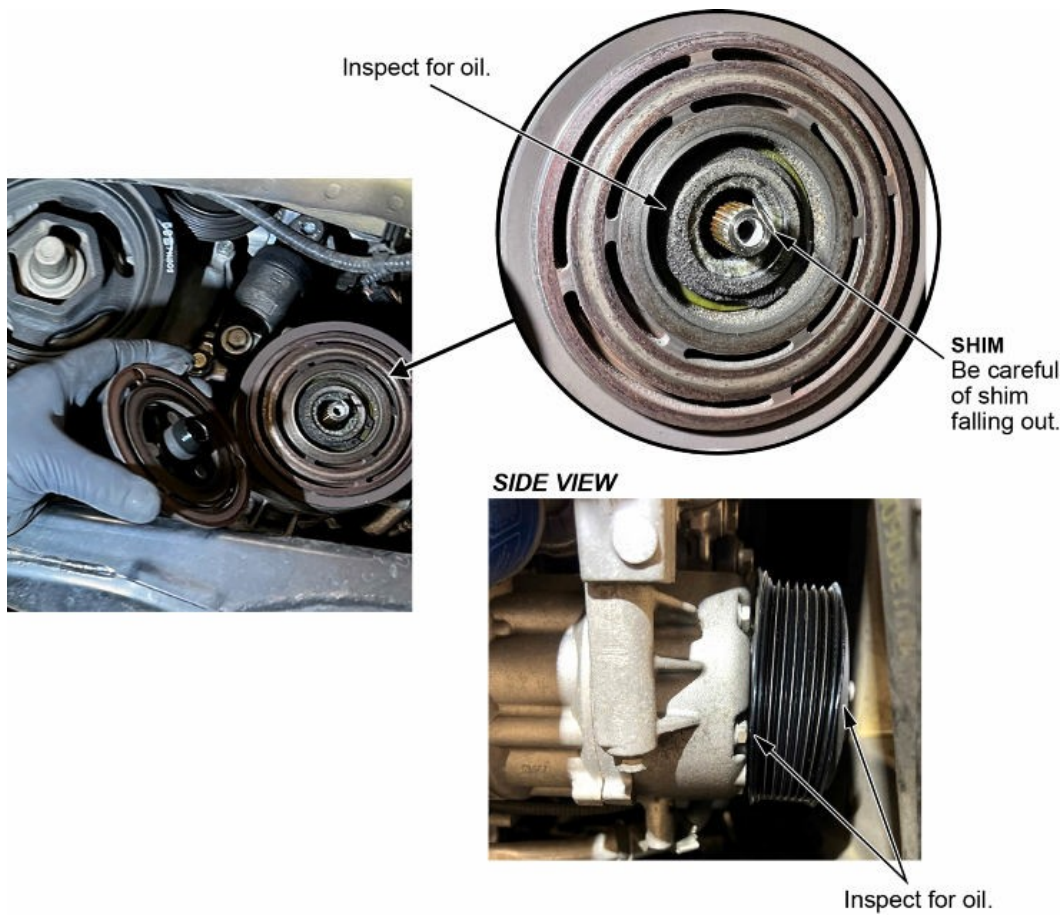
5. If oil no oil is noticed, leave the compressor on the vehicle. Remove the center hub bolt while holding the armature plate with the A/C clutch holder and remove the armature plate from the compressor. Then inspect both for oil.

- If oil is present on the hub/armature plate, then proceed to the repair procedure.
- If no oil is present, then proceed to step 6.

Examples of dry and oily clutch assemblies.

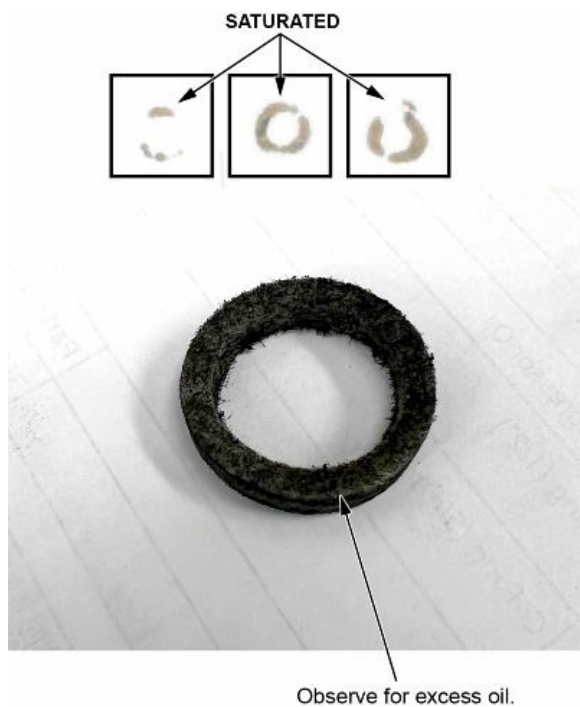
6. Remove the felt washer from the compressor and gently place it on a clean sheet of paper.

NOTE: If oil transfers from the felt washer to the paper after **10 seconds**, proceed to the repair procedure. If not, continue to the next step.

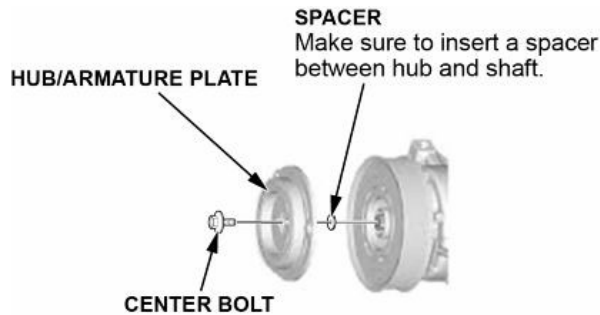
8. If no oil or leak is found, reassemble the hub/armature plate with the original bolt and torque to **(17 N·m or 13 lb-ft)**.  
If this is a second time and no leak is found, reassemble the hub/armature plate with a new bolt and torque to **17 N.m (13 lb-ft)**.

- Verify that the armature plate and pulley rotate smoothly and independently.
- Measure the clearance between the pulley and armature plate all the way around. If clearance is not within specified limits, remove the armature plate and add/or remove shims as needed.
- Clearance: **0.30–0.60mm (0.012–0.024in)**
- Shims are available in three sizes: **0.3mm, 0.4mm, 0.5mm**.

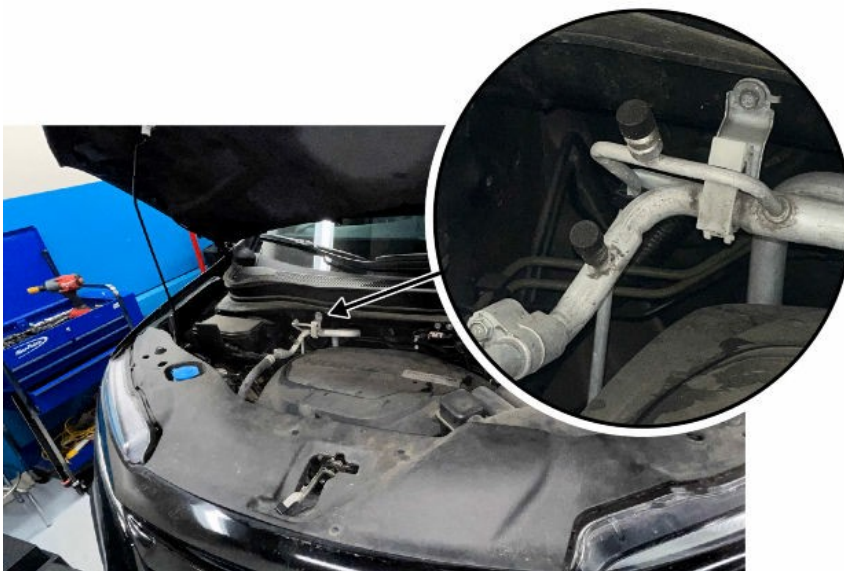
1. Connect an A/C recover/recycle/recharge machine to the high-pressure service port and the low-pressure service port following the equipment manufacturer's instructions.

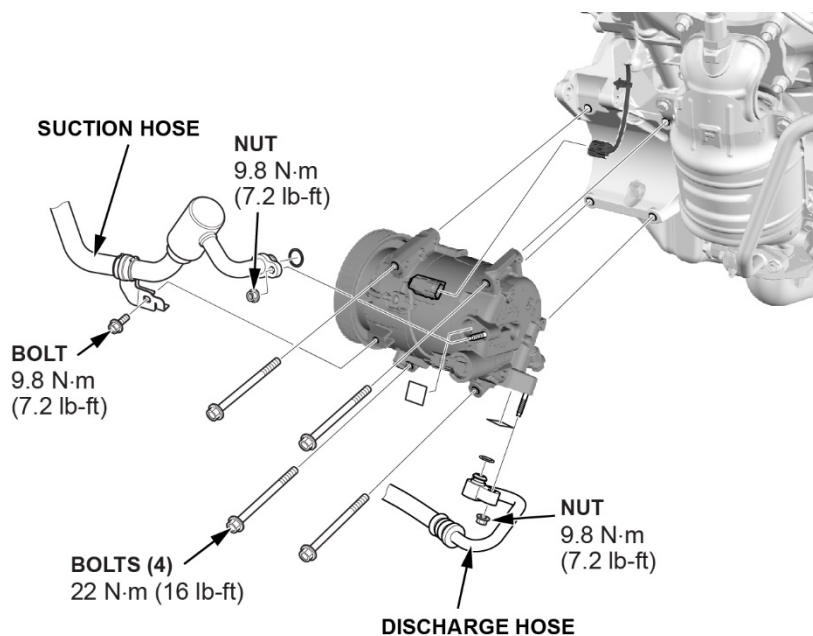
8. Disconnect the discharge and suction hose.

NOTE: Use the port plugs in the seal assembly kit to immediately seal the ports after disconnection. This avoids moisture and dust contamination from entering the A/C compressor. Installing an A/C compressor into a contaminated system can result in premature A/C compressor failure.

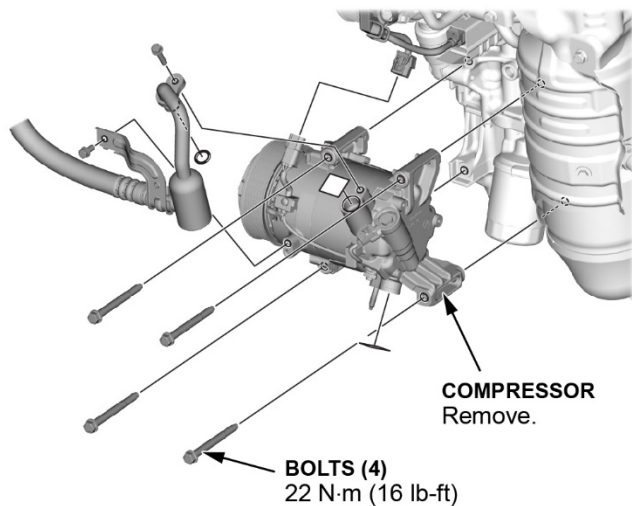
9. Remove the A/C compressor.

NOTE: Be careful not to damage the radiator fins when removing the A/C compressor.

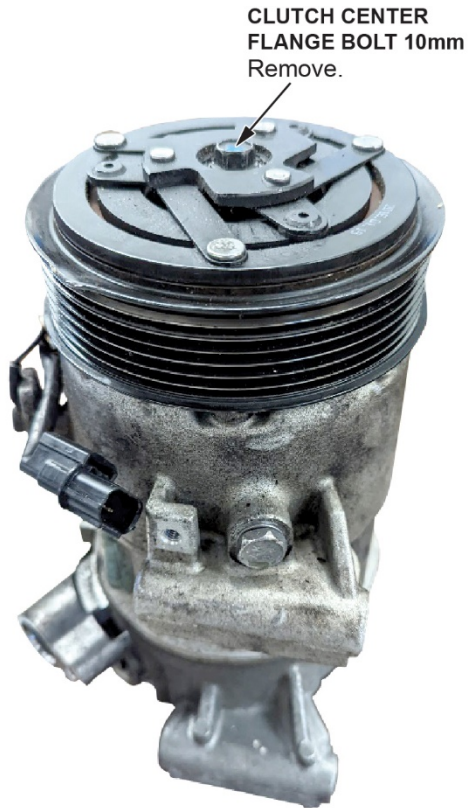
10. If the clutch has not been removed from a previous step, remove the clutch center flange bolt while holding the armature plate with the A/C clutch holder. **(17 N·m 13lb-ft)**.

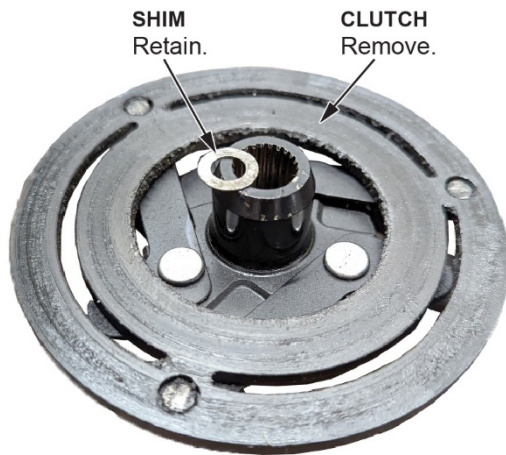
11. If the clutch has not been removed from a previous step, remove the clutch while being careful not to drop/lose any shims (usually 1–2).

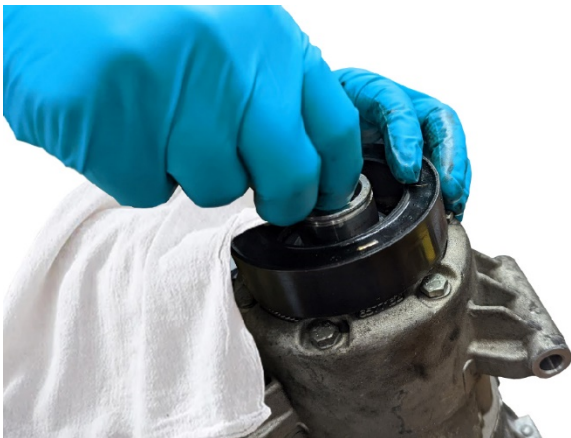
16. Thoroughly clean the bore and shaft with a lint free cloth.

NOTE: Do not use compressed air. The bore needs to be very clean as to prevent debris from entering the compressor once the seal is removed. Failure to remove all debris will result in future failure.

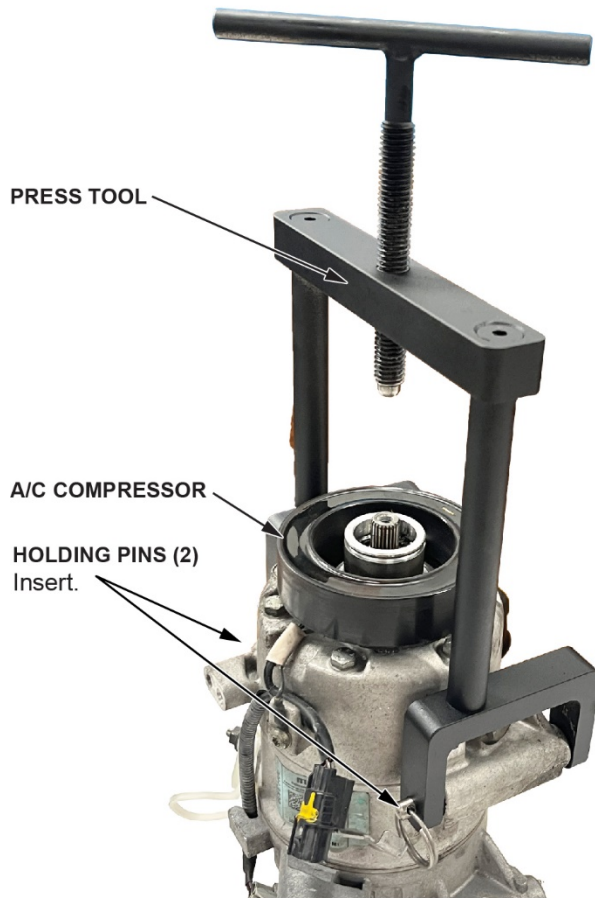
18. Place the press tool onto the A/C compressor and insert the holding pins (2). Make sure the press tool installs where the press shaft should align with compressor shaft. The press tool will only align correctly in one orientation. The pins must go all the way through.

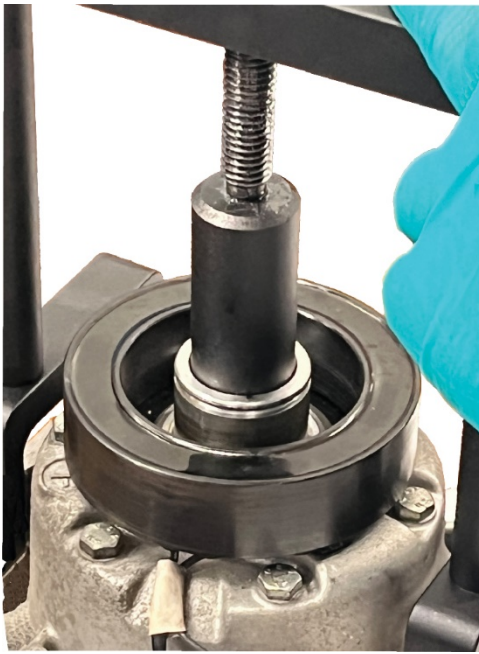
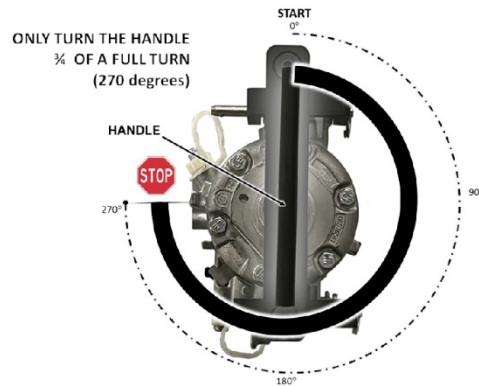
21. Tighten the press until there is no clearance, then **3/4 turn (270°)**.

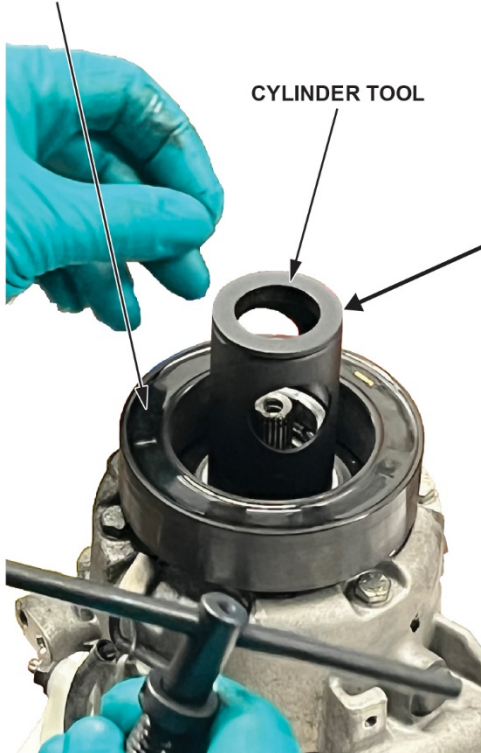
A/C COMPRESSOR

23. Insert the cylinder onto the A/C compressor.

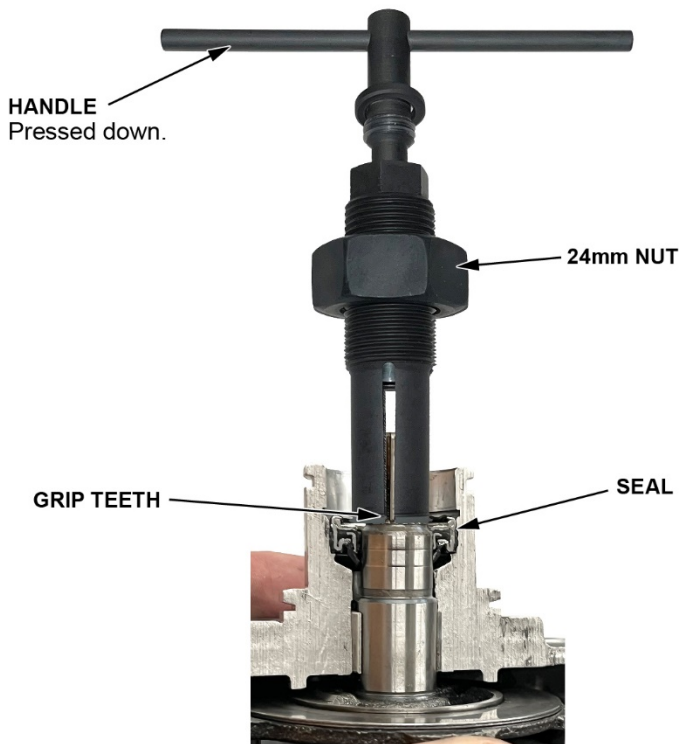
24. Insert the extractor tool, and make sure the **24 mm** nut is positioned towards the top. Look into the cylinder window to align the extractor tool onto the flange and press the handle fully down to grab the seal.

NOTE: The **24mm** nut will use a 36 mm wrench.

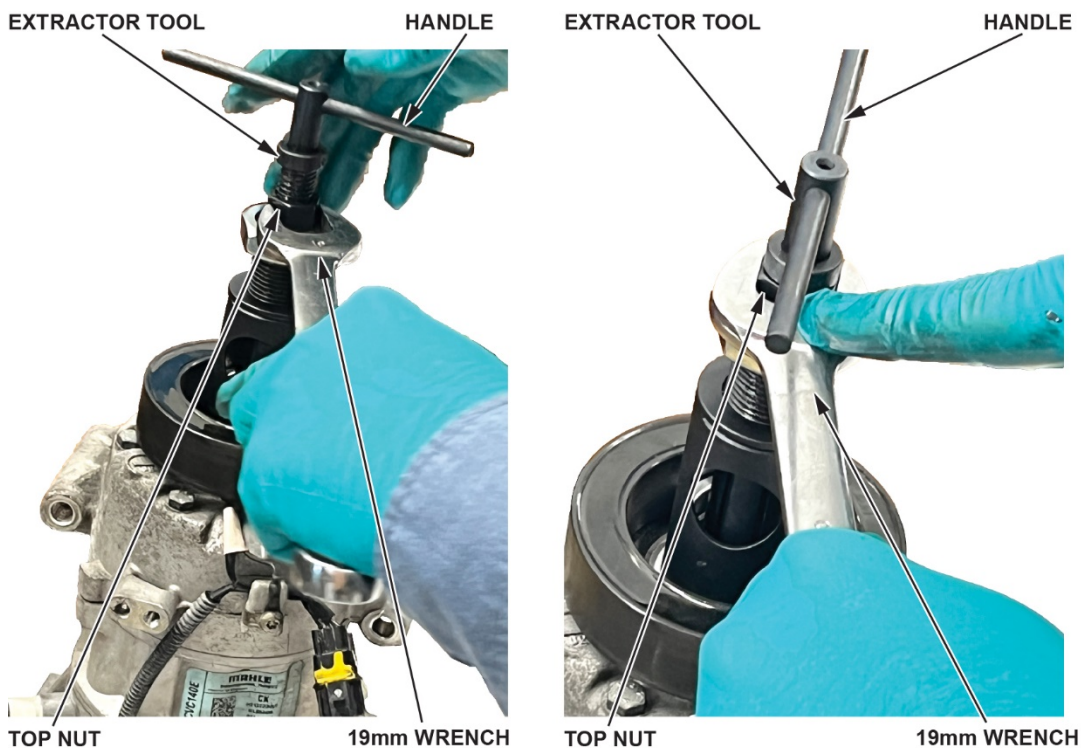
25. Stabilize the extractor tool using a **19 mm** wrench on the top. Then, turn the handle clockwise until the resistance is felt. Make sure that the space between the **19 mm** wrench and the bottom portion of the extractor tool is minimal.

NOTE: To confirm the extractor is engaged, hold the extractor tool and lift the compressor up.

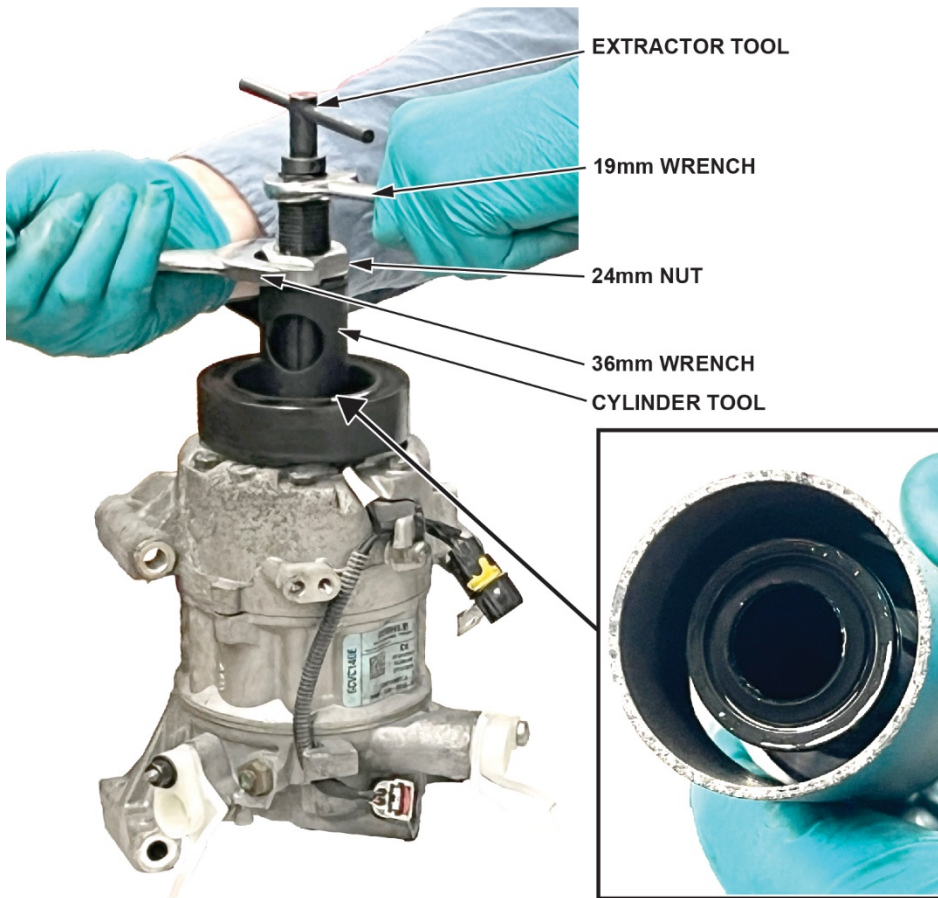
27. With the **19 mm** wrench in place, lower the **24 mm** nut down until it reaches the cylinder. Slowly and carefully adjust until the extractor tool comes out freely with the seal.

- Resistance will be felt while lowering **24 mm** nut and will cease once the seal is extracted.
- If the seal does not come out on the first step, repeat the process starting at step 13.

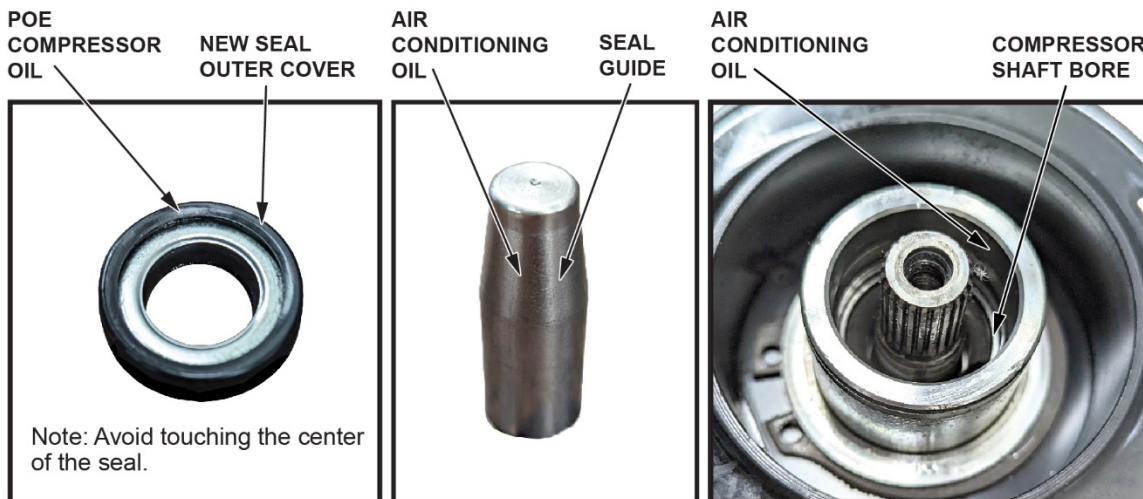
29. Inspect the compressor shaft bore for visible damage; Inspect the seal guide for contamination or damage.

30. Lubricate the new seal outer surface, seal guide, and bore with new POE air conditioning oil.

NOTE: Avoid touching the center of the seal with hands as to prevent cross-contamination of the A/C refrigerant system.

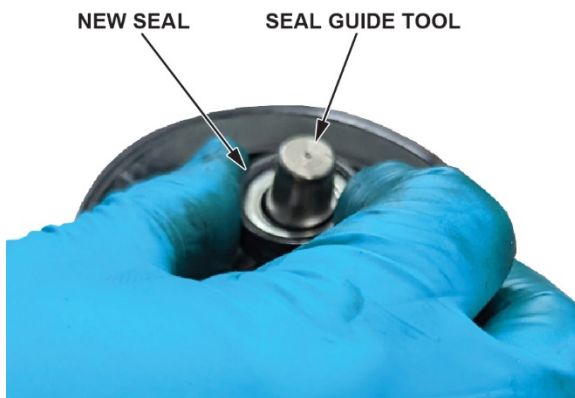
32. Insert the new seal onto the seal guide tool.

NOTE: The seal is directional and must be placed with the metal side upward.

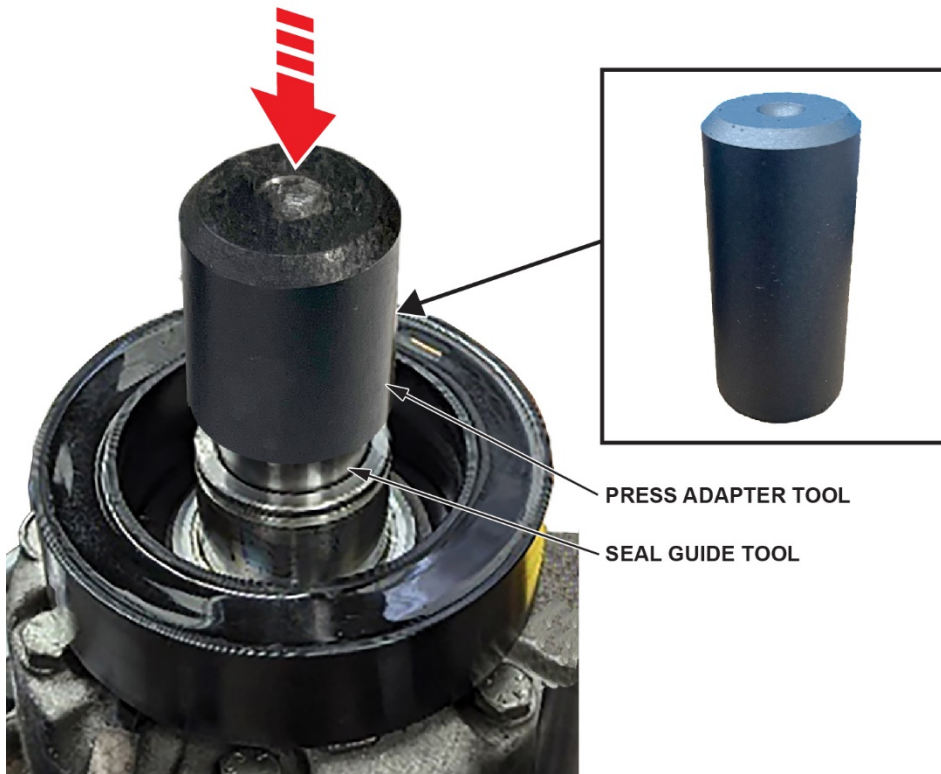
34. By hand press down to seat the new seal about 5 mm below the top edge of the bore and remove the press adapter.

Push down.

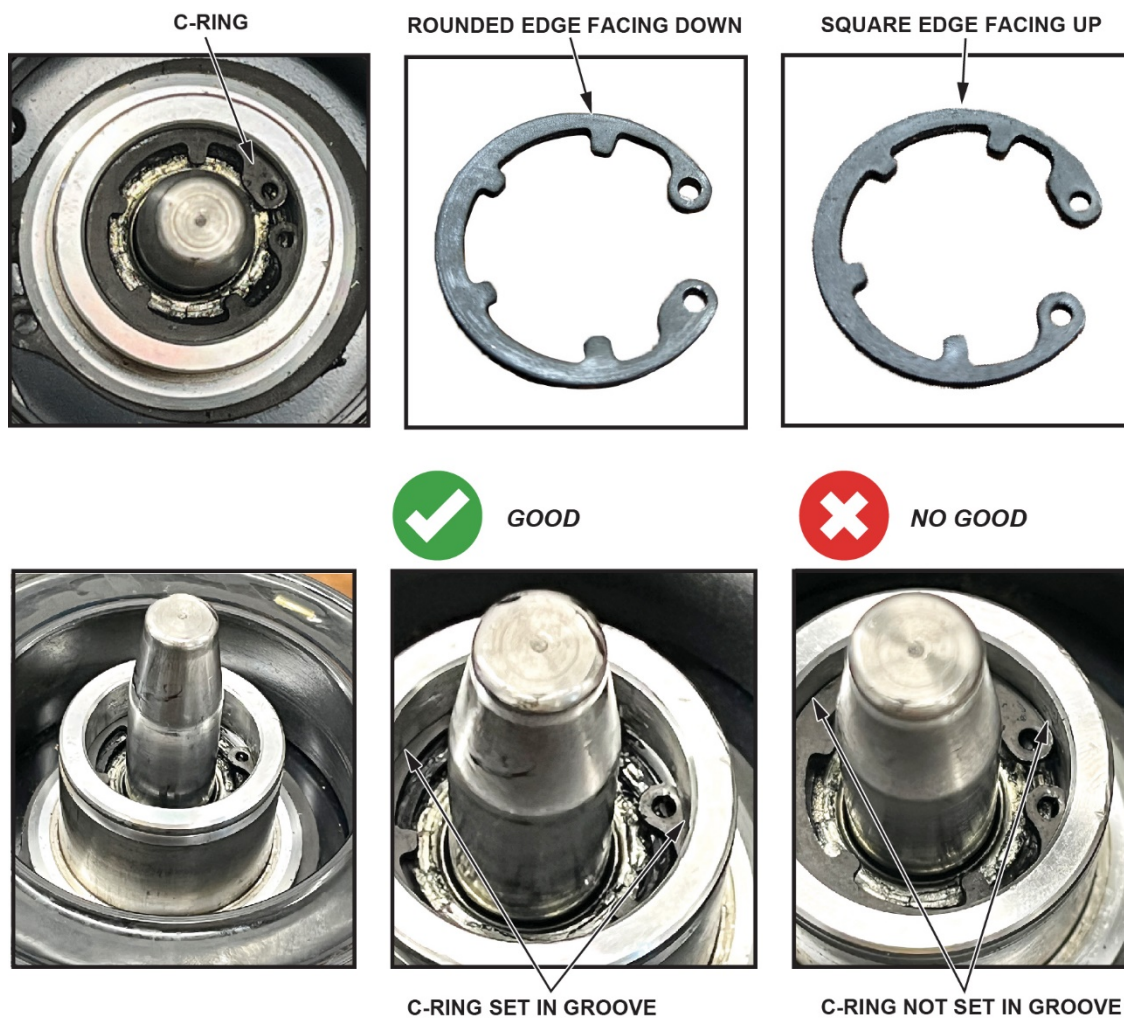
35. Insert the seal C-ring with the teeth's rounded side pointing down into the bore.

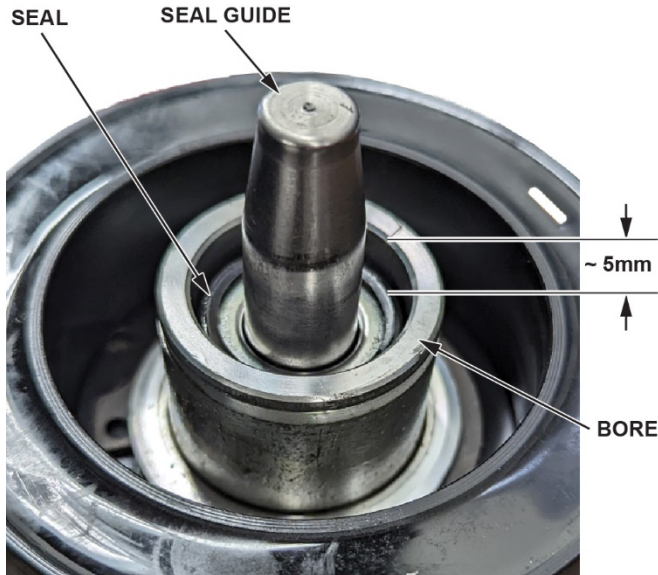
37. Tighten the press by rotating the handle clockwise until it reaches the adapter tool. Slowly and carefully continue to rotate the handle clockwise until the seal is pressed down roughly **10 mm** below the bore.

NOTE: Tighten the press until the C-Clip is installed into the clip groove. There will be a sound or vibration felt when the C-clip is fully set.
