**SERVICE BULLETIN**

**NUMBER:** 06-90-24

**SUBJECT:** Brake Caliper Leakage Diagnosis

**DATE:** 06/25/24

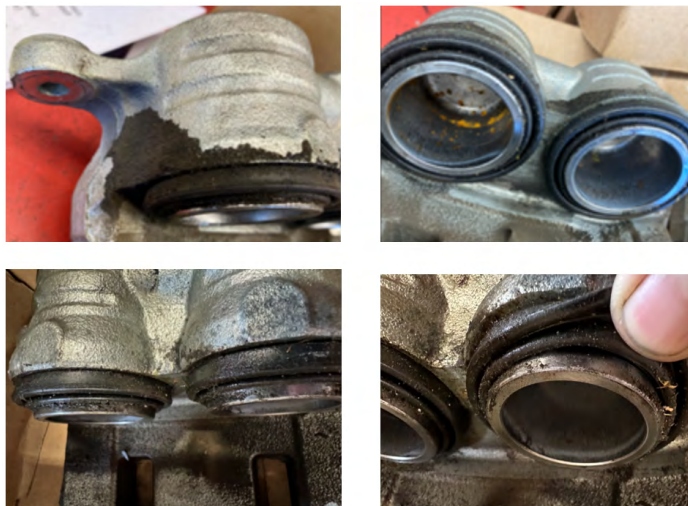
**IMPORTANT:** Residual caliper assembly grease applied during vehicle production may in some cases be mistaken for a brake fluid leak. Over time, grease around the pistons, boots and calipers may develop a dirty/oily appearance. This condition is considered normal and does not require any further repair. See the **EXAMPLE** images below and refer to the inspection procedure information outlined on the next page to ensure the caliper is operating as designed and no actual brake fluid leakage is present.

**All of the EXAMPLE images below depict assembly grease misdiagnosed as brake fluid loss.**

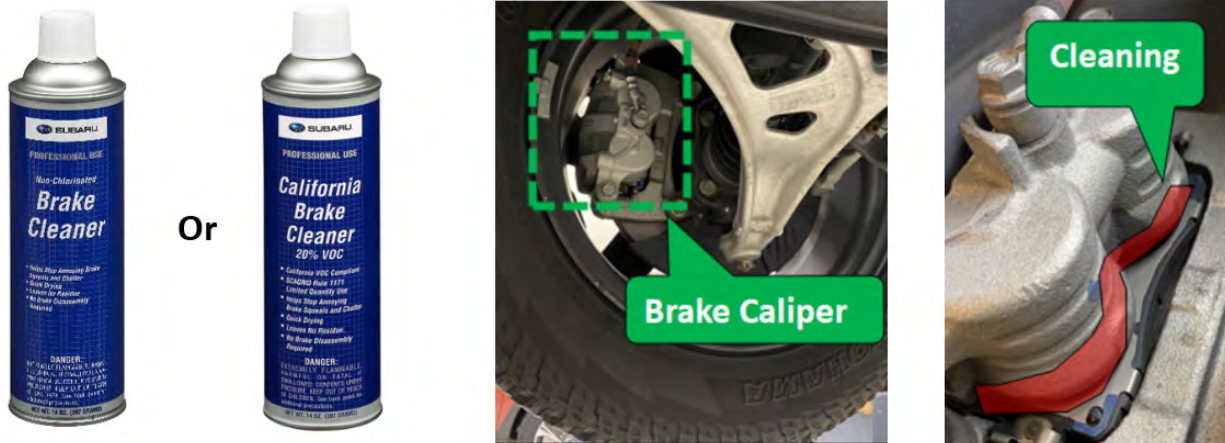
**STEP 1:** Prepare the caliper(s) by cleaning the surrounding area. It is important to use **CAUTION** when cleaning and **ALWAYS** wear eye protection. Abrasive materials and excessive force may cause damage to piston boots. Subaru Low VOC Brake Cleaner (p.n. **SOA868V9110**) is the recommended cleaner to be used to clean the caliper(s). California based retailers are recommended to use Subaru California Brake Cleaner (p.n. **SOA868V9116**). This is specifically formulated to meet California VOC standards.

**NOTE:** Both brake cleaner types can also be in bulk 53 Gallon drums. The bulk part numbers are listed below.

- Subaru Low VOC Brake Cleaner (p.n. **SOA868V9111**)
- Subaru California Brake Cleaner (p.n. **SOA868V9126**)

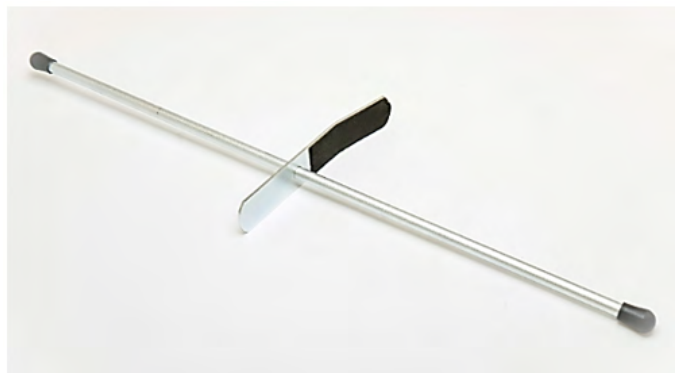
**NOTE:** A Hunter® (p.n. **WA15-S**) Brake Pedal Depressor is shown in the EXAMPLE image to the right.

**STEP 2:** A second person or a brake depressor tool will be required to depress the brake pedal.

If the vehicle is equipped with an **electric brake booster**, turn **ON** the ignition switch and firmly apply brake pedal pressure for ten seconds. If equipped with a **negative pressure (vacuum) brake booster**, the engine must be running with brake pedal pressure firmly applied for ten seconds.

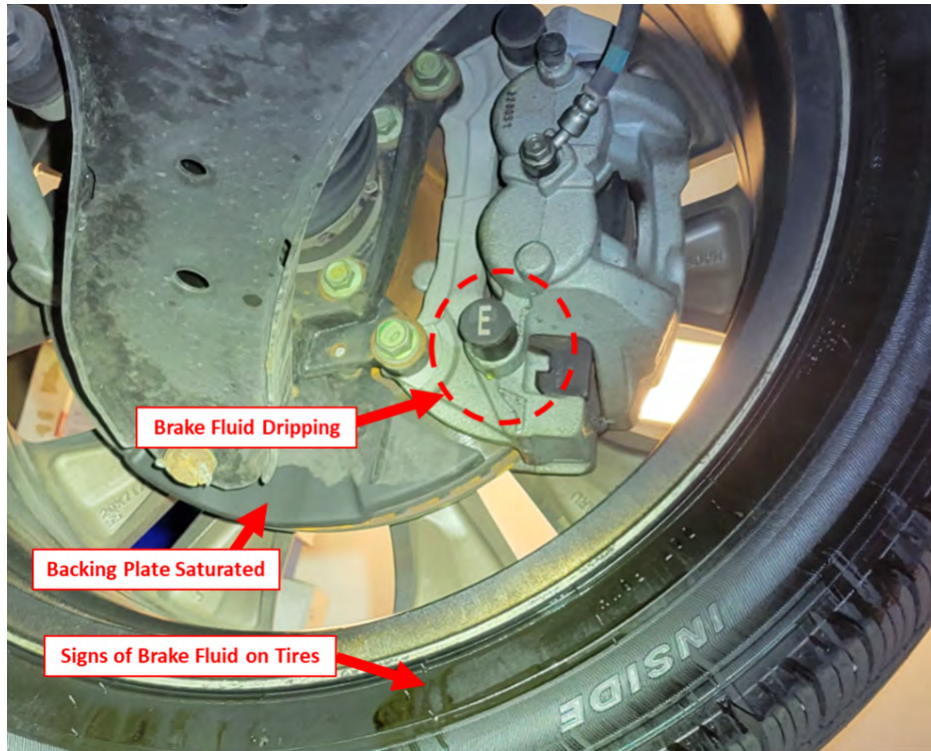
**The image below is an EXAMPLE of a brake fluid leakage requiring repair.**

**YES:** Replace the affected caliper(s) and perform the brake system bleeding procedure as per the applicable Service Manual.
