Technical Service Bulletin SB-73 Repair Instructions

Purpose: To provide instructions on how to remove the incorrectly rated flexible water lines on the Aqua-Hot Hydronic Heating System heat exchanger and replace them with pex lines that have the correct heat ratings.

SB-73 2023-2024 Convoy & 2023-2024 Tiffin GH1 Flexible Water Line Replacement

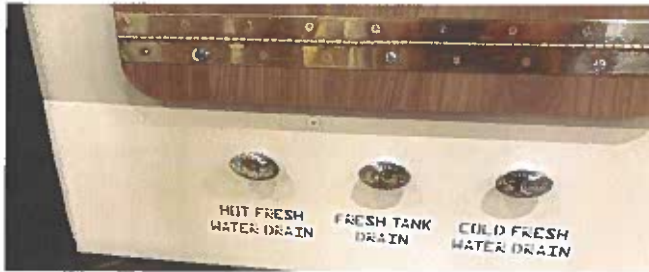
Figure 3

4. Drain the water lines by opening the low point drain line valves located under the outdoor table. Ensure the valve handles are in the horizontal position as shown below (Figure 3). **NOTE:** It may be beneficial to turn on the shower or sink fixtures to allow more airflow through the lines and drain more effectively.

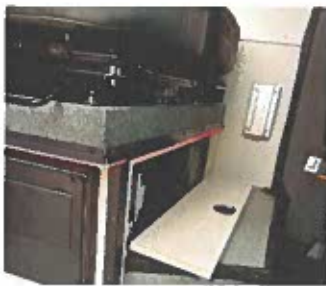
Figure 4

5. Open the maintenance door on the front of the jump seat cabinet (Figure 4).

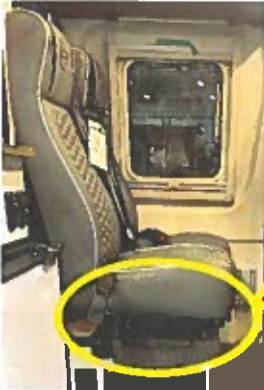
Figure 5A

6. Locate the jump seat assembly located behind the driver's seat. Pull the handle (Figure 5A) on the end of the jump seat assembly up and out to separate the seat and reveal the Aqua-Hot access panel (Figure 5B).

Pull Handle

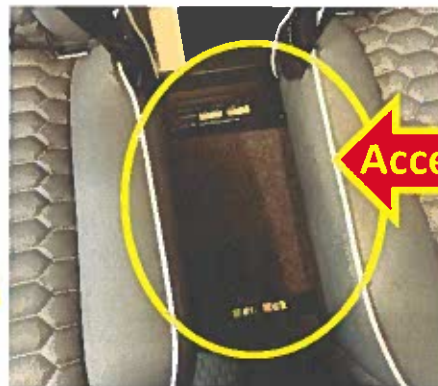
Figure 5B

Access Panel

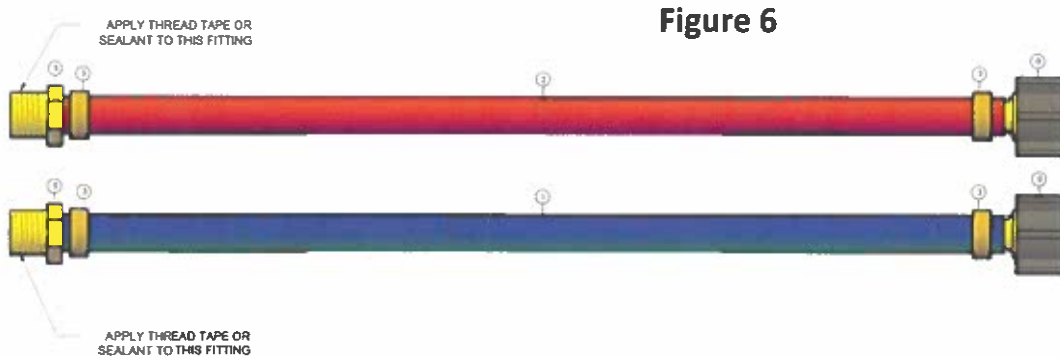
7. Build the new heat exchanger line assemblies as shown in (Figure 6) below. Place the ½" crimp ring over the Pex tubing. Insert the barbed ½" fitting into the Pex pipe on the same end. Crimp the ring directly over the fitting's location (about 1/8" from the outside edge of the tubing). The fitting should be tight enough it cannot be removed by hand.

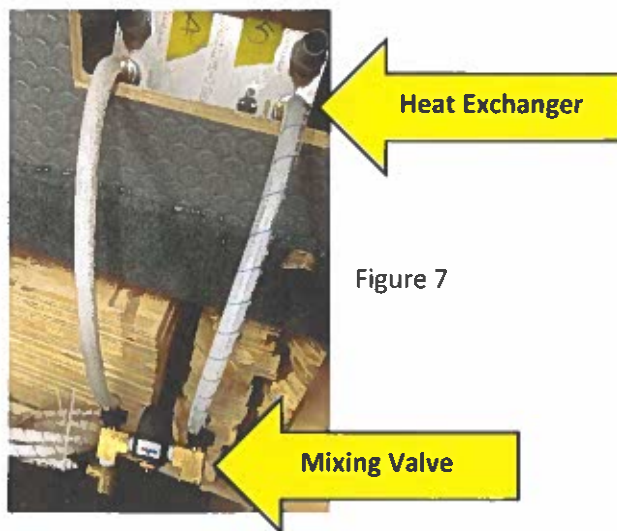
8. Ensure the two white water lines between the heat exchanger and the mixing valve are cool to the touch. Unscrew the plastic fittings from the mixing valve and unscrew the brass fittings from the heat exchanger. Discard the hoses. See diagram figure 7.

9. Apply thread sealant to the brass NPT fittings on the replacement assemblies and screw the brass NPT fitting side into the heat exchanger.
10. Screw the plastic FPT fitting side onto the mixing valve. The plastic FPT fittings do not require thread sealant since the ends contain rubber gaskets.
13. Turn water back on and test for leaks.
