# PRODUCT BULLETIN

6/27/2024

## Galvanized Slider Inspection

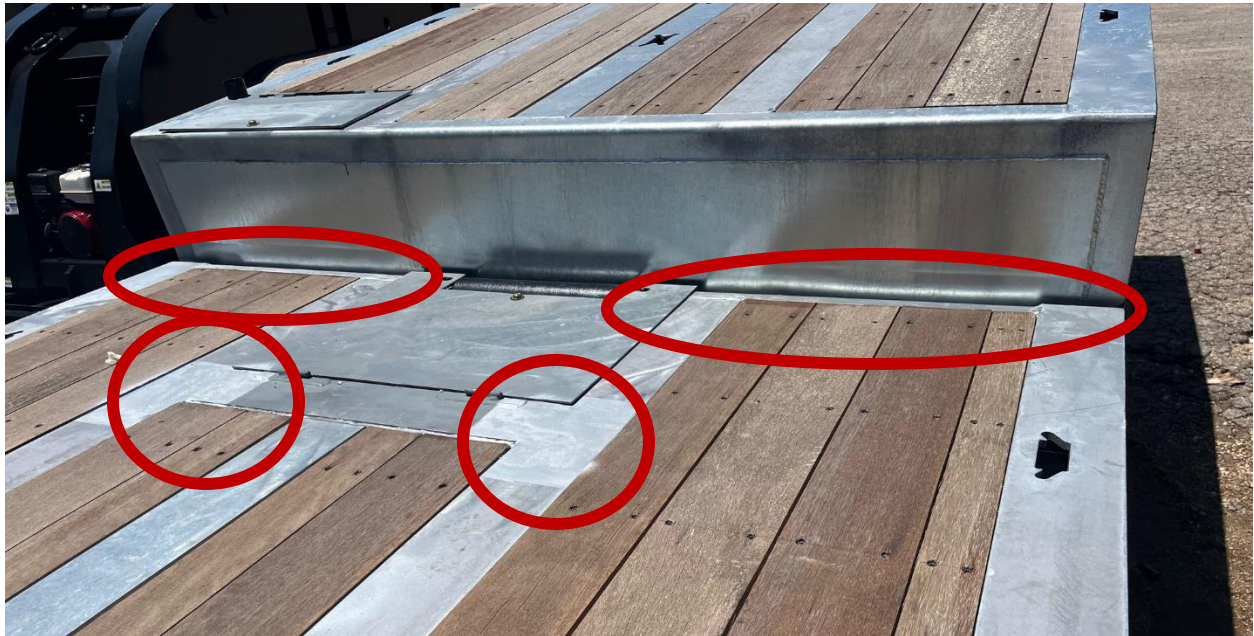
Front of deck: Main Beams and Side Rails

Despite our confidence that fielded trailers are not at risk, we encourage end users in possession of the following serial numbers to conduct a simple, visual inspection for cracks at the locations identified. Should irregularities be identified, please contact Josh Godfrey, Warranty Manager ([jgodfrey@kalyntx.com](mailto:jgodfrey@kalyntx.com)), so we can assist with any questions or further inspections.

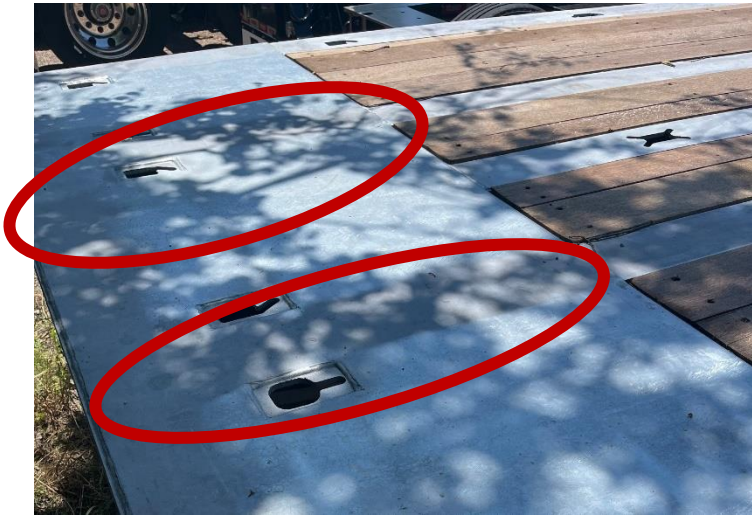
Mean Beams on top of transition plate

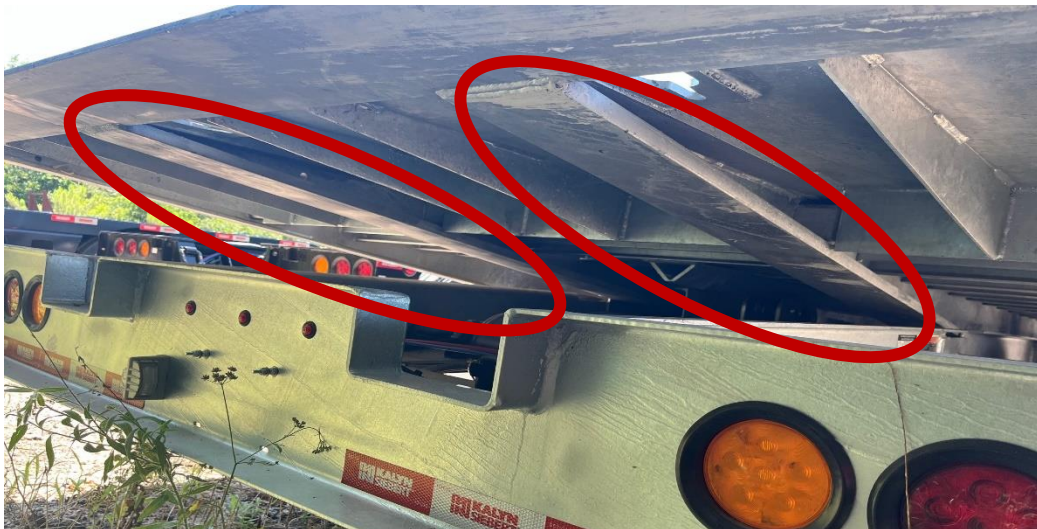
Main Beams underneath transition plate

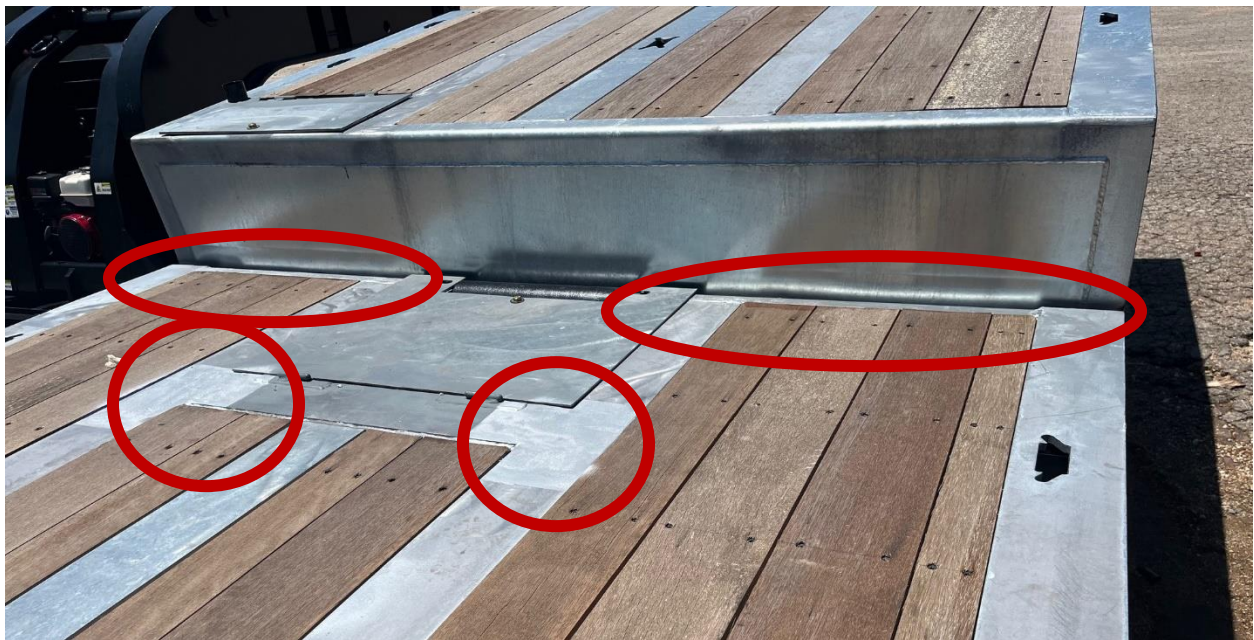
Front of deck: Main Beams and Side Rails

Despite our confidence that fielded trailers are not at risk, we encourage end users in possession of the following serial numbers to conduct a simple, visual inspection for cracks at the locations identified. Should irregularities be identified, please contact Josh Godfrey, Warranty Manager ([jgodfrey@kalyntx.com](mailto:jgodfrey@kalyntx.com)), so we can assist with any questions or further inspections.

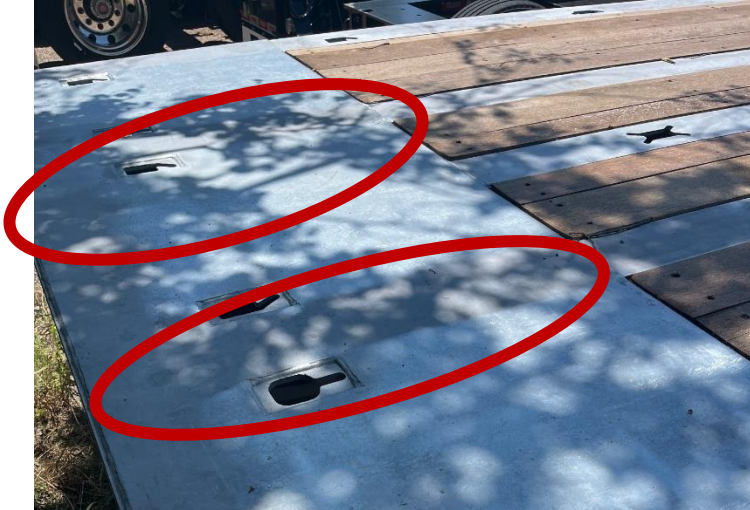
Mean Beams on top of transition plate

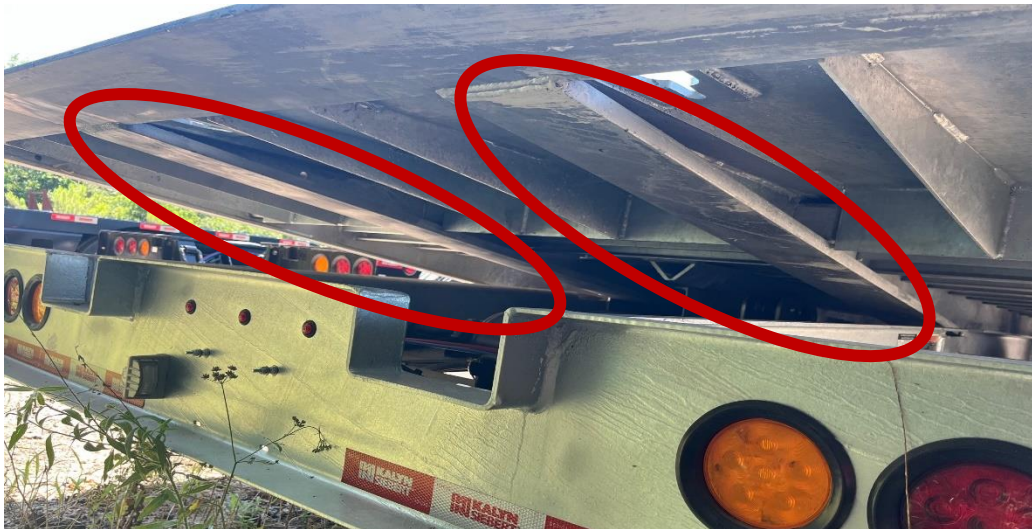
Main Beams underneath transition plate

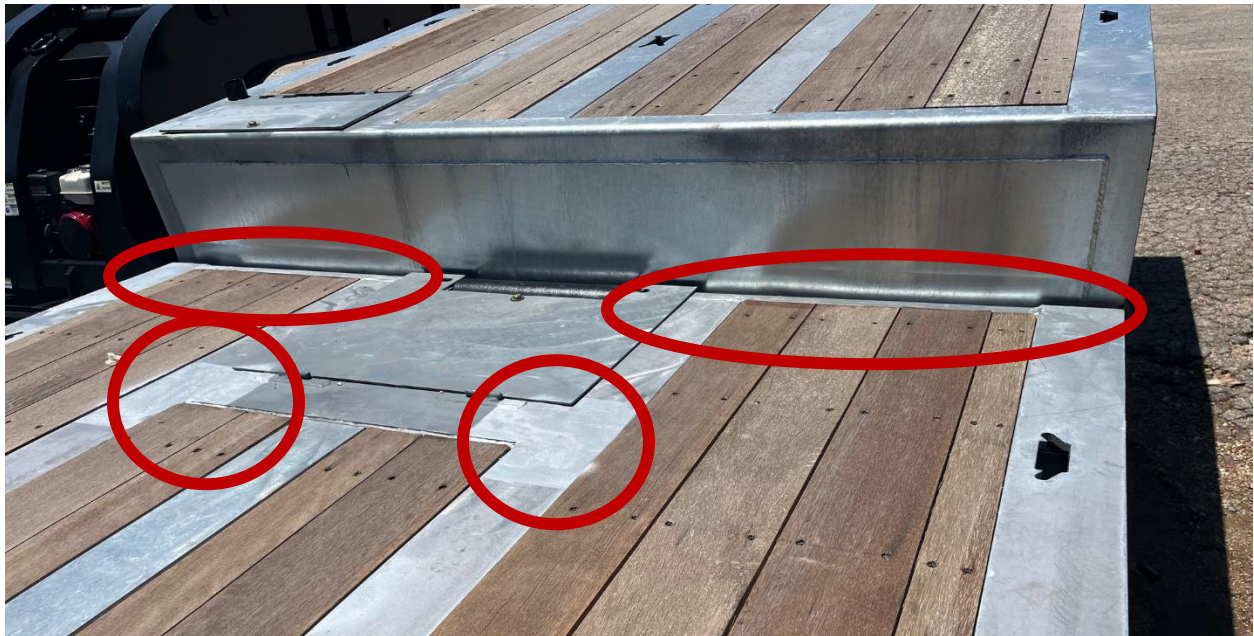
Front of deck: Main Beams and Side Rails

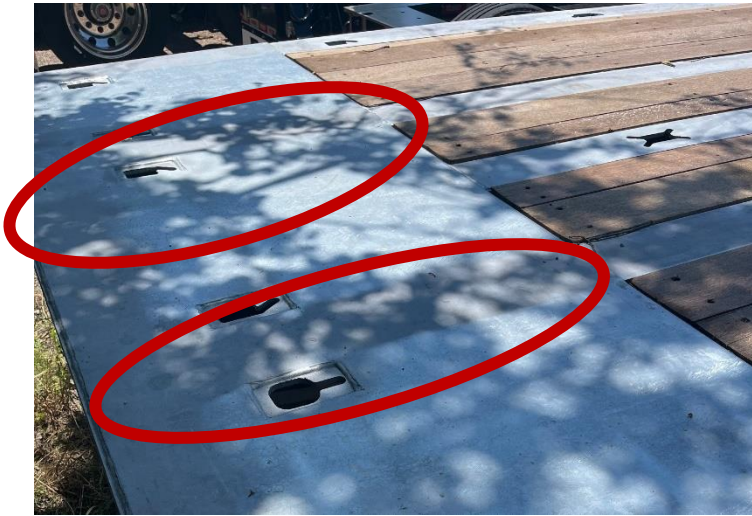
Mean Beams on top of transition plate

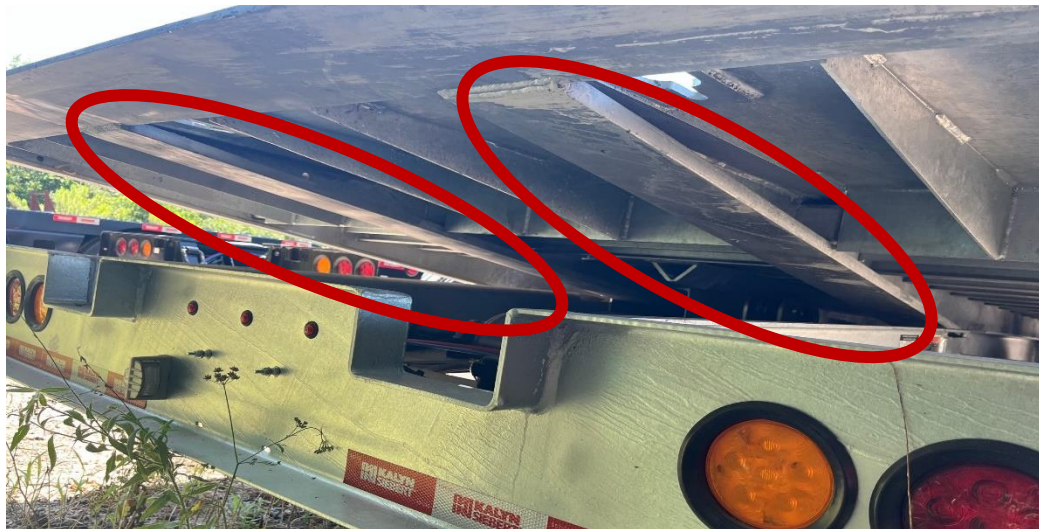
Main Beams underneath transition plate
