Service Action Code: 66EX

Subject	Compliance Label				
Document History	Date		Summary		
	06/18/2024		Original publication		
Affected Vehicles	Country	Beginning Model Year	Ending Model Year	Vehicle	Vehicle Count
	USA	2024	2024	JETTA	51
	USA	2024	2024	TAOS	3,316
	USA	2024	2024	TIGUAN	4,310
	<p>Check Campaigns/Actions screen in ELSA on the day of repair to verify that a VIN qualifies for repair under this action. ELSA is the <u>only</u> valid campaign inquiry & verification source.</p> <ul style="list-style-type: none"> ✓ Campaign status must show "open." ✓ If ELSA shows other open action(s), inform your customer so that the work can also be completed at the same time the vehicle is in the workshop for this campaign. 				
About this Service Action	On certain vehicles, the year of manufacture listed on the compliance label is incorrect. Dealers will affix an overlay label to the vehicle's compliance label to provide the correct month/year of manufacture.

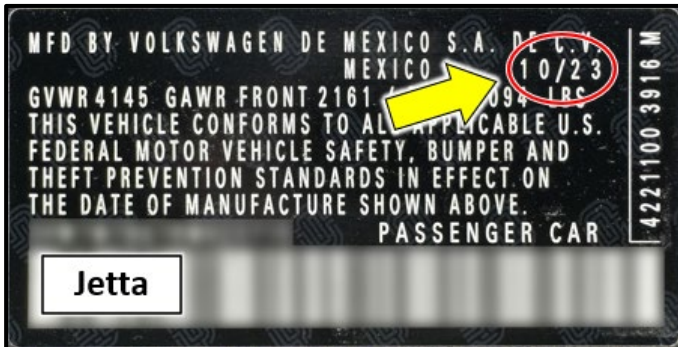
- Locate the Month/Year text <arrow> on the compliance label.
