Technical Service Bulletin

90 Audi virtual cockpit display has semi-circular marks on edges of display

90 24 03 2070020/3 June 11, 2024. Supersedes Technical Service Bulletin Group 90 number 23-28 dated June 8, 2023 for reasons listed below.

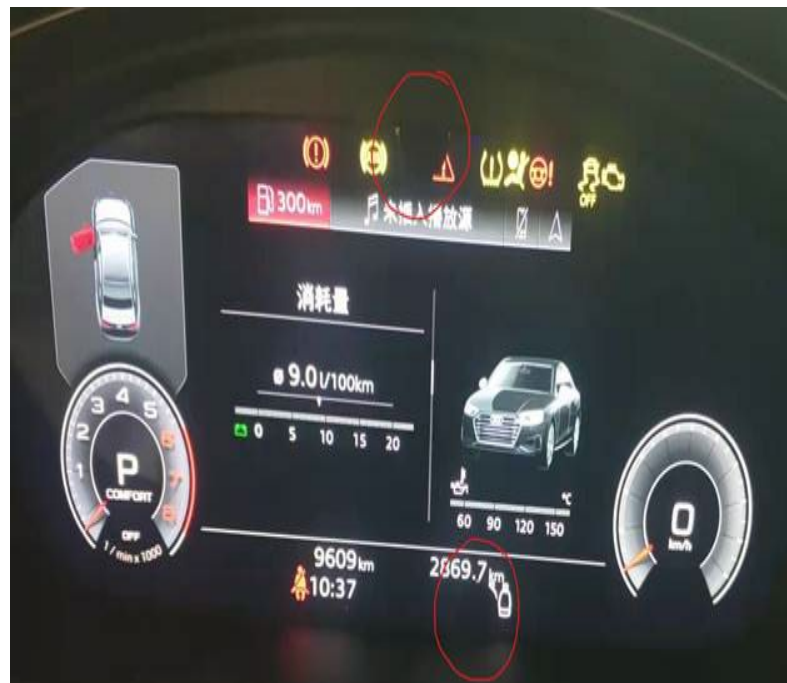
The display of the Audi virtual cockpit has semi-circular marks on the edges of the display glass.

Hardware issue within the instrument cluster.

Figures 1 and 2 are examples of the circular marks that may be present on the screen of the instrument cluster.

Figure 1: Circular spots along the top and bottom of display.

1. In your warranty claim notes document the production date of the instrument cluster. To do so:
 - a. Using Self Diagnosis: Select diagnostic address 17.
 - b. Use the control module OBD drop down and select Identification.
 - c. Click “show expanded identification”.
 - d. Expand the “Fazit identification” and document “Day of manufacture”.
2. Replace the Audi Virtual Cockpit - J285- according to the instructions of the ELSA repair manual.

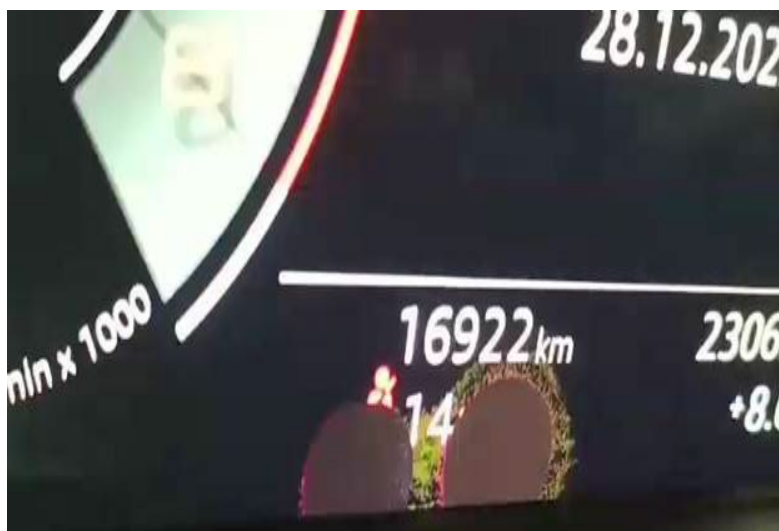
Figure 2: Circular spots in the trip odometer.
