Technical Service Bulletin

27 PSS MLB PHEV/BEV: 12V battery discharged by bus wake-up

27 24 74 2074126/1 June 21, 2024.

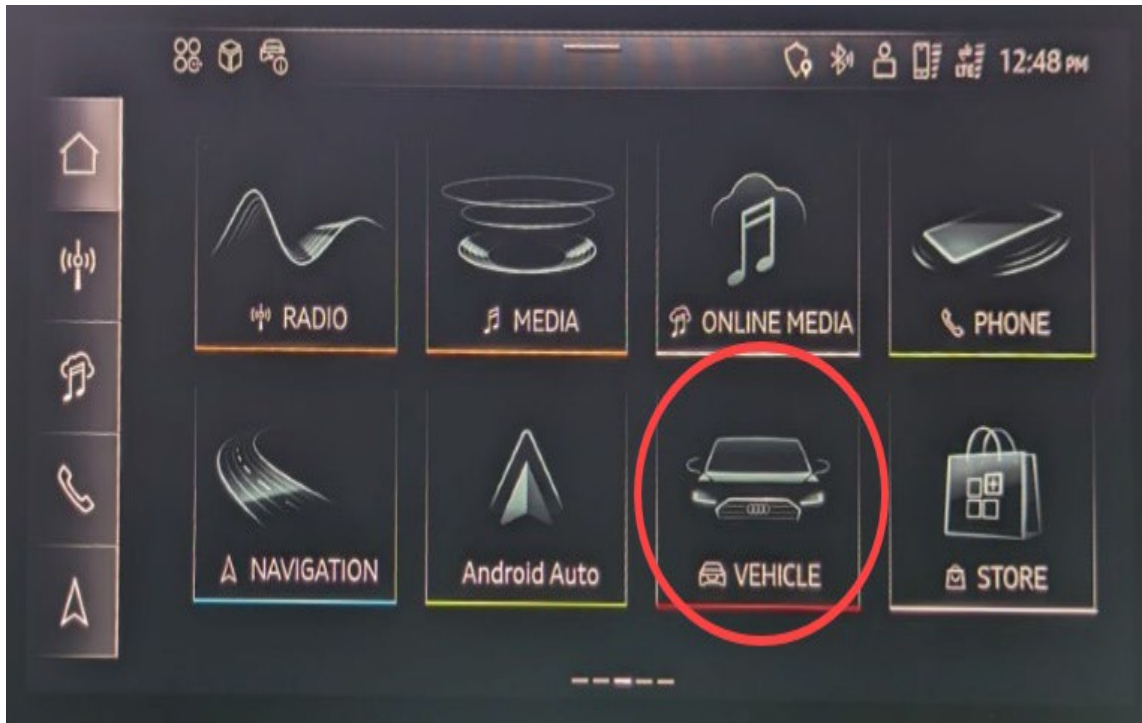
Figure 1. "VEHICLE" tile.

1. With the ignition on, select the "VEHICLE" tile.

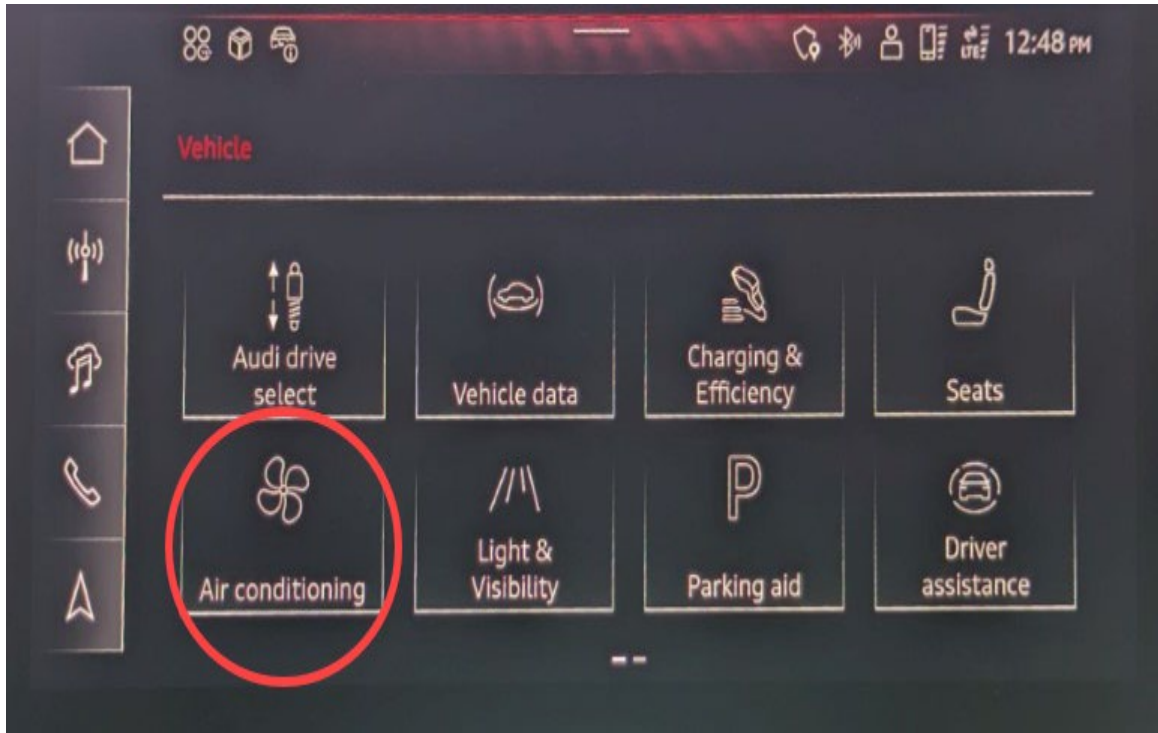
Figure 2. “Air conditioning” tile.

2. Select the "Air conditioning" tile.

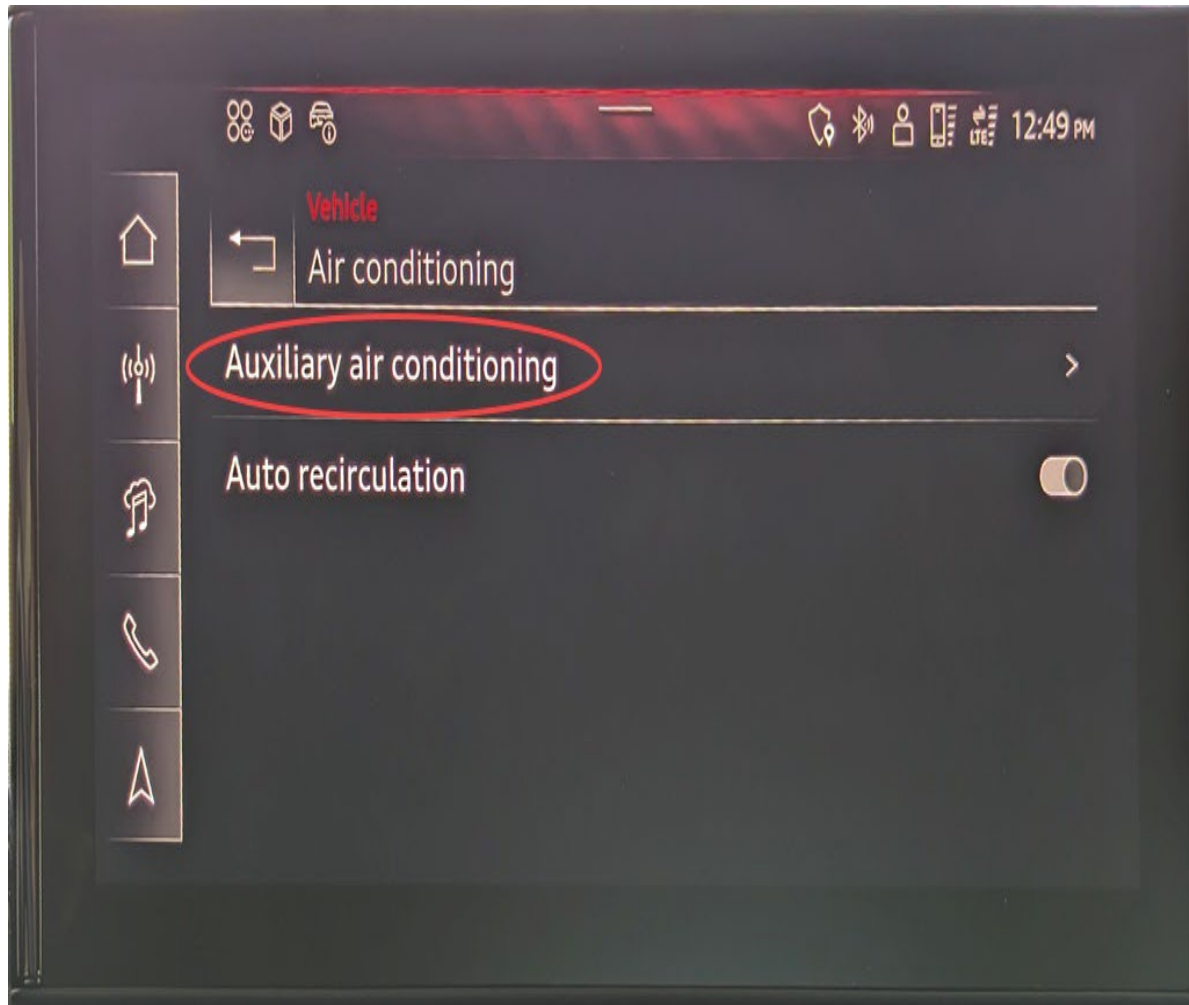
Figure 3. “Auxiliary air conditioning”.

3. Select “Auxiliary air conditioning.”

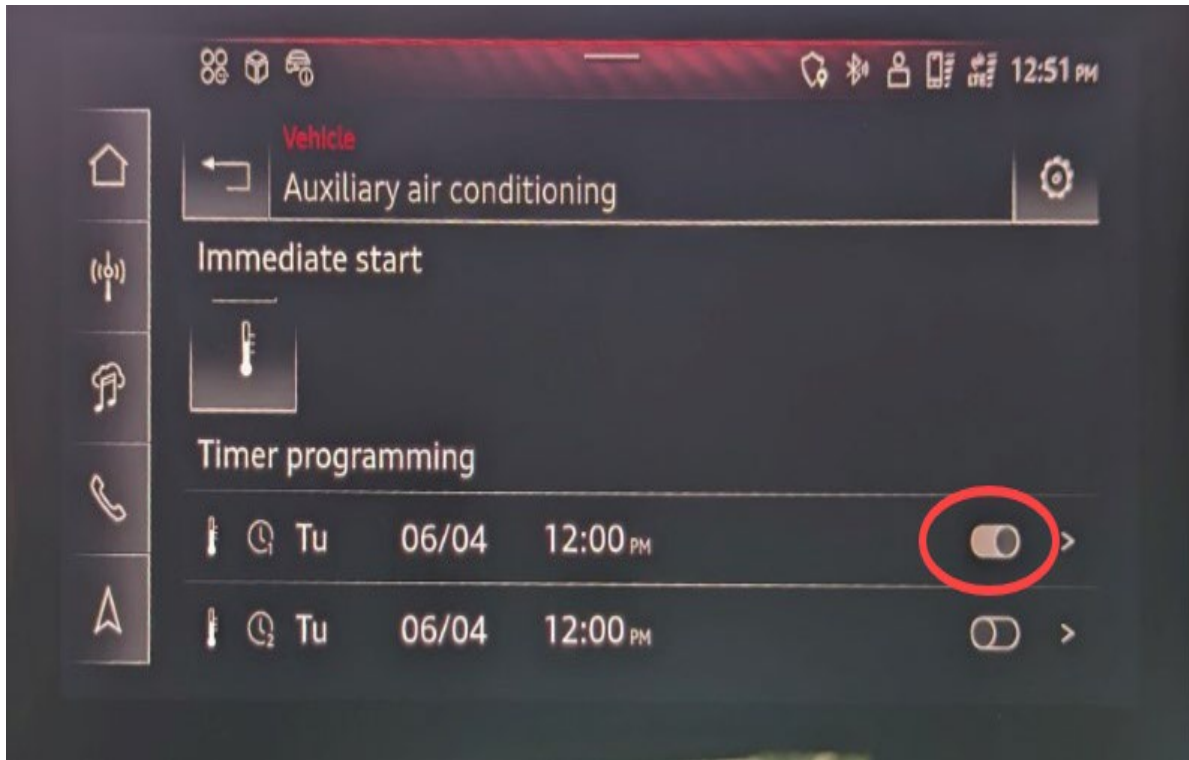
Figure 4: Active A/C timer.

4. Select a timer and turn it on.

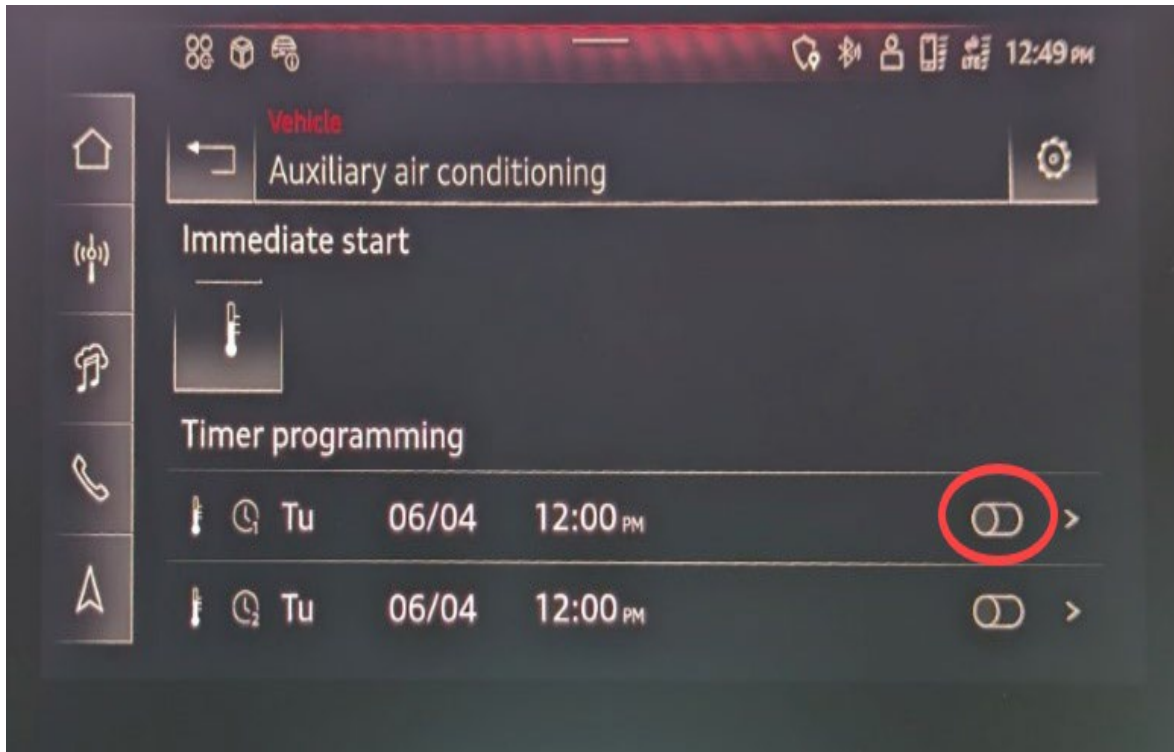
Figure 5. Deactivated A/C timer.

5. Turn the timer off.

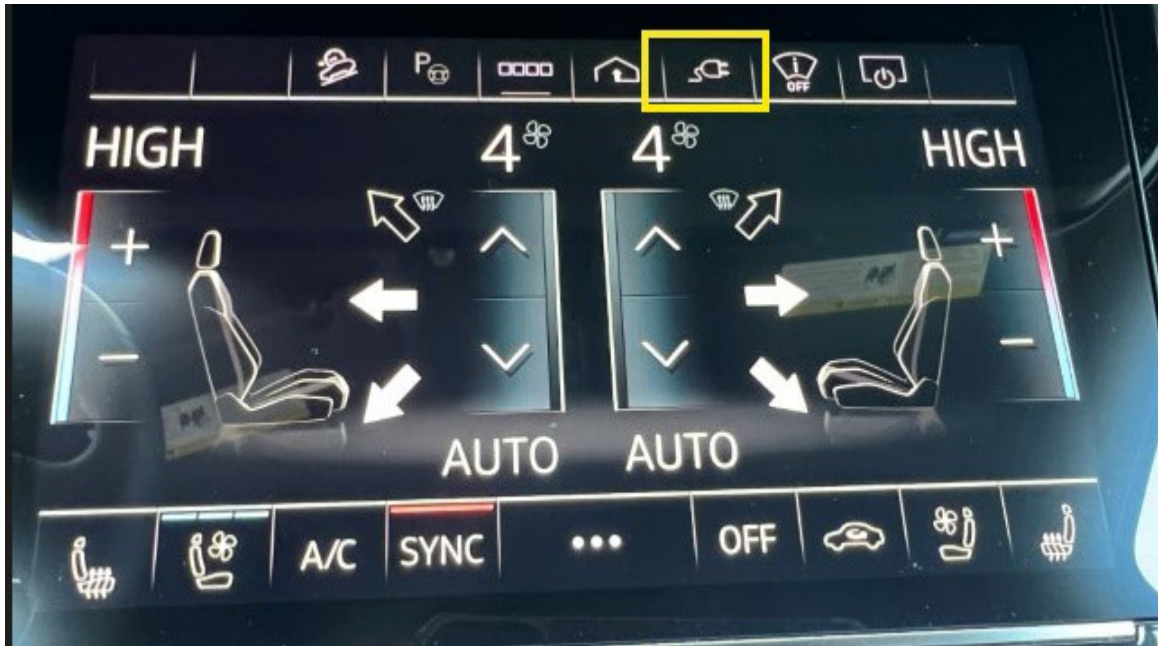
Figure 5: Charging symbol.

1. Select the charging symbol in the lower MMI screen.

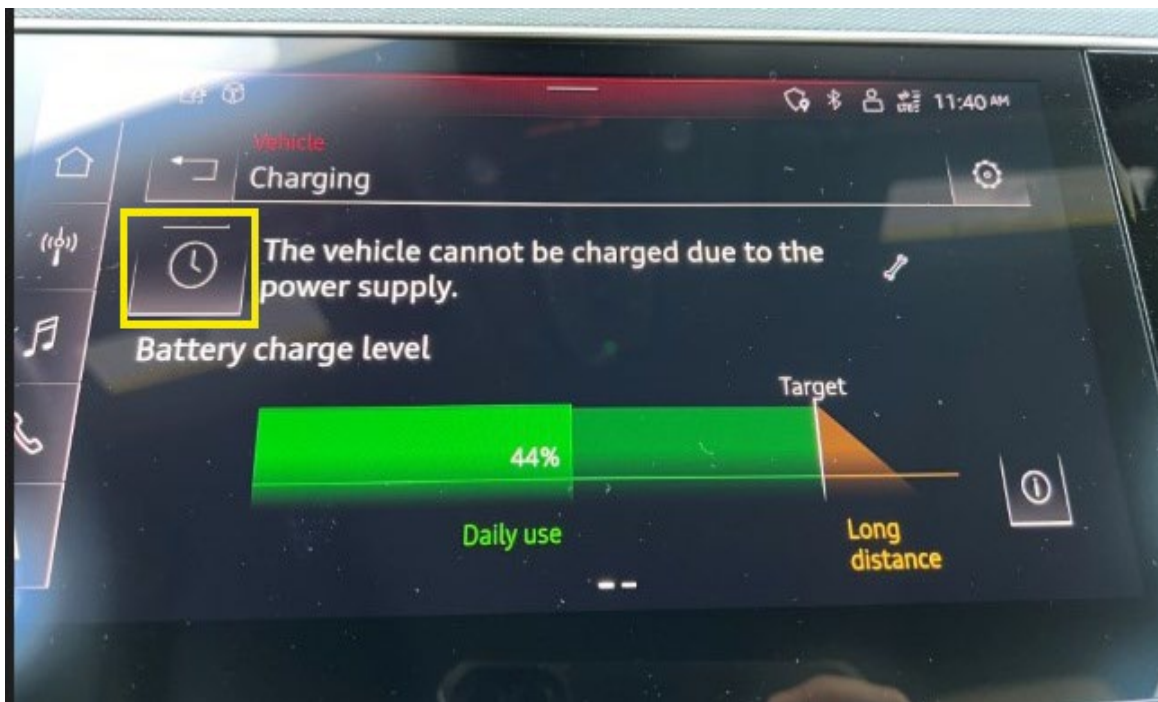
Figure 6: Clock symbol.

2. Select the clock symbol.

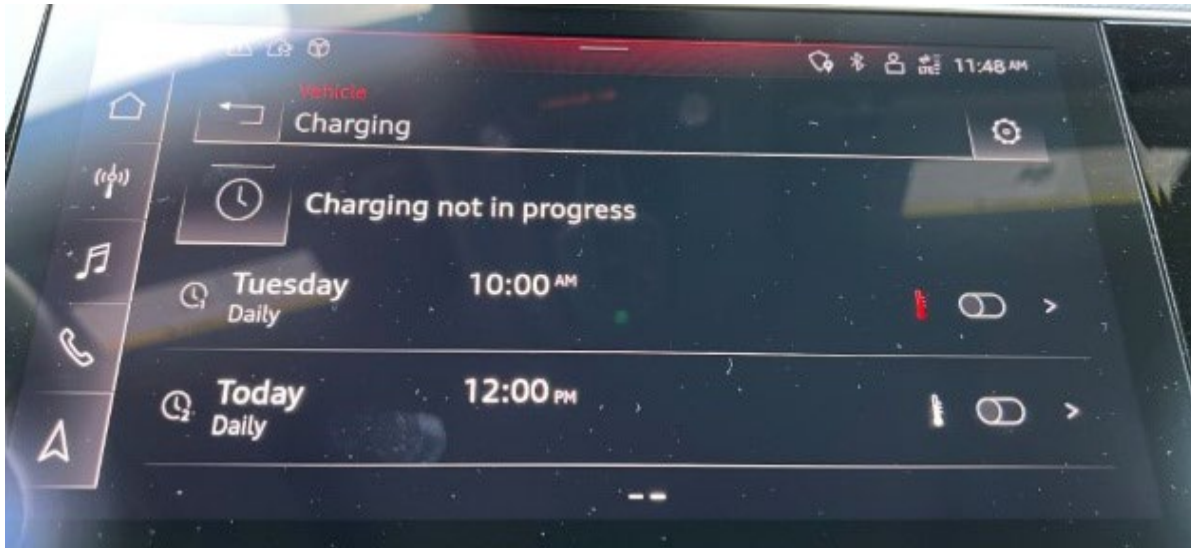
Figure 7. Charging timer menu.

3. This takes you to the charging menu.

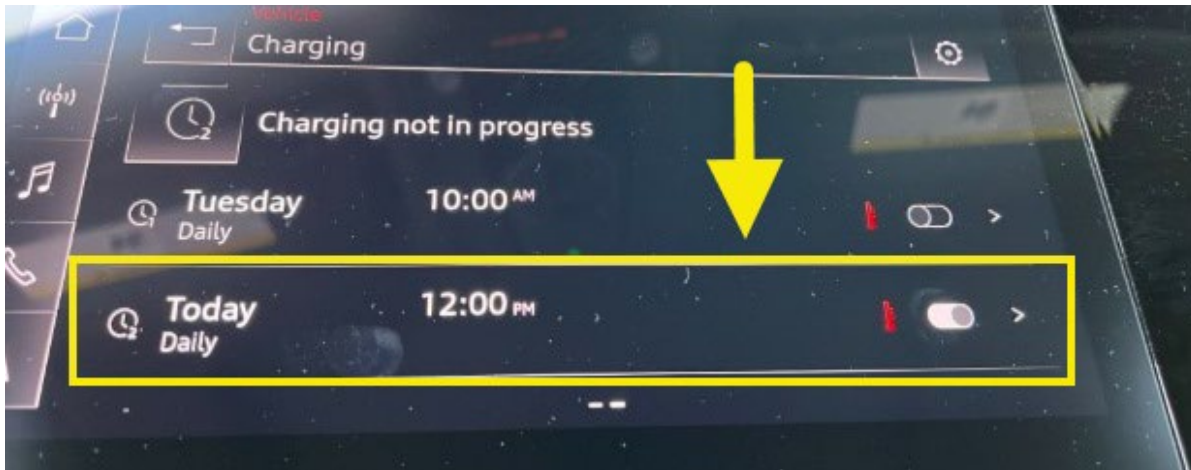
Figure 8. Active timer.

4. Activate a timer.

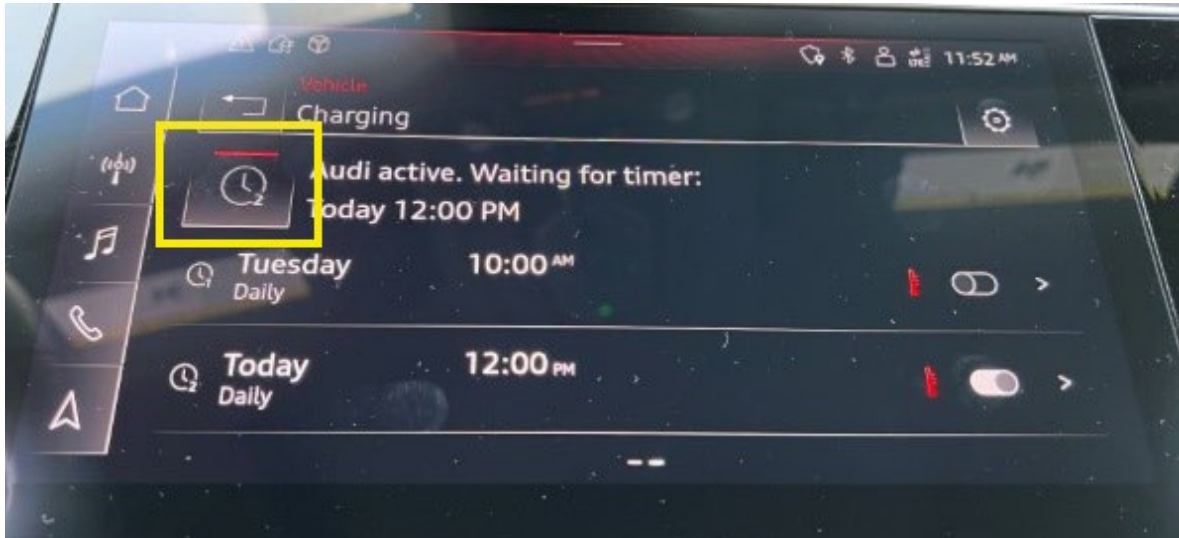
Figure 9. Active clock symbol for timer.

5. Select the clock symbol to activate the timer.

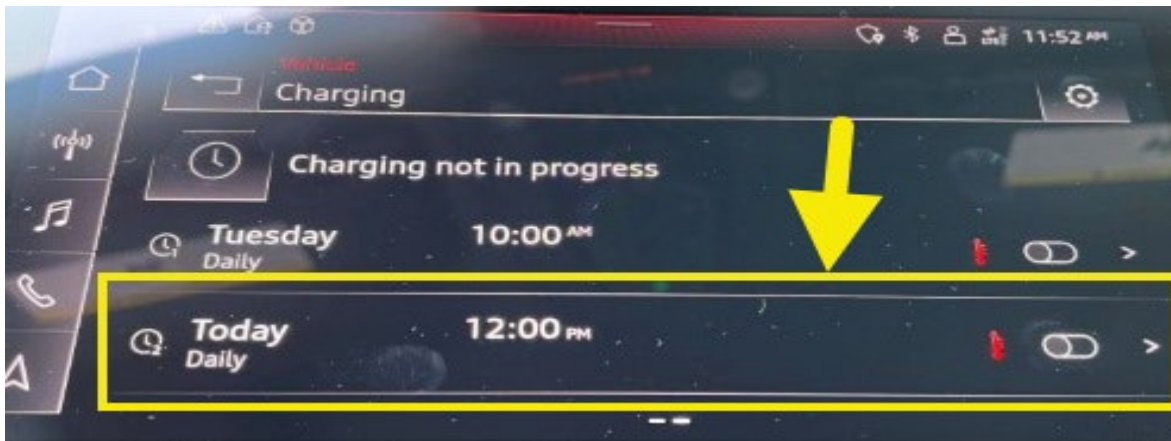
Figure 10. Timer deactivated.

6. Deactivate the time selected in step 4.
