Technical Service Bulletin

90 Horn sound quality poor
90 24 08 2074436/1 June 28, 2024.

Model(s)	Year	VIN Range	Vehicle-Specific Equipment
All Audi Vehicles	2011 - 2024	All	Not Applicable

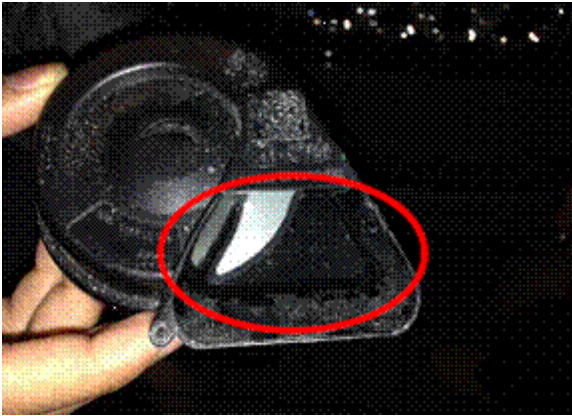
Figure 1. “Horn opening”

Then turn the horn so that the opening of the horn funnel (see red mark on illustration) points to the floor and the water can drain.

Shaking the horn slightly helps the water to drain quickly.

Do not open/disassemble the horn to dry it, as doing so may damage the seals and cause water to enter the electronics.

After the water has been removed from the horn, it must be refitted on the bracket.
