Technical Service Bulletin

91 RSE: Tablet for rear seat entertainment system - removing battery

91 24 24 2074414/1 June 28, 2024.

Model(s)	Year	VIN Range	Vehicle-Specific Equipment
A4, A4 allroad, and Q7	2017	All	Rear Seat Entertainment
A8	2019 - 2021		
A8 e quattro, and S8	2020 - 2021

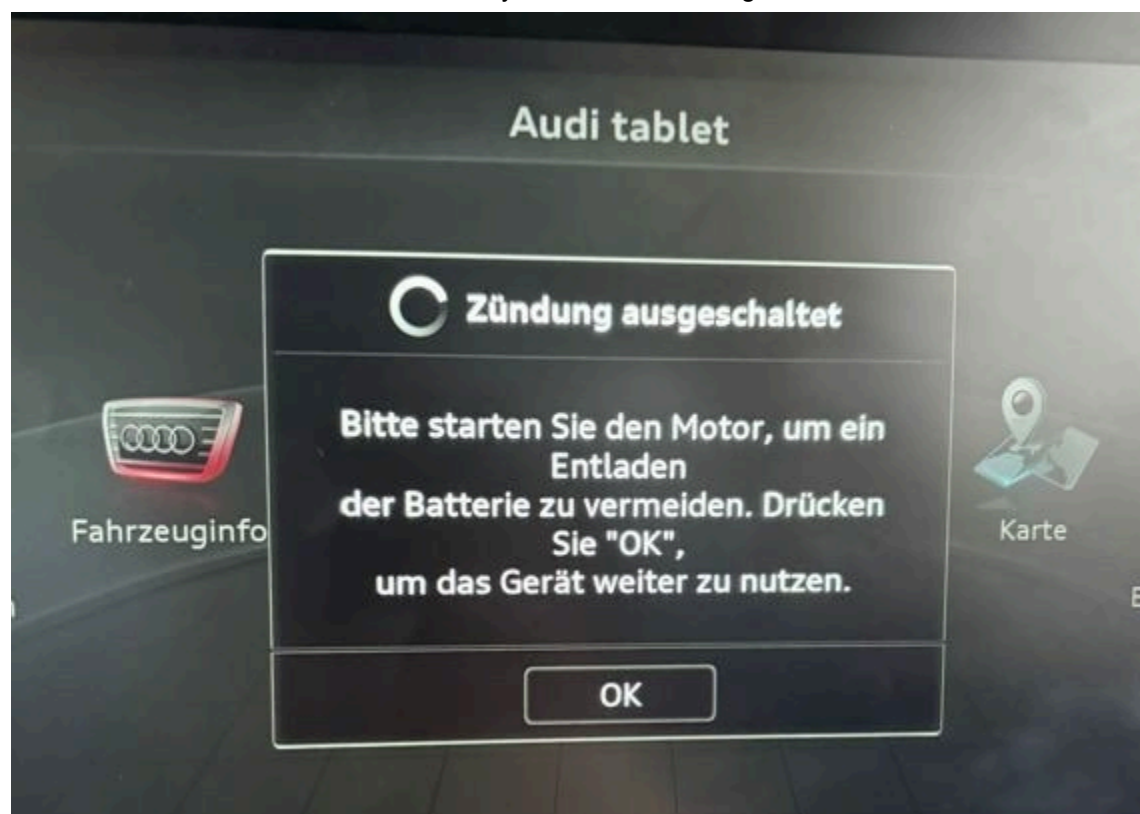
- The tablet for the rear seat entertainment system can only be used on its mount.
- The message “**The battery is defective. Please contact your Audi dealer**” (Figure 1) appears and the tablet for the rear seat entertainment system does not charge.

Figure 1. Message in RSE.

If the customer complaint is confirmed and the message ***“The battery is defective. Please contact your Audi dealer”*** is displayed when the tablet is switched on, follow the procedure below and check whether the internal battery pack has failed:

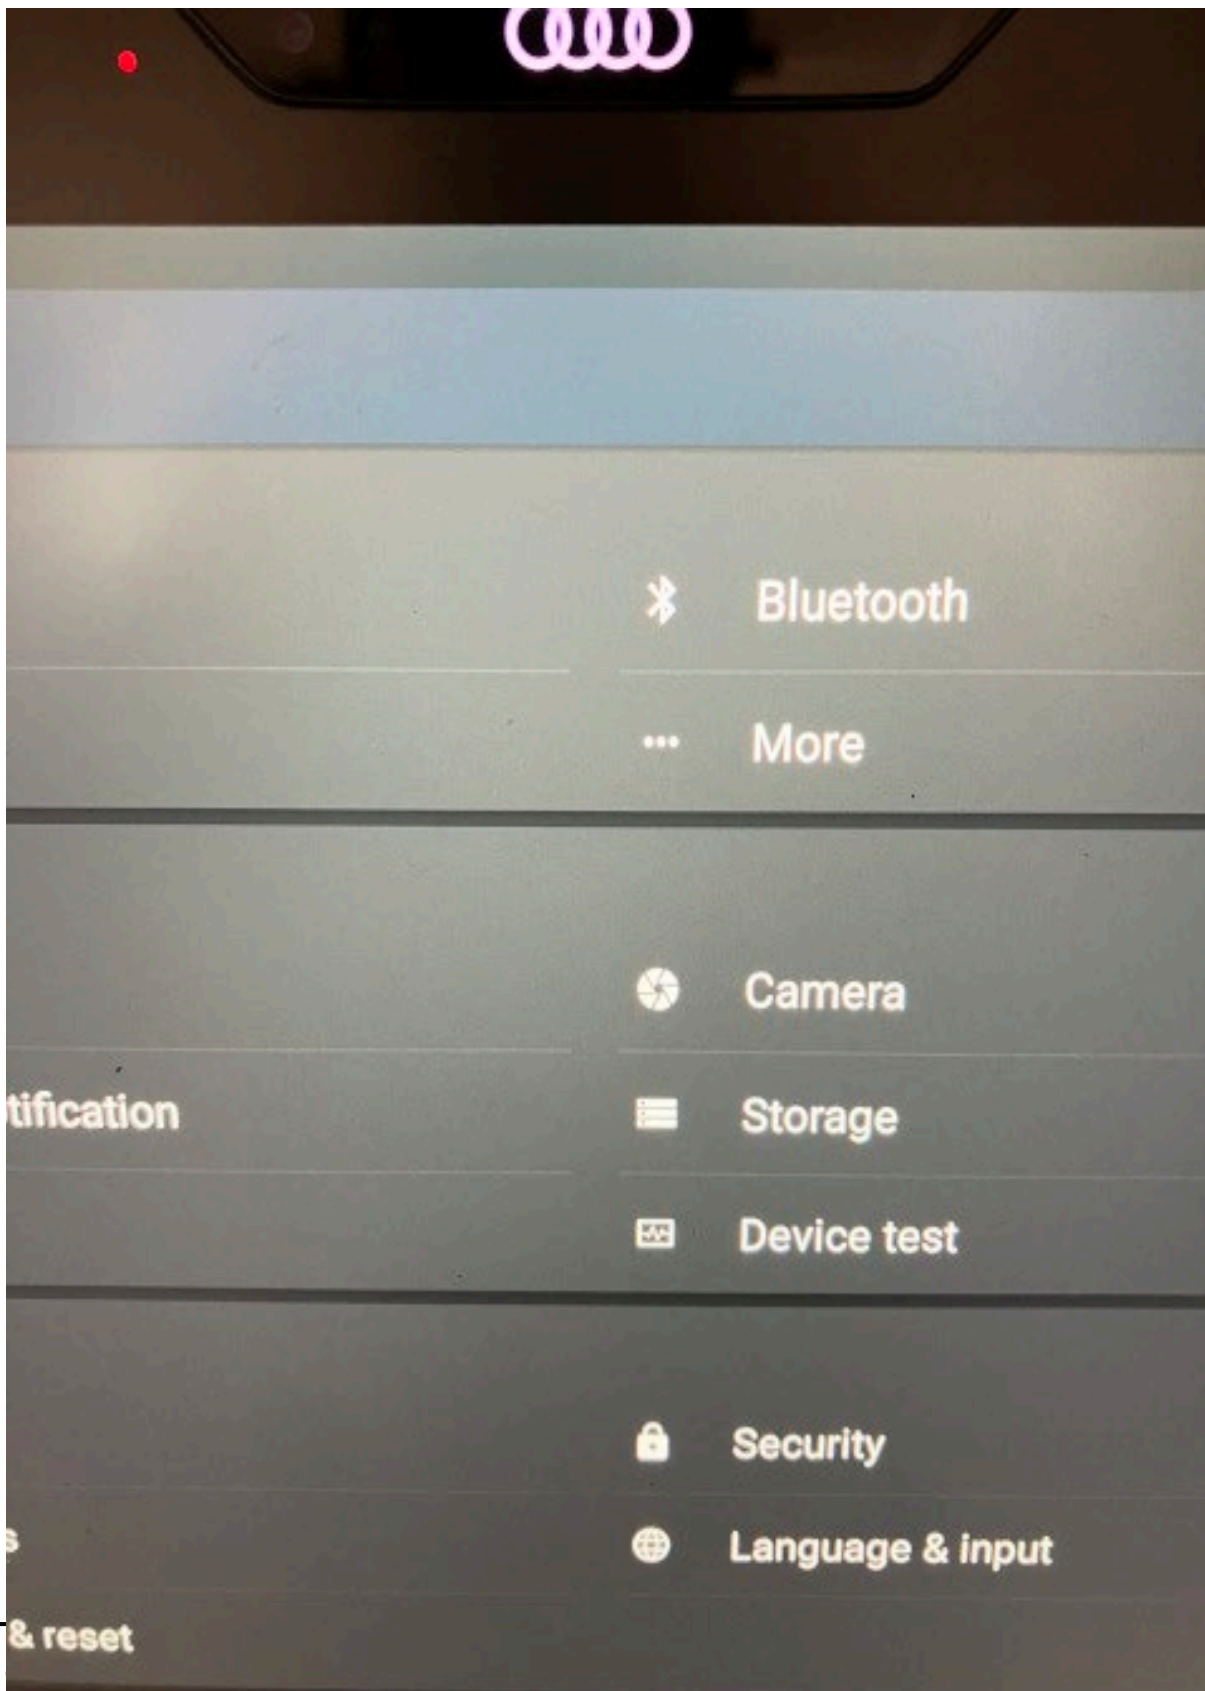
- Select ***“Settings”*** for the rear seat entertainment (RSE) system.
- Select the “Device test” option shown in Figure 2.

Figure 2. Device test screen for RSE.

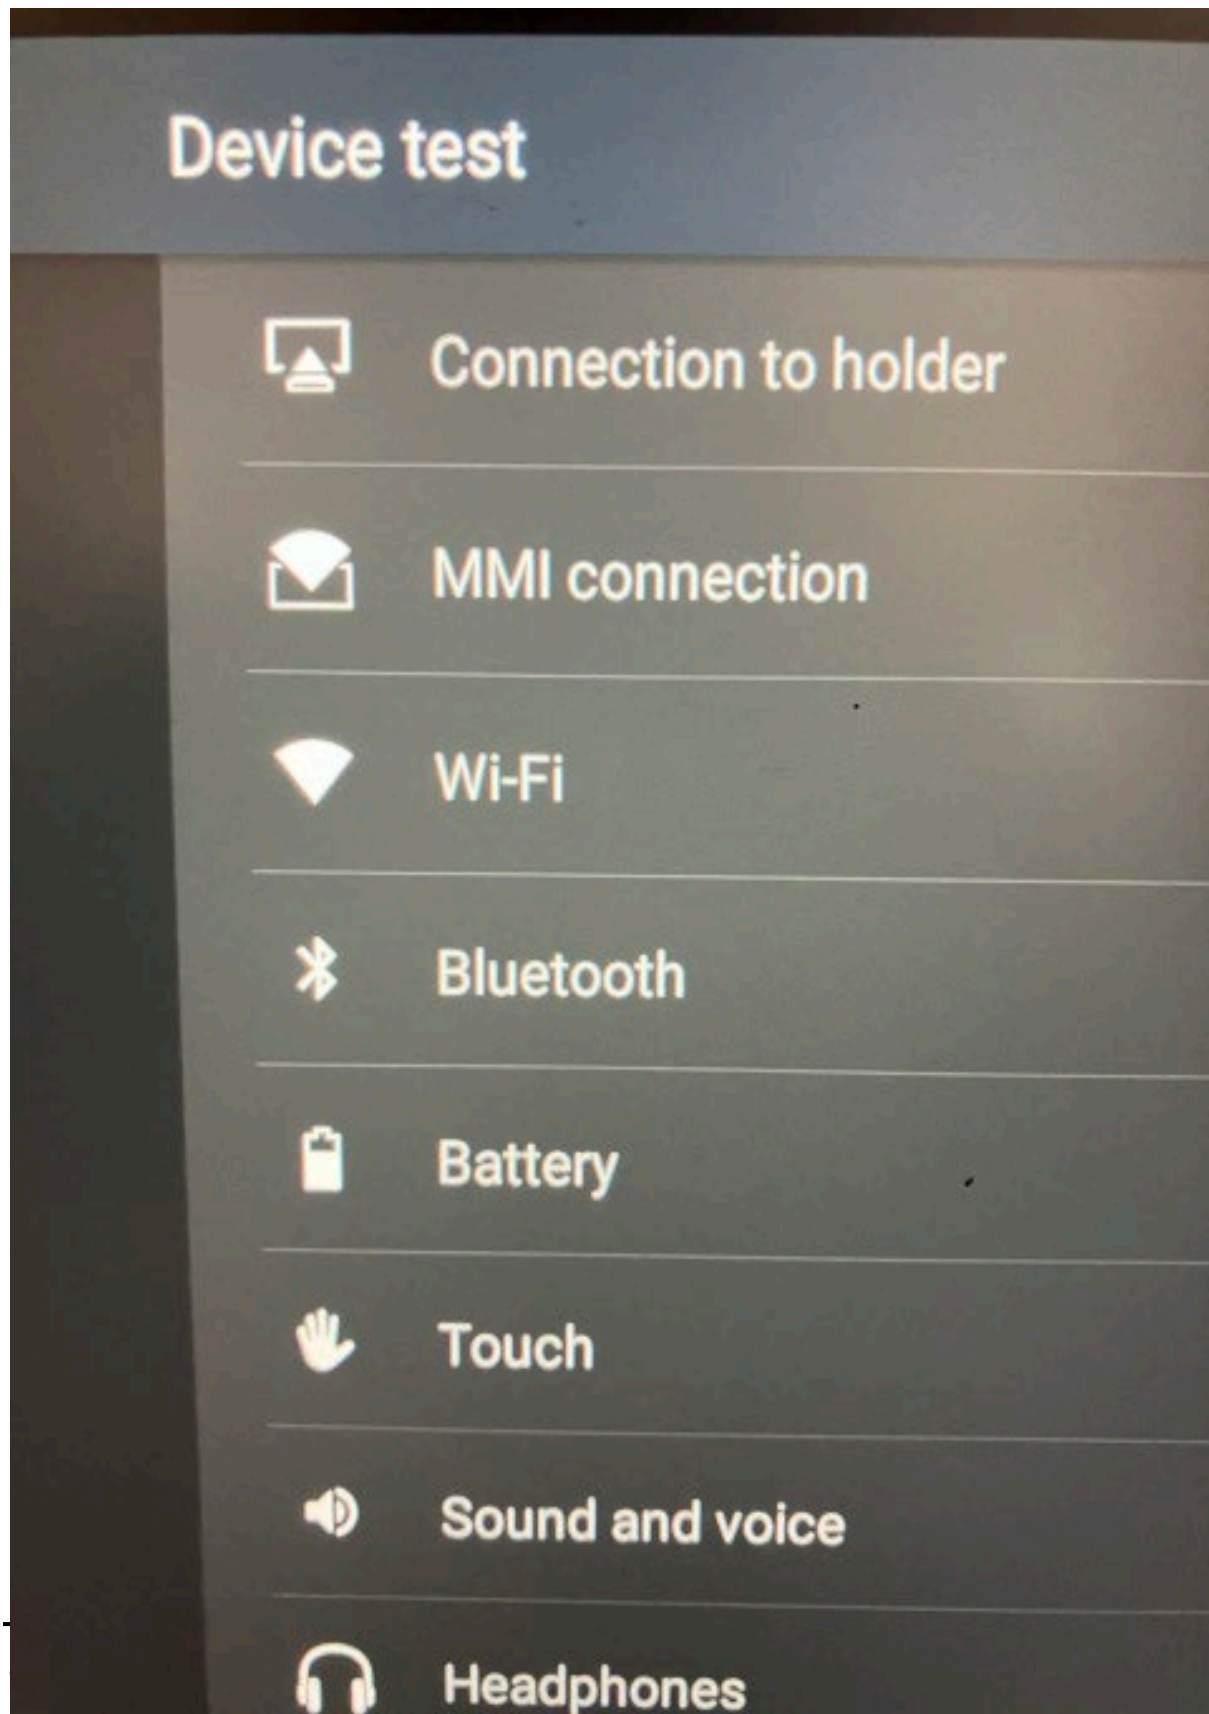
- Select the **“Battery”** option shown in Figure 3.

Figure 3. Select the battery option.

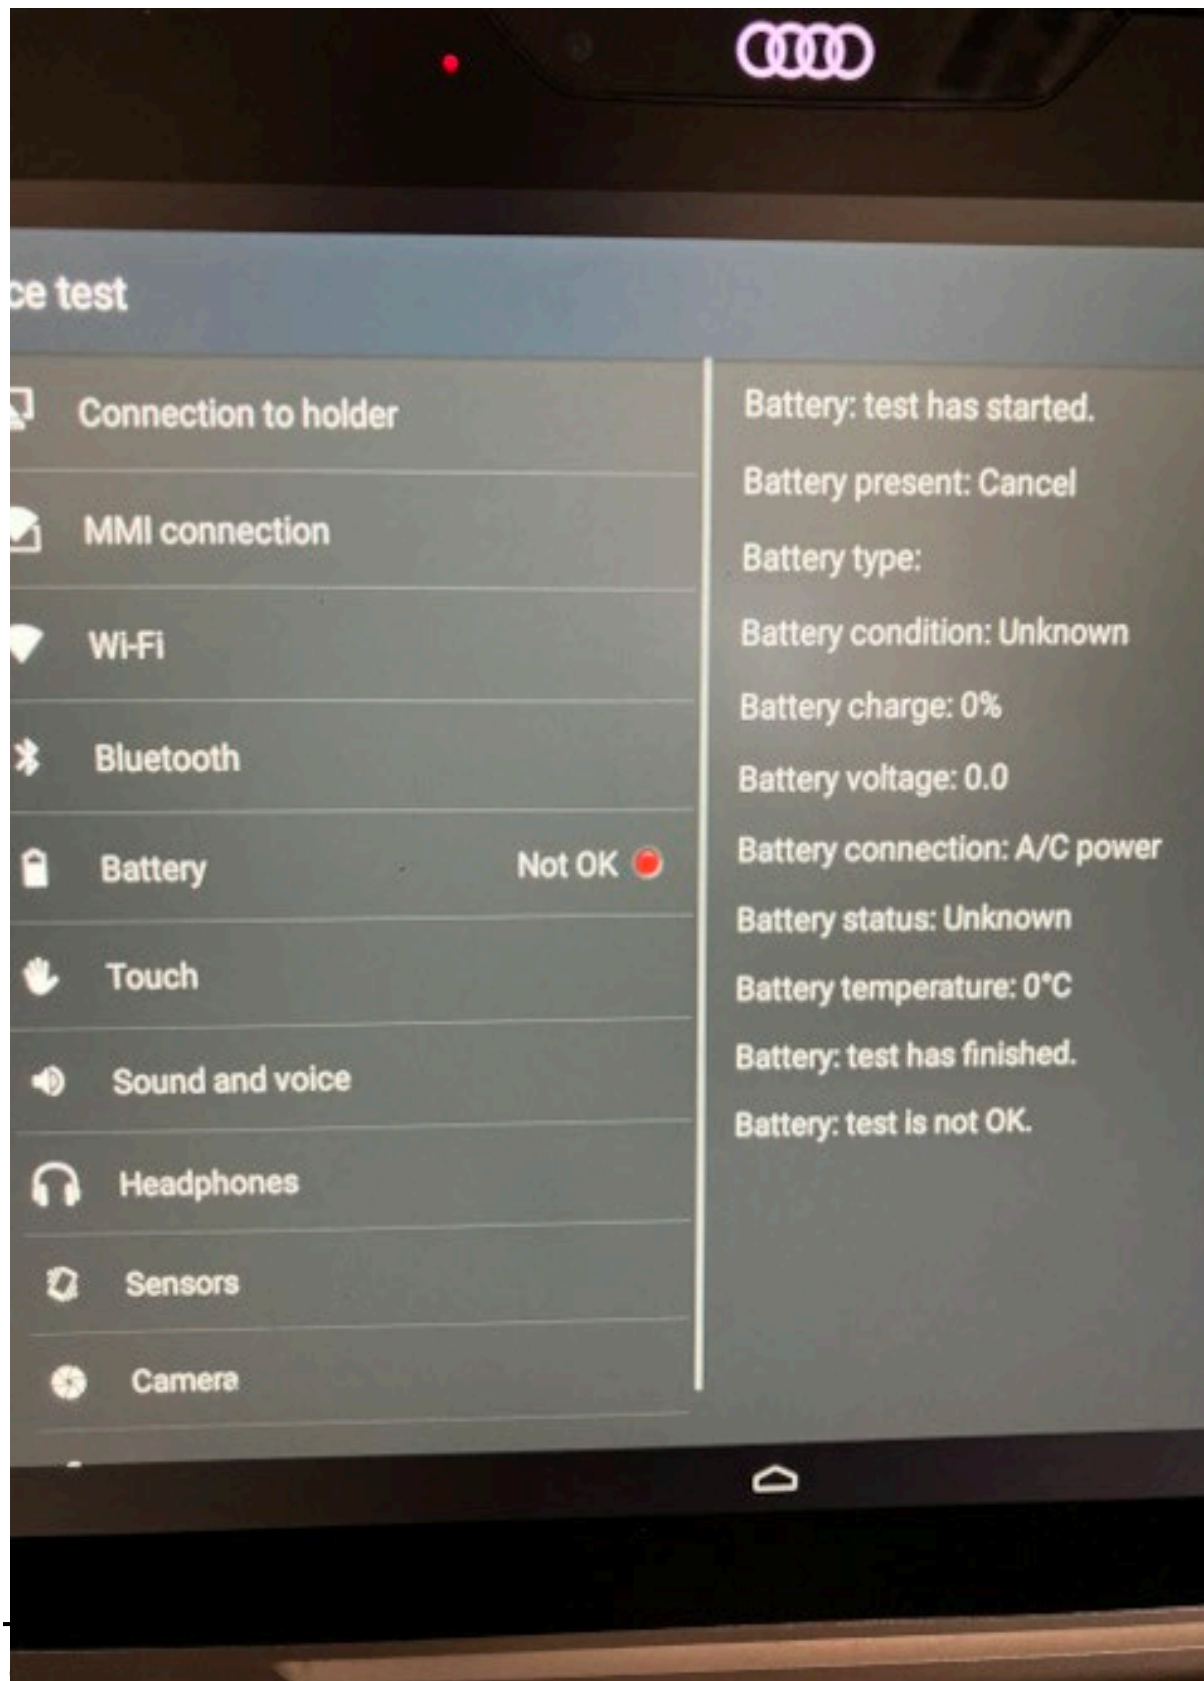
The test result will be shown as either **“OK”** with a green mark (Figure 5) or **“Not OK”** with a red mark. The internal battery pack of the tablet for the rear seat entertainment system may only be replaced if the test result is **“Not OK”** (Figure 4).

Figure 4. Not OK indicator.

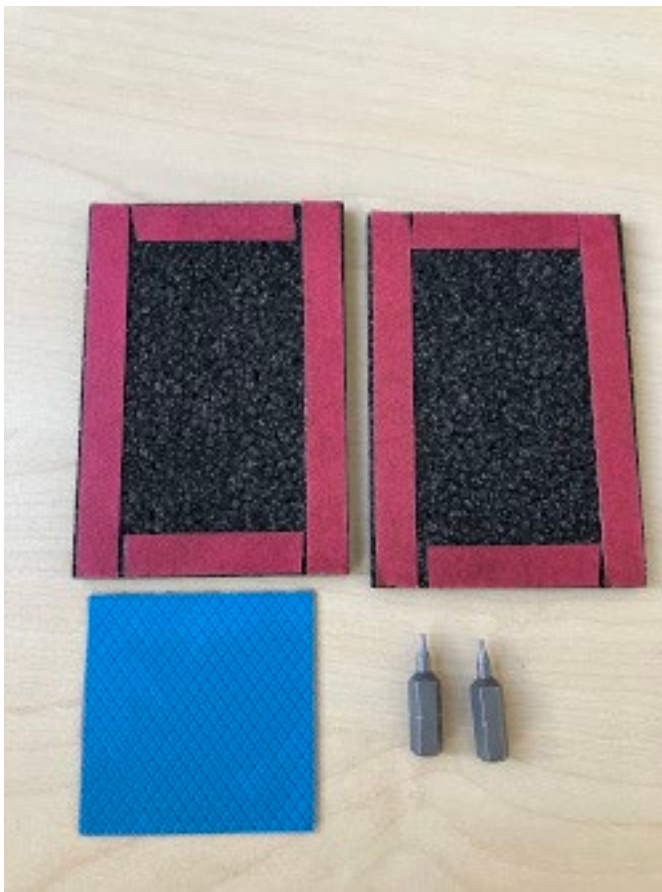
Before removing the battery, check that the repair kit with part number **4N0 998 003** (Figure 6) is complete. The repair kit consists of two plastic inserts with double-sided adhesive tape on one side. The two plastic inserts fill the space once the battery has been removed. A heat conducting pad is shown in the bottom left of the image. The original heat conducting pad will be damaged when the tablet is opened and must be replaced. The two Torx T3 and T6 screwdrivers are for removing the screws to open the housing (T6) and for loosening the screws for the battery frame (T3).

Figure 6. A complete RSE Battery repair kit.

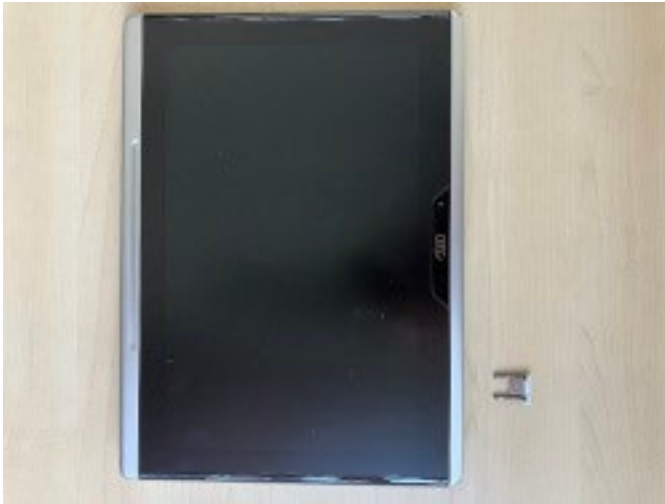
Figure 7. The SIM card holder is to the right of the tablet.

- Remove the SIM card holder from the tablet (Figure 7).

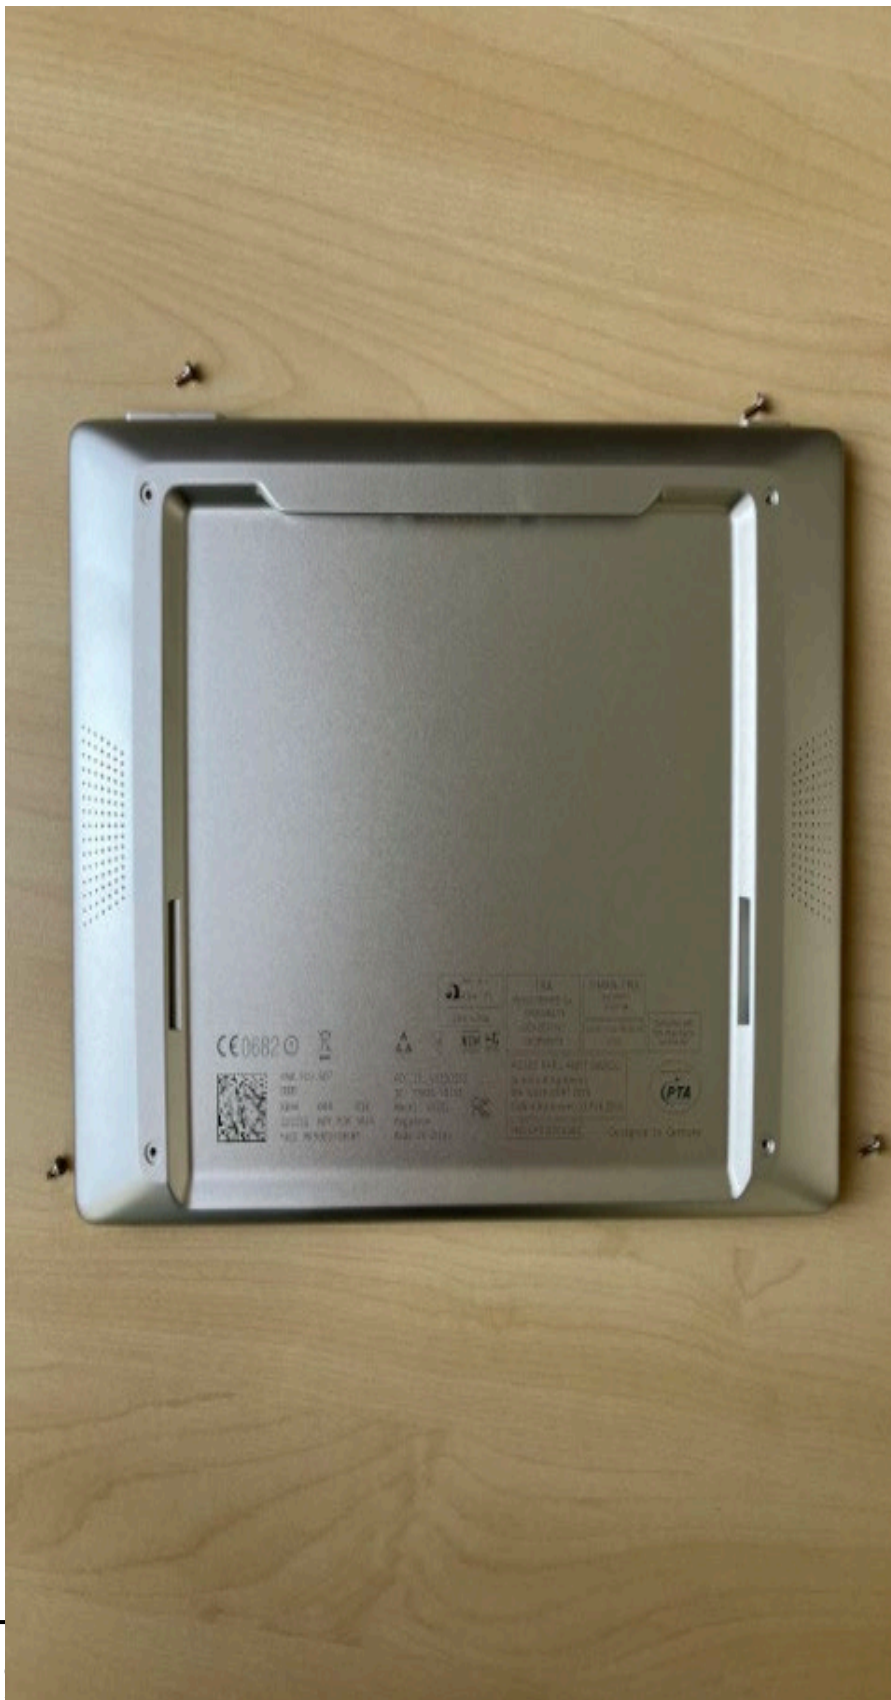
Figure 8. The T6 Torx screws must be removed from each corner.

- Remove the four T6 Torx screws on the back of the tablet (Figure 8).

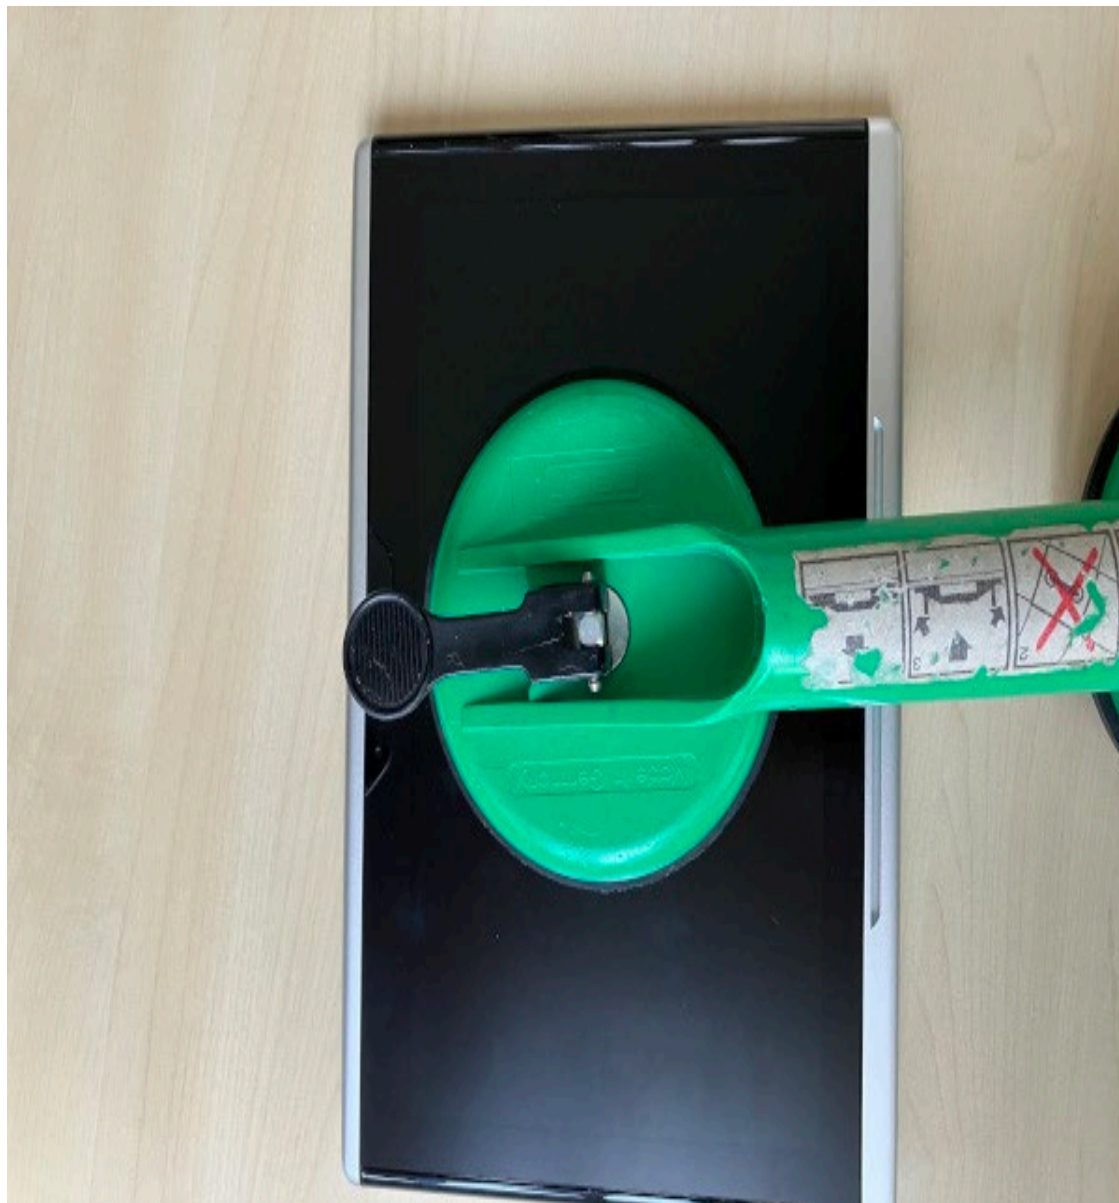
Figure 9. Attach a suction cup to the screen as shown.

- Attach a suction cup with a diameter of about 100 mm to the tablet screen (Figure 9).

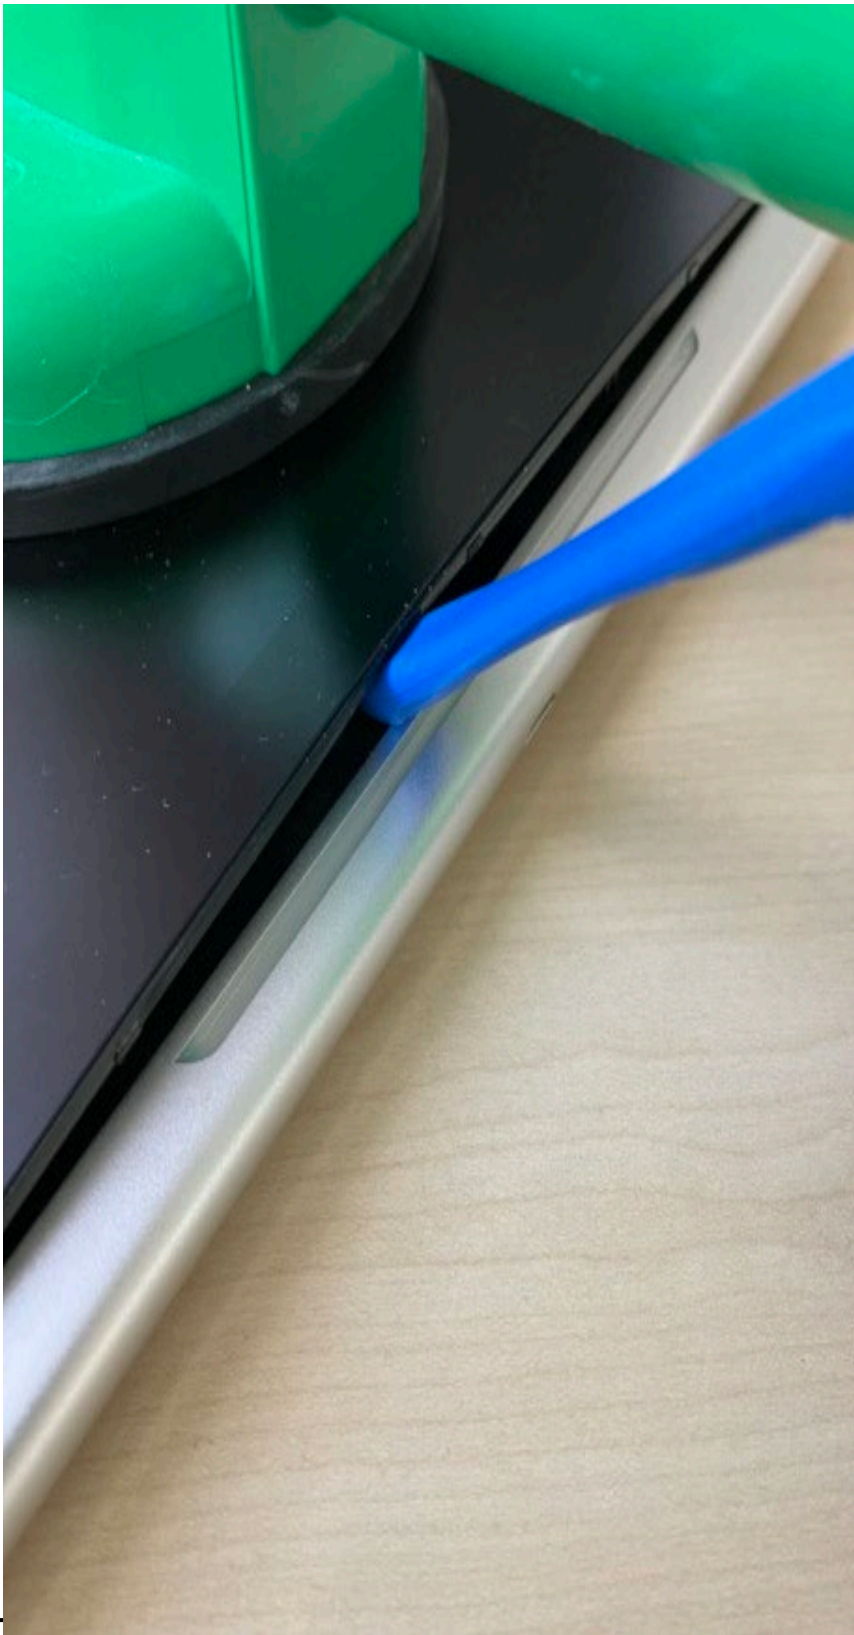
Note: There is a row of small catches on the bottom edge of the tablet screen securing it to the cover.

Figure 10. Use a small non-metallic wedge-shaped tool to remove the screen, being mindful of the small catches that secure the screen to the case.

- Have a second person hold the tablet housing in place while you lift the suction cup carefully to create a small gap at the **bottom edge**. Use a small, non-metallic, wedge-shaped tool to detach the lower front edge of the screen from the housing (Figure 10).

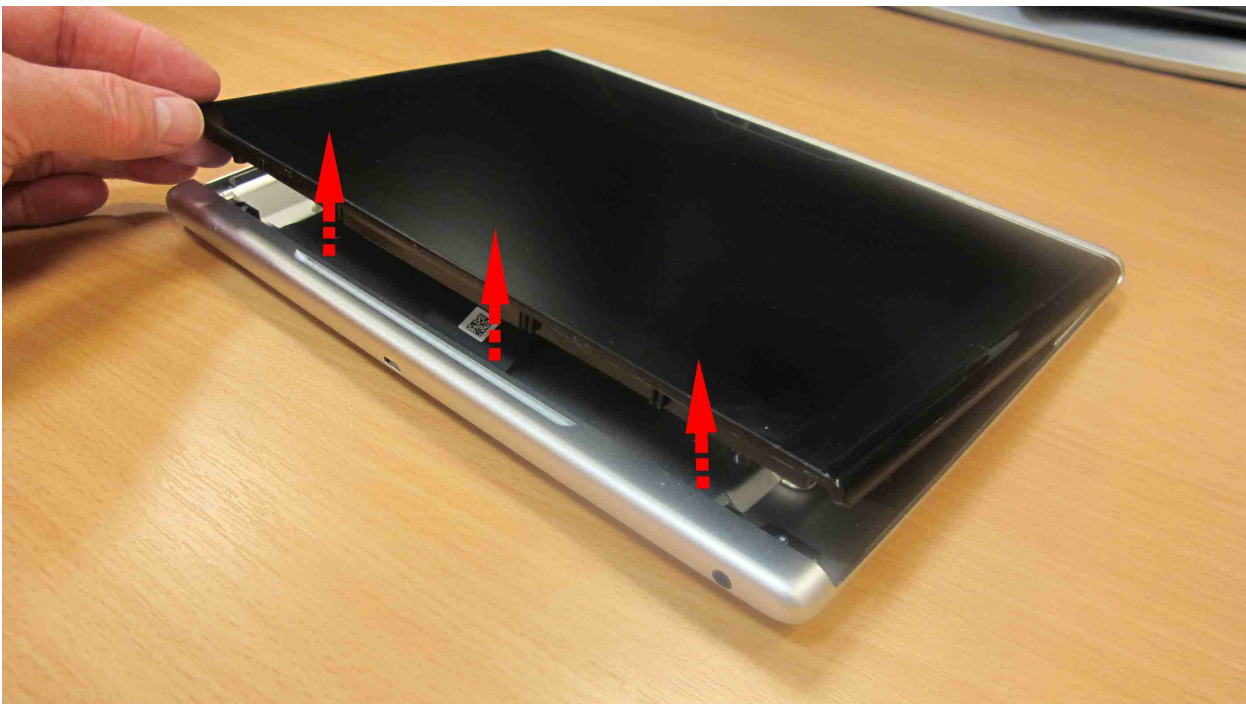
Figure 11. Lift the tablet screen a maximum of $\frac{3}{4}$ in. from the bottom edge of the housing.

- Carefully lift the tablet screen a maximum of $\frac{3}{4}$ in. away from the bottom edge of the housing (Figure 11).

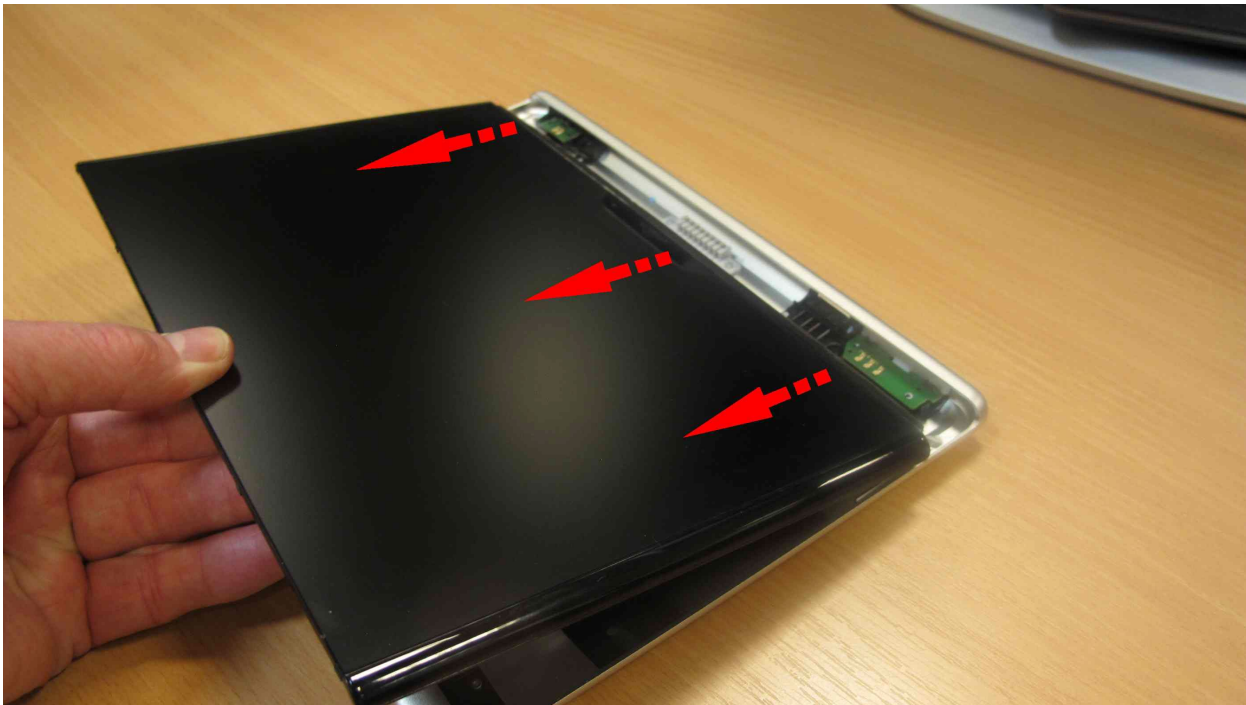
Figure 12. Slide the screen out of the housing.

- Slide the screen out of the housing (figure 12).

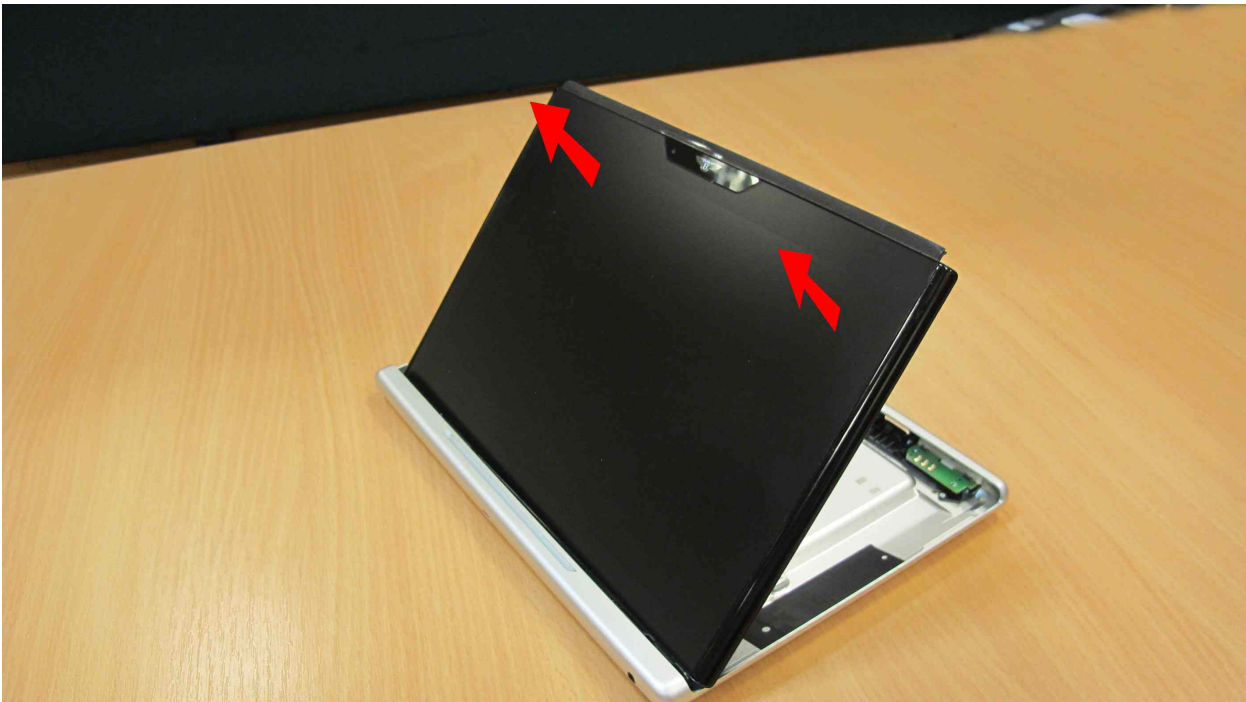
Figure 13. Lift the top edge of the screen to continue opening the tablet.

- Lift the top edge of the screen and continue opening the tablet (Figure 13).

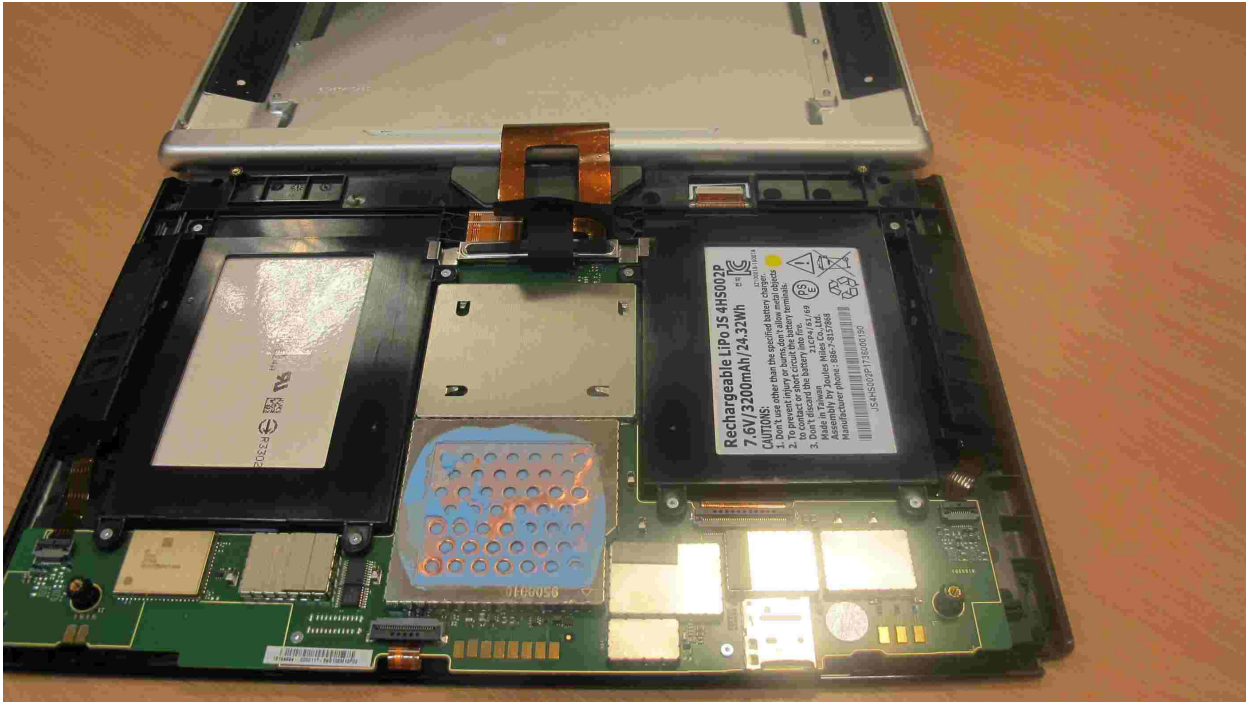
Figure 14. Place the screen face down.

- Place the screen face down (Figure 14).

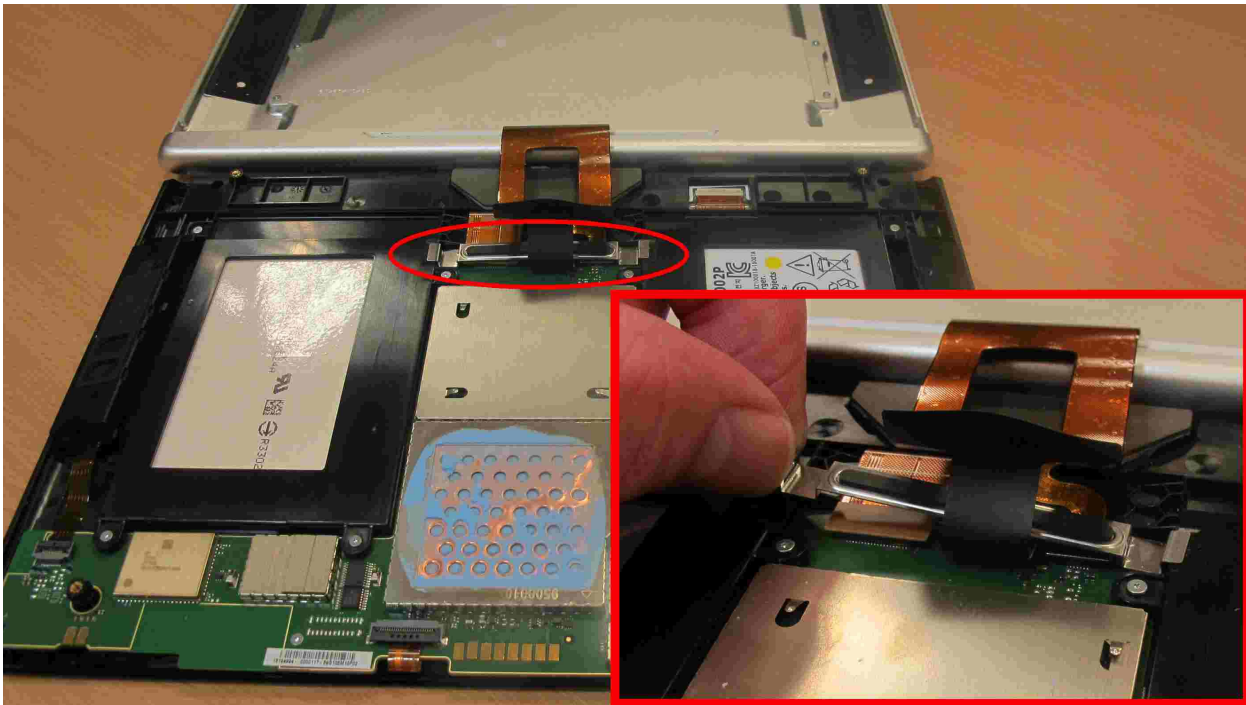
Figure 15. Remove the guide rail for the ribbon cable.

- Remove the guide rail for the ribbon cable by disengaging it at both ends (Figure 15).

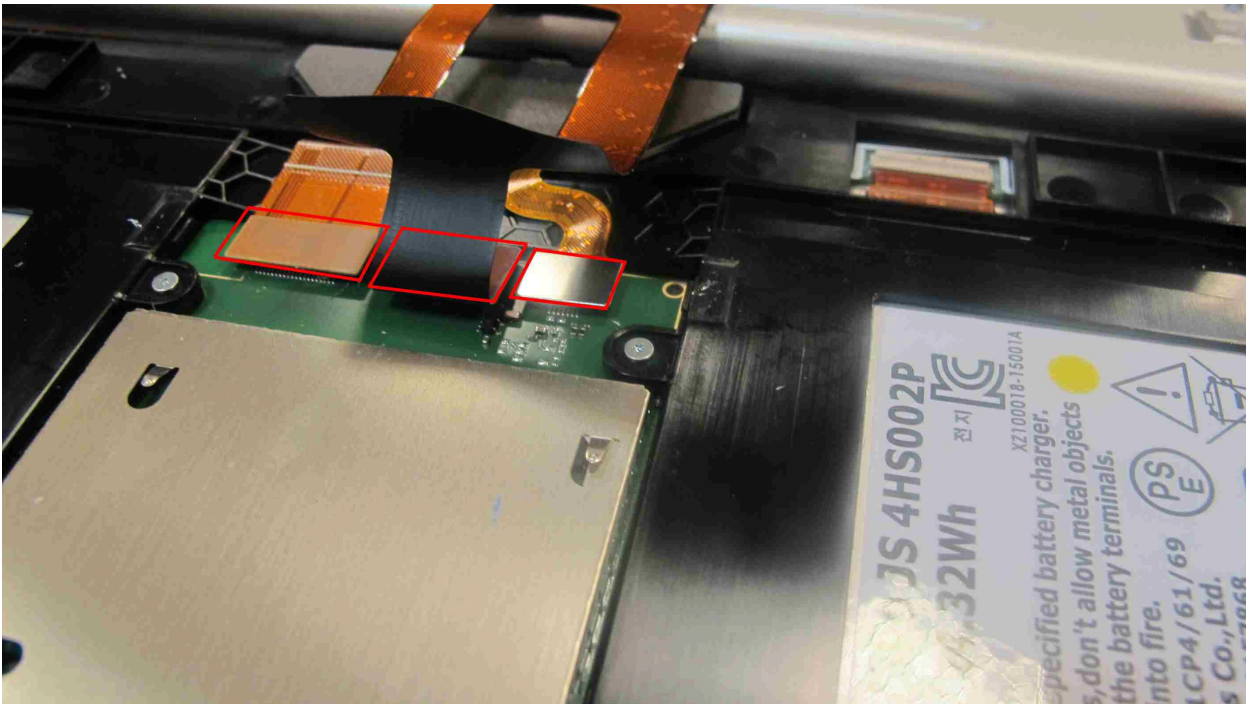
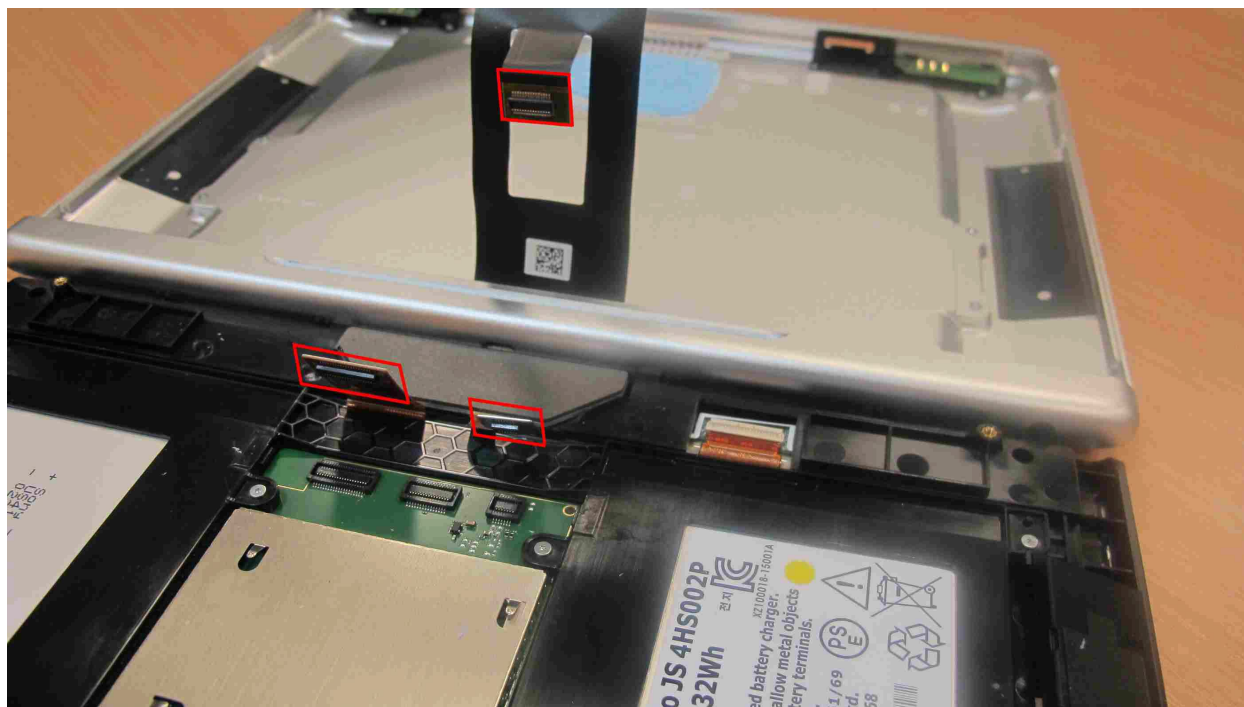
Figure 16. Unplug the ribbon cable connections with caution.

Figure 17. Unplug the ribbon cable connections with caution.

- Carefully unplug the three ribbon cable connectors (Figures 16 and 17).

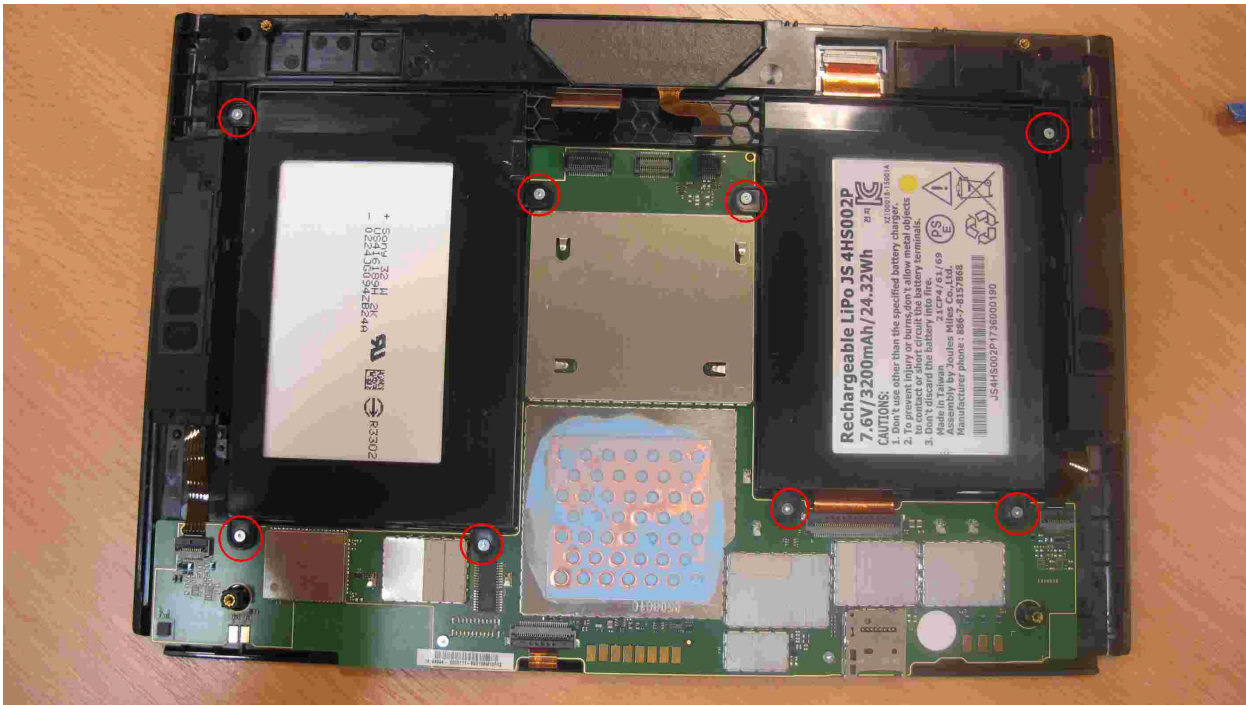
Figure 18. Remove the T3 Torx screws that secure the battery pack.

- Remove the eight T3 Torx screws that secure the battery pack. Dispose of the battery pack in accordance with local regulations (Figure 18).

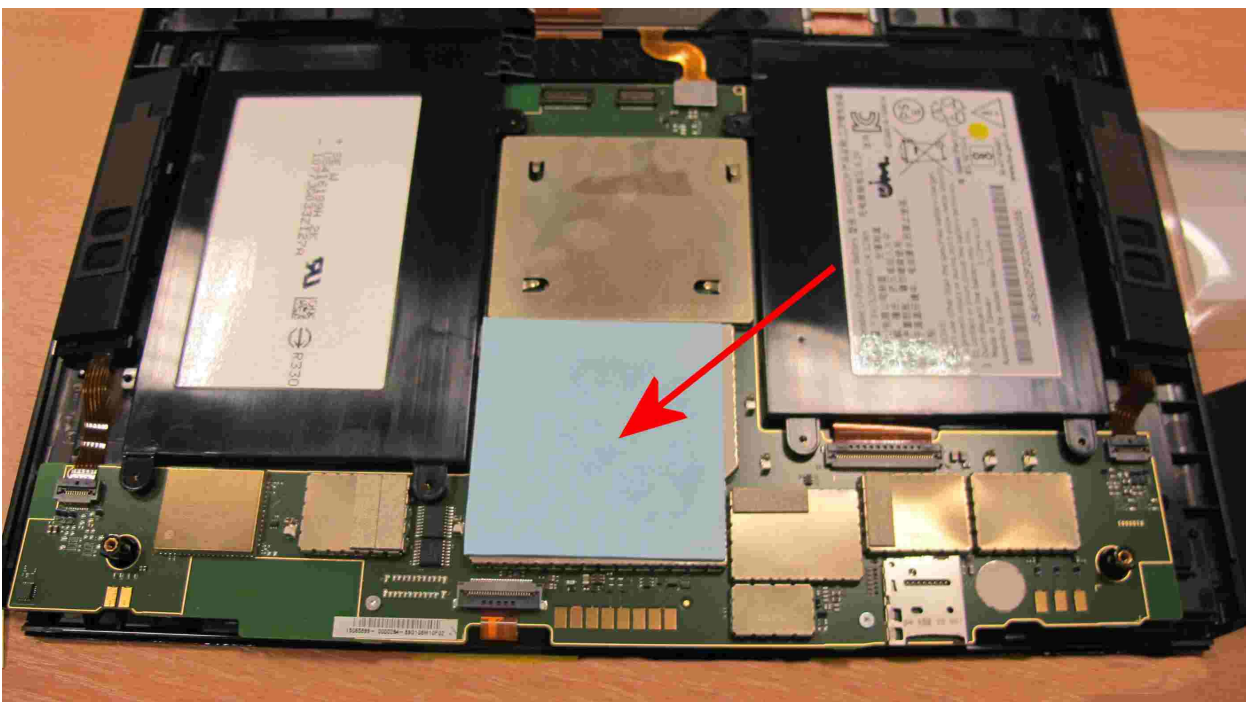
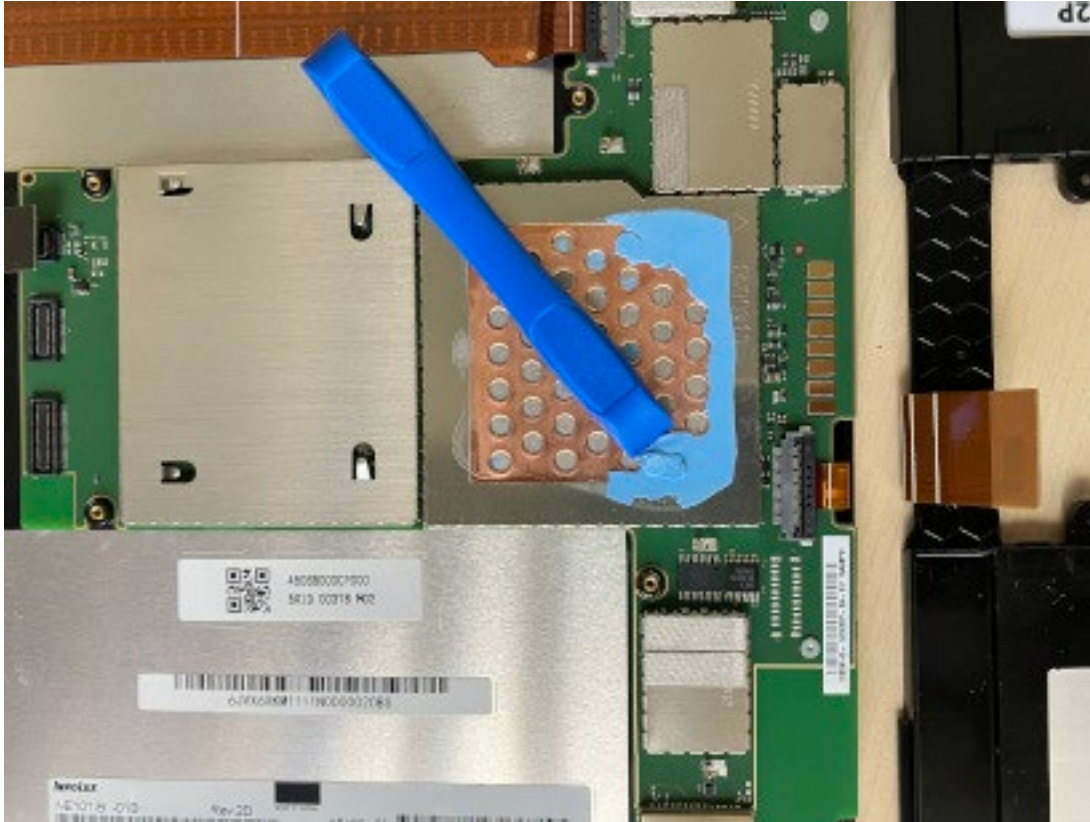
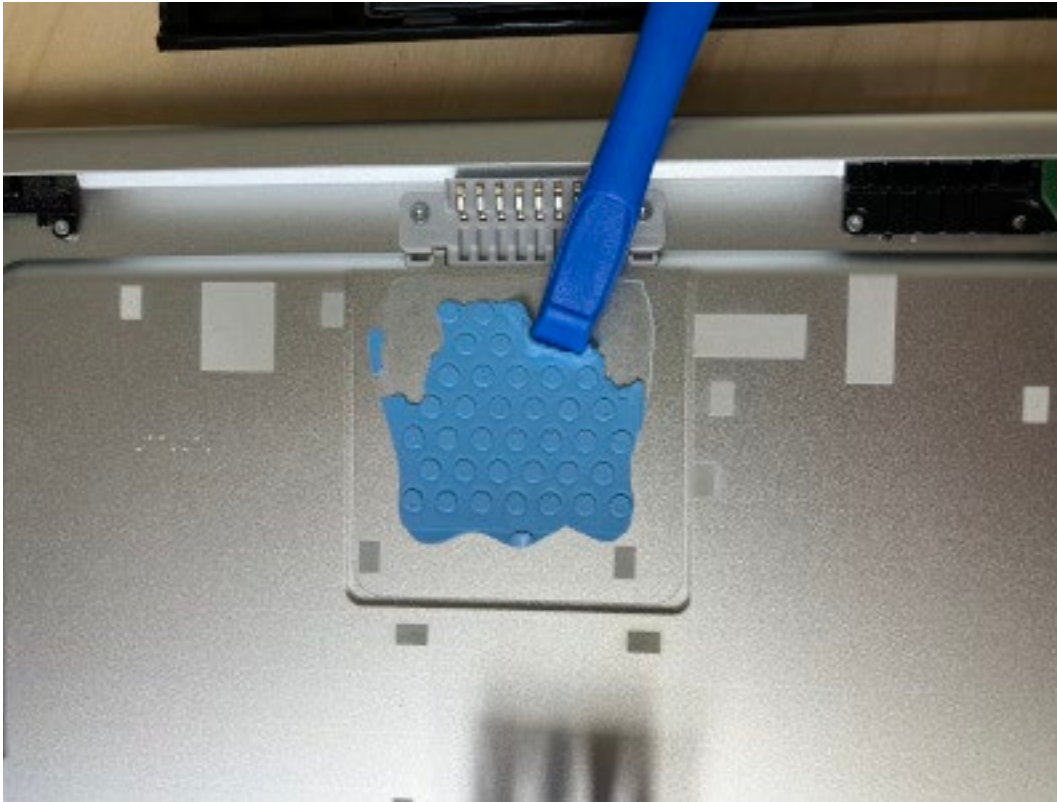
Figure 19. Remove the used thermal grease with a nonmetal scraper.

Figure 20. Remove the used thermal grease.

Figure 21. Remove the used thermal grease.

- Remove the used thermal grease with a non-metallic scraper or similar tool and dispose of it (Figures 19 to 21).
