Technical Service Bulletin

91 RSE: Tablet for rear seat entertainment system - removing battery

91 24 24 2074414/1 June 28, 2024.

Model(s)	Year	VIN Range	Vehicle-Specific Equipment
A4, A4 allroad, and Q7	2017	All	Rear Seat Entertainment
A8	2019 - 2021		
A8 e quattro, and S8	2020 - 2021

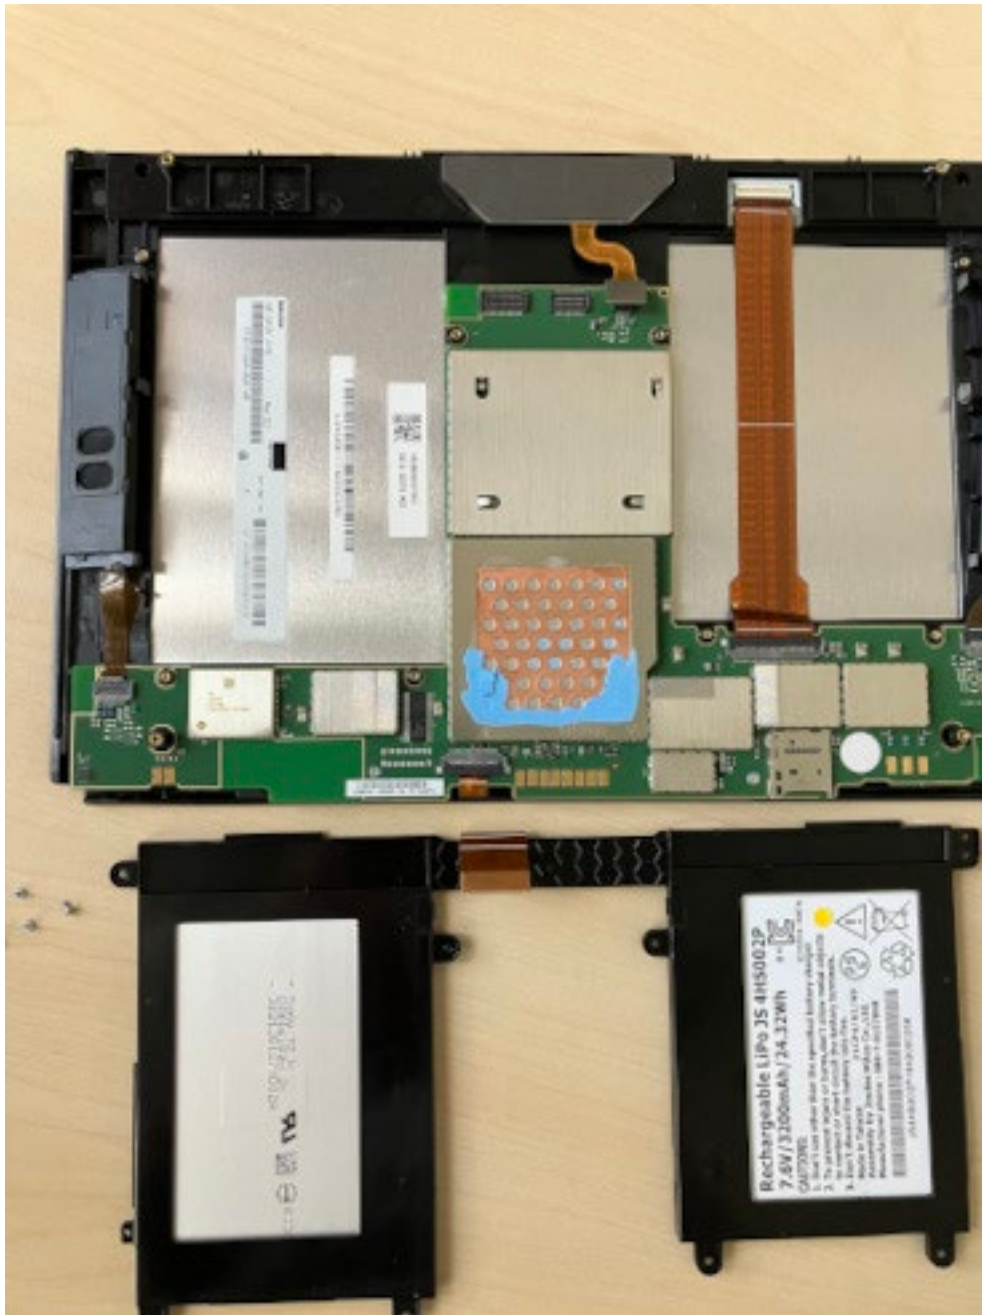
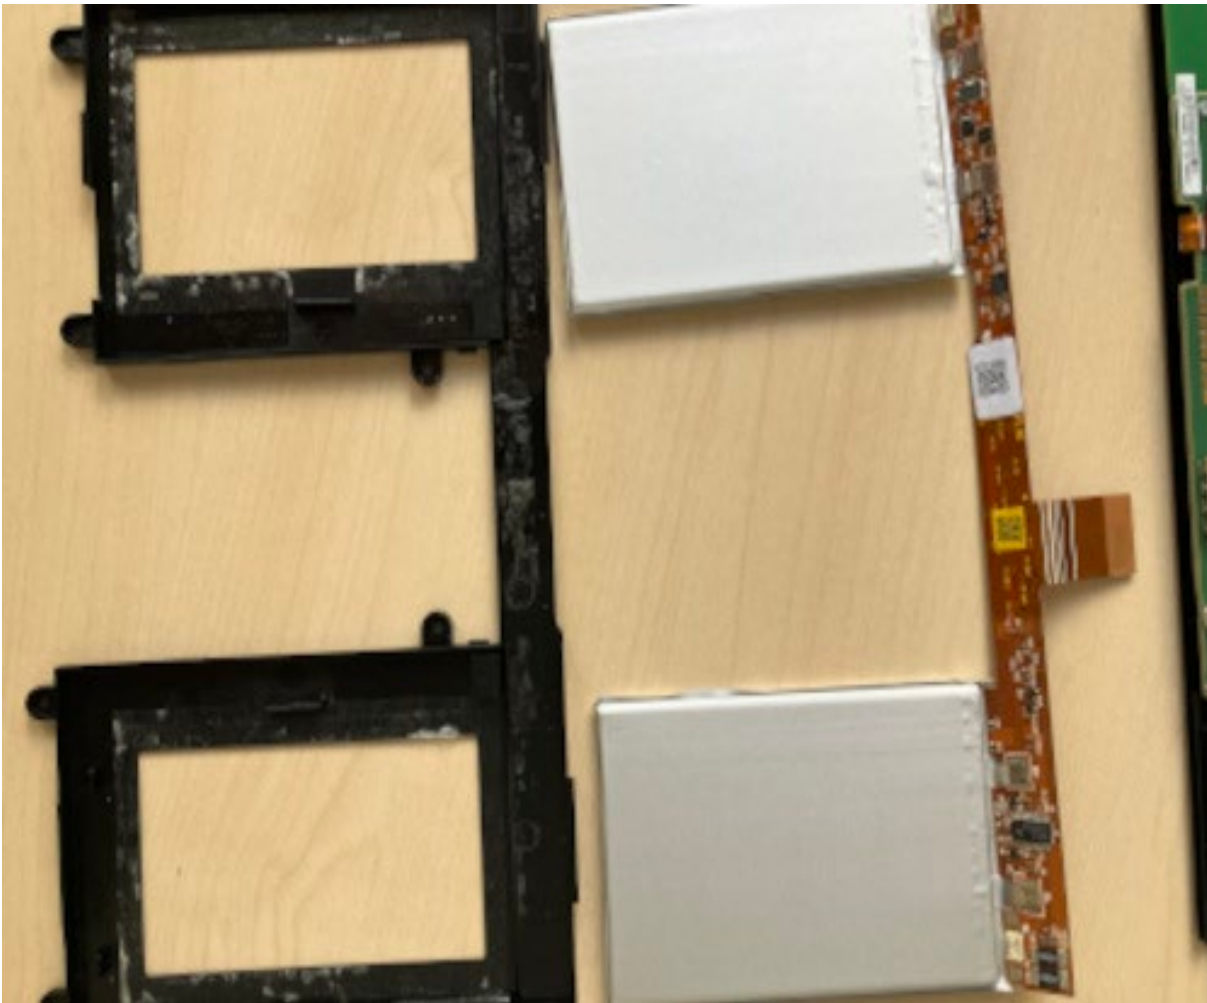
Figure 23. Remove the battery pack from the frame.

- Remove the battery pack from the plastic frame (Figures 22 and 23).

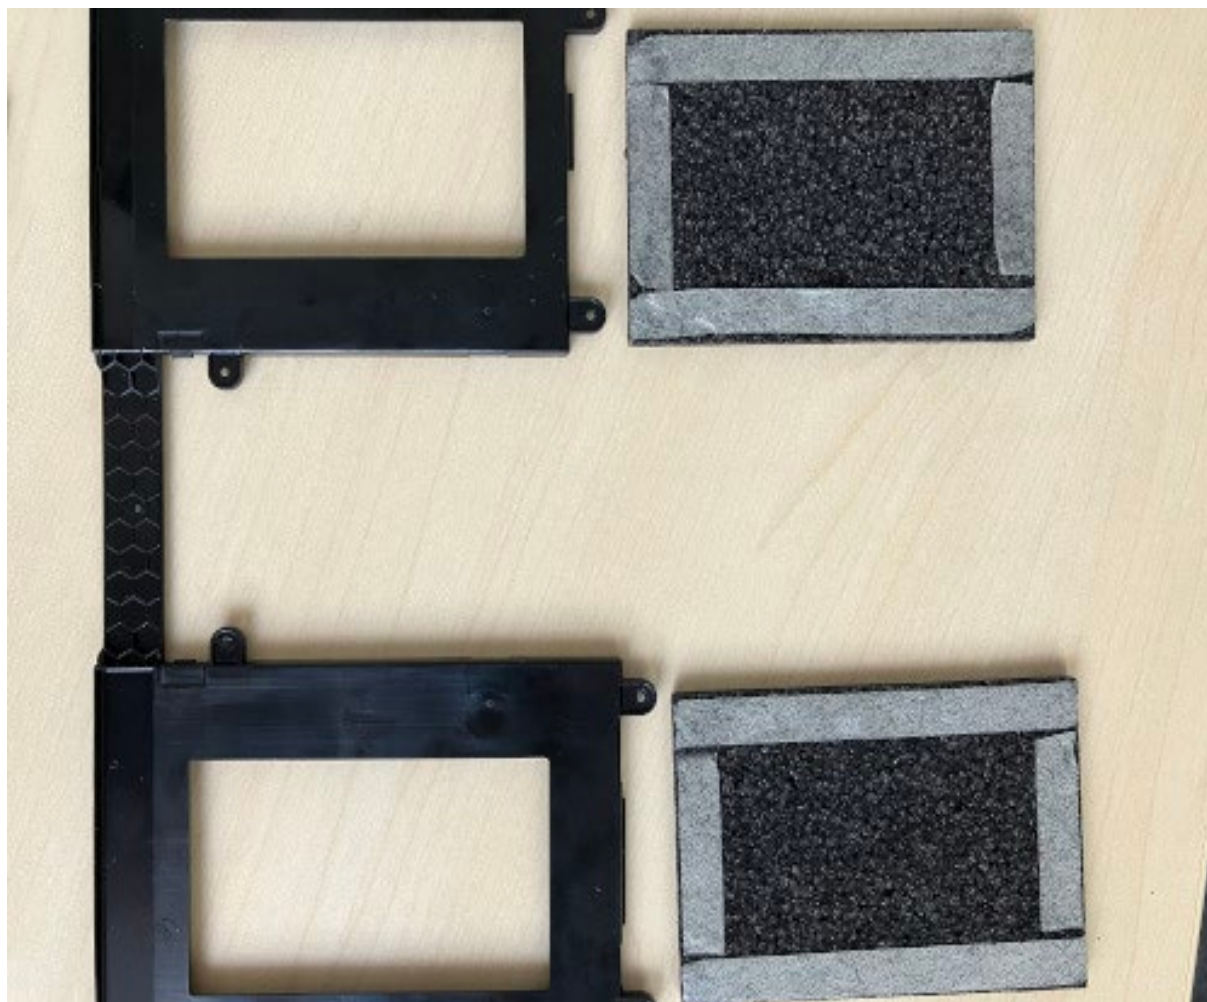
Figure 24. Remove the protective film from the double-sided tape on the plastic dummies.

- Remove the protective film from the double-sided adhesive tape on the two plastic dummies (Figure 24). Place the plastic dummies in the frame as shown in Figure 25 and screw the frame back together with the eight Torx T3 screws.

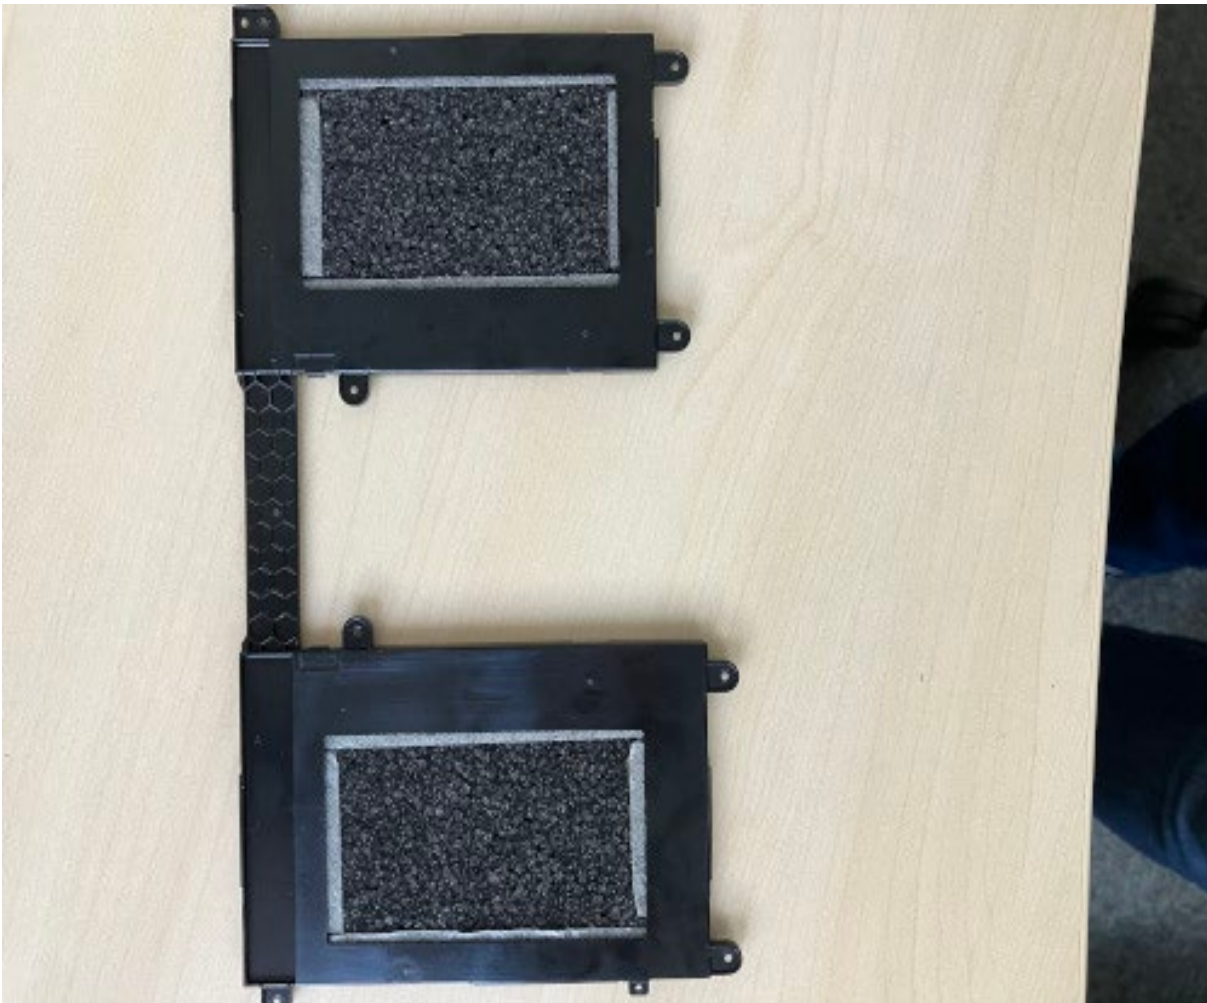
Figure 25. Adhere the plastic dummies in the frame as shown.

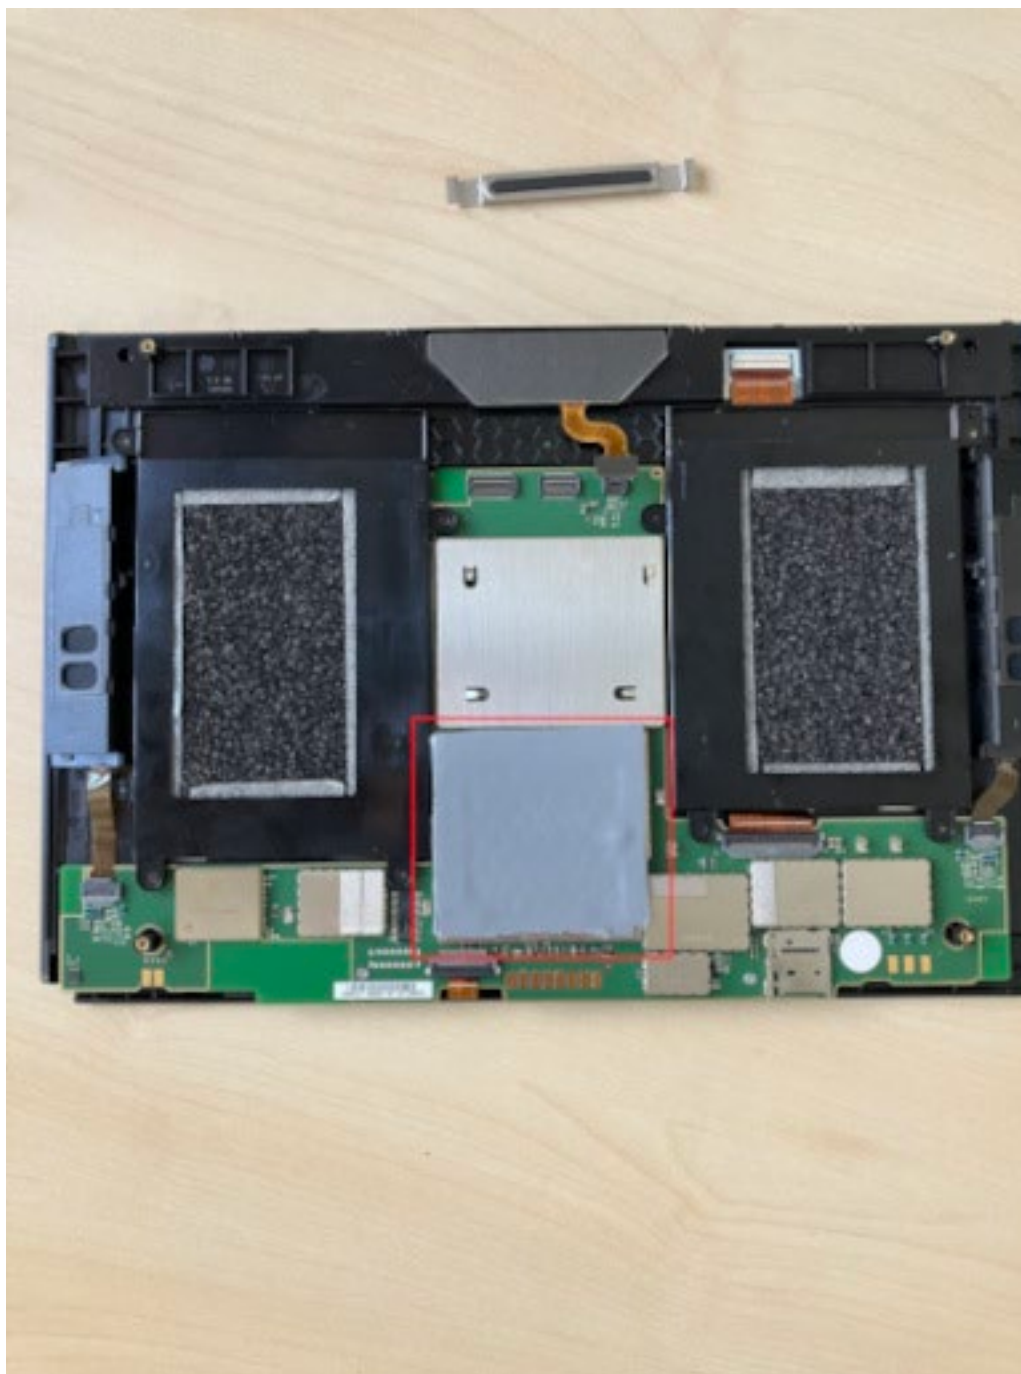
Figure 26. *Replace the heat conducting pad.*

- Replace the heat conducting pad. To do this, first remove the first piece of protective film and carefully place the pad on the surface indicated by the red square in Figure 26. Then remove the second piece of protective film.

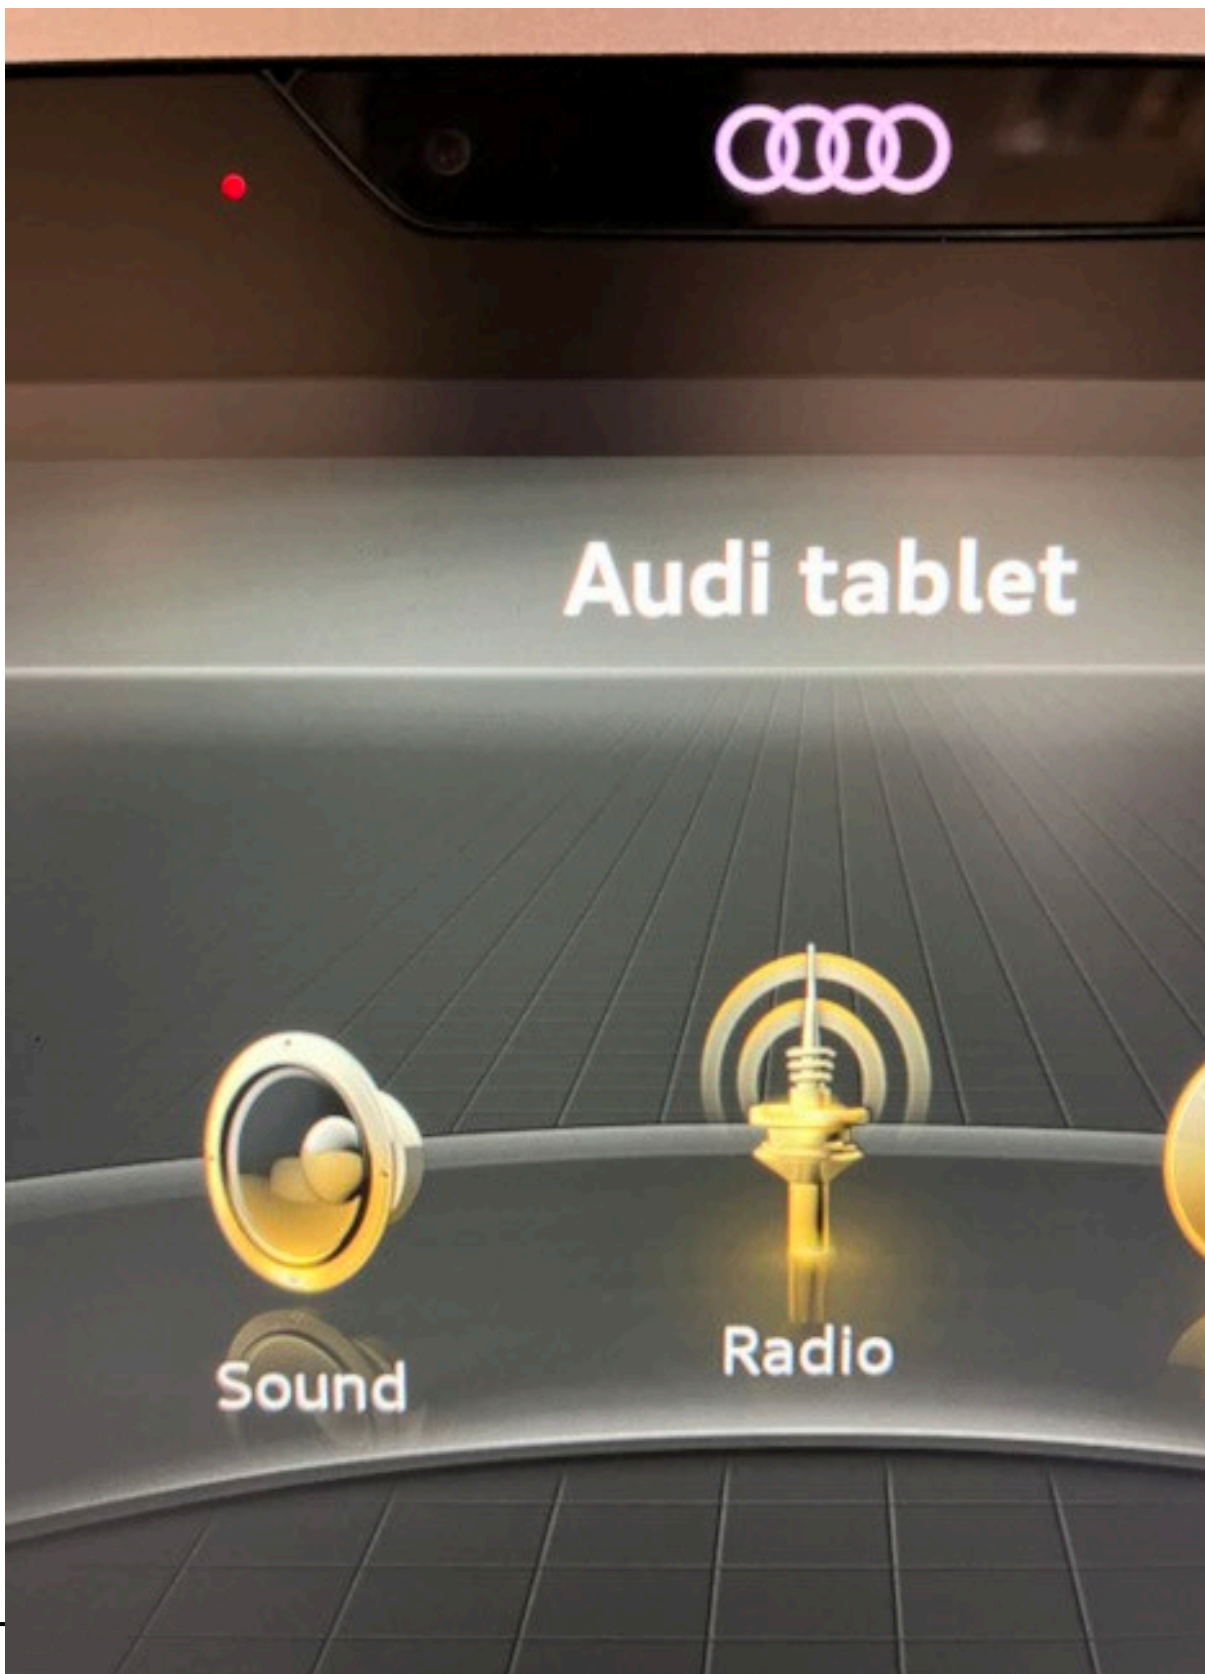
Before carrying out the repair, inform the customer that the tablet cannot be used outside its mount (in battery mode) once the measure has been implemented. As a result of the internal battery being removed, the messages relating to the internal battery will no longer be displayed. After the internal battery has been removed, the tablet's status LED will light up in red continuously as shown in the image (Figure 27).

Figure 27. Red indicator light will light up continuously.

Place the tablet in the corresponding holder and check that it works. After the conversion, the tablet will only work when it is on its mount. The messages about the battery will no longer be displayed. After the internal battery has been removed, the tablet's status LED will light up in red continuously. The following event memory entry (active/static) will be logged in the applicable diagnostic address (004E for the rear right display/operating unit or 005E for the rear left display/operating unit): *B15B3F2: Multimedia display unit, battery faulty*. The event memory entry is justified after the repair but does not constitute a fault in this case as the battery has been removed. The corresponding Guided Function in ODIS is no longer applicable in this case.
