**Transmission Symptom - Oil Leakage on Transfer Box: Observe Specified Procedure (SY 206/20)**

Model Line: **Cayenne (9YA / 9YB)**

Model Year: **As of 2018**

Concerns: **Transfer gear**

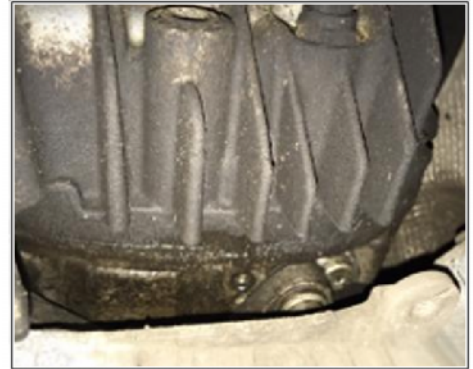
Oil penetration of the connection point on the transfer box housing (housing cover) can result in incorrect interpretations.

Check for oil leaks in the area of the input shaft for hang-on transfer box ⇒ *Oil migration* and ⇒ *Oil leak on input-shaft radial shaft*.

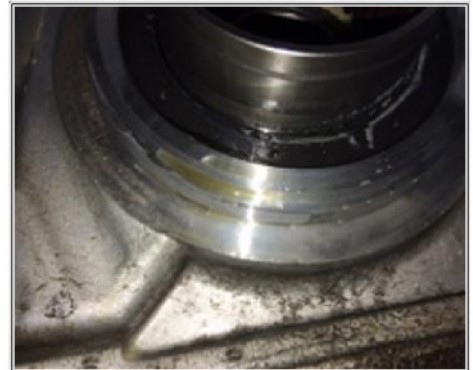
*Oil leak on input-shaft radial shaft*

- 1 Oil leak on transfer box housing with drops forming in the area of the input shaft. The upswinging motion of the input shaft in the axial direction causes the transmission oil ahead of the radial shaft seal to surge with strong pressure fluctuations. This can result in an oil leak complaint.
  - 1.1 In the event of a complain, first check the technical status of the transfer box using the differentiation table:

- If the serial number on the transfer box corresponds to the specified differentiation data from the table, the entire transfer box must be replaced, see ⇒ *Technical Information 'Replacing transfer box'*. Replacing the radial shaft seal alone would not be effective in the long term and the radial shaft seal would leak again.
- However, if the serial number corresponds to a newer version than that in the differentiation list, only the radial shaft seal may then be replaced, see ⇒ *Technical Information 'Replacing sealing ring for transfer box (front transmission side)'*. The hardware version of the transfer box corresponds to the latest technical status.

- 1.2 If the radial shaft seal on the automatic transmission is damaged, see ⇒ *Technical Information 'Complaint - Oil leaks on automatic transmission: Observe specified procedure (205/20)'*.

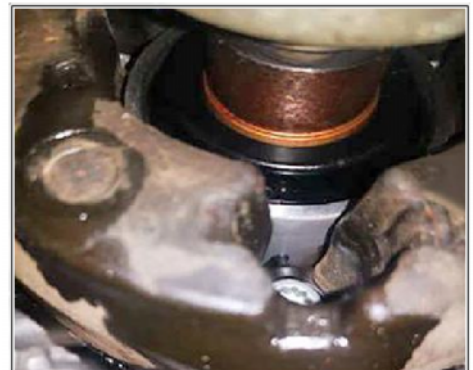
*Oil leak on output-shaft radial shaft seal*

- 2 Oil leaks in the area of the output shaft to the rear axle ⇒ *Oil leak on output-shaft radial shaft seal.*  
If the output-shaft radial shaft seal is damaged, see ⇒ *Technical Information 'Replacing sealing ring for transfer box (rear transmission side)'*.

- Work Procedure: 1 Replace radial shaft seal on output shaft for hang-on transfer box, see ⇒ *Workshop Manual '399255 Replacing sealing ring for transfer box'*.
- 2 Check and top up oil for transfer box, see ⇒ *Workshop Manual '399035 Checking and topping up oil for transfer box'*.
