**IMAGE AND TEXT ERROR IN ACCESSORY RUNNING BOARD
INSTALLATION INSTRUCTIONS**

Service Alert No.: SA-039/24

2024-2025 CX-90

2025 CX-70

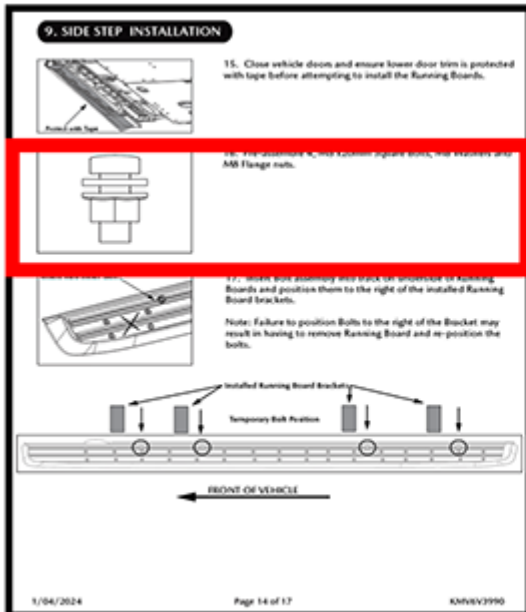
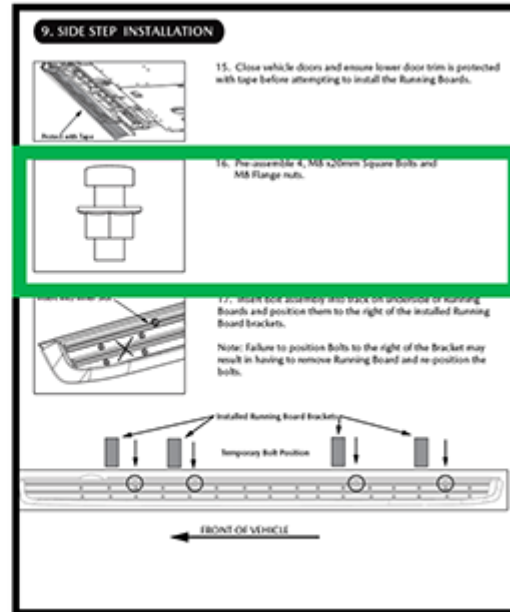
The image and text are incorrect in the original installation instruction for Section 9, step 16 where it shows a square head nut, washer, and flange nut. The washer is not used in this portion of the installation and the image and bolt assembly description is incorrect. The correct image shown below in image on the right.
