Topic	Pre Delivery Inspection (PDI) Coolant fan operation check (SC24/08)
Market area	United States E05 Bentley USA and rest America (6E05)
Brand	Bentley
Transaction No.	2073357/5
Campaign number	ED01
Note	
Type	
US code

### New Continental GT / GTC and New Flying Spur - W12 only

### Technical background

The correct operation of the cooling fan is required to be checked / confirmed

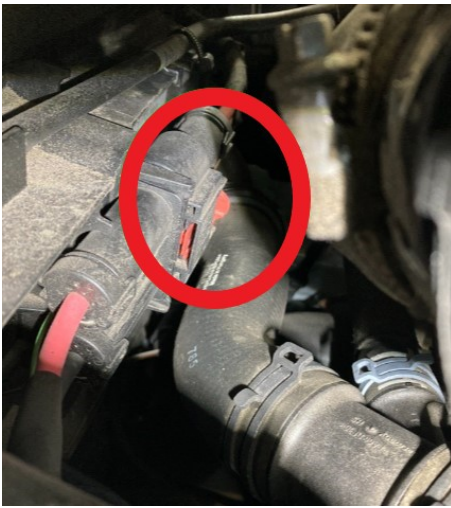
- Referring to Figure 3 - Check the coolant fan electrical connection is plugged in / connected

In the event the coolant fan electrical connection was not plugged in / not connected please raise a technical DISS query ensuring a photograph of the issue is attached - Continue with all remaining instructions

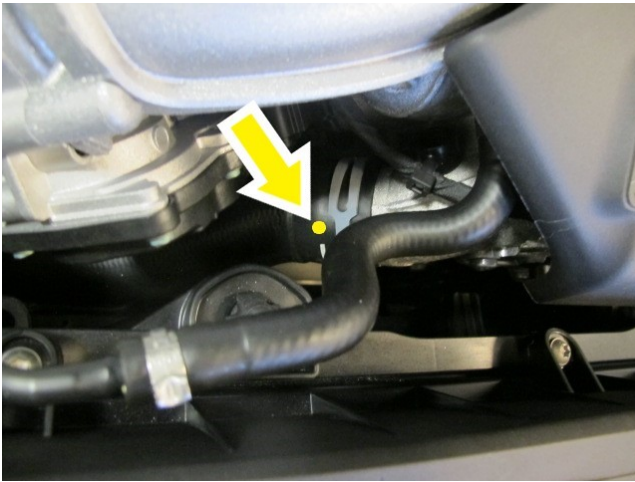
Figure 7

**Yes the fan is spinning / operating whilst the engine is running** - Apply a yellow paint completion mark on the radiator top hose (Figure 7) no further action is required

Yellow paint completion mark on the radiator top hose confirms the fan is spinning / operating (Figure 7)
