VOLUNTARY RECALL CAMPAIGN

Classification: AN24-001	Reference: NTB24-034	Date: July 3, 2024
-----------------------------	-------------------------	-----------------------

VOLUNTARY SAFETY RECALL CAMPAIGN 2018-2022 LEAF; REAR CAMERA

CAMPAIGN ID #: R23D7
APPLIED VEHICLES: 2018-2022 LEAF (ZE1)

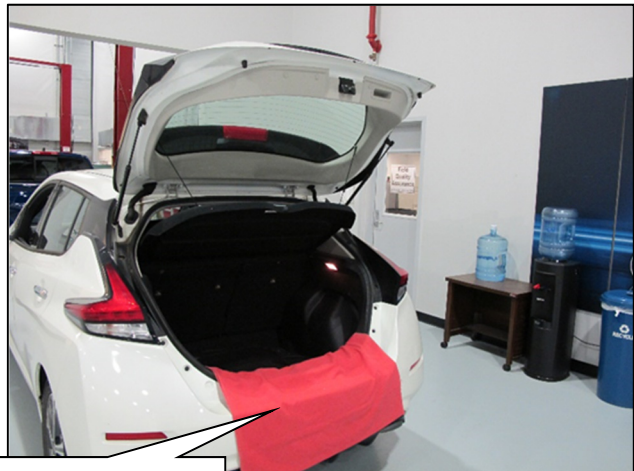
Figure 1

6. Fully open the back door.
 - Install fender covers to protect rear bumper from damage.

Fender Cover

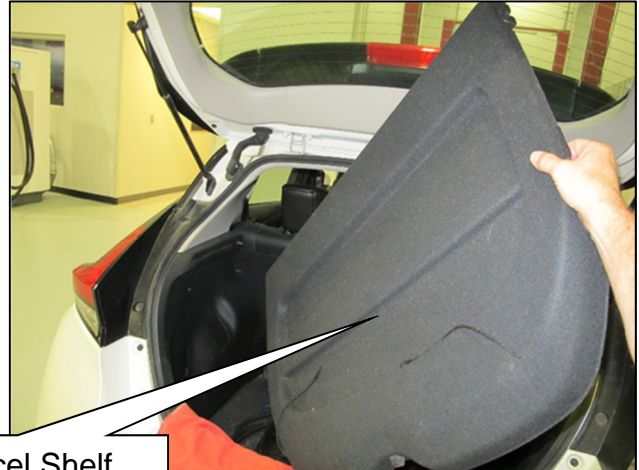
Figure 2

7. Remove the rear parcel shelf finisher.
 - a. Unhook the straps from the back door side finishers.
 - b. Lift the rear parcel shelf finisher and slide it out of the vehicle.
 - c. Store the rear parcel shelf finisher in a safe location to prevent damage.

Rear Parcel Shelf
Finisher

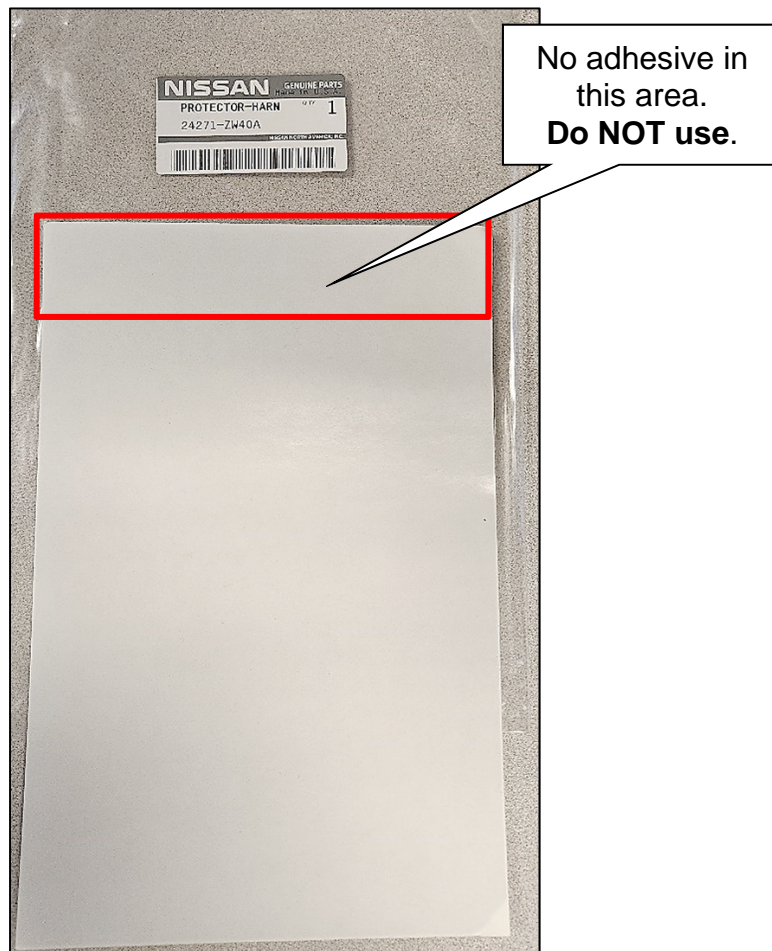
Figure 14

- Do NOT use the portion of the adhesive backed foam protector that does NOT have adhesive applied (Figure 14).
- Each part ordered is sufficient to perform seven (7) repairs.

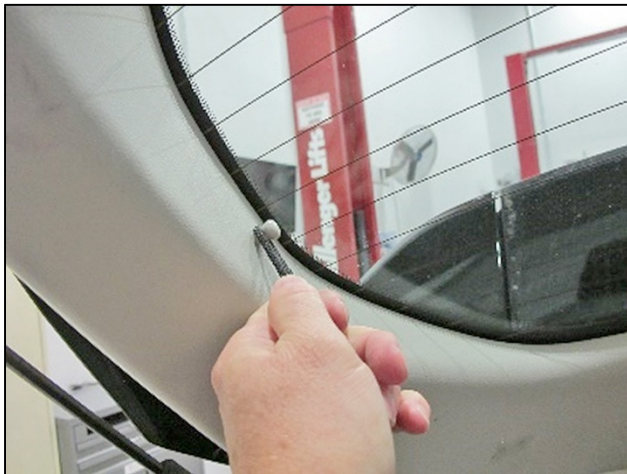
Figure 23

- Install the back of the rear parcel shelf on the finisher pins.
- Hook the straps to the back door side finishers (Figure 23 and Figure 24).
