GROUP	MODEL
Service Campaign	2014-2017MY Forte & Forte Koup (YD)
NUMBER	DATE
SC238 (Rev 3, 07/11/2024)	August 2022

VOLUNTARY SERVICE CAMPAIGN

BRAKE TUBE/ LINE INSPECTION/REPLACEMENT & ANTI-CORROSION MATERIAL APPLICATION (SC238)

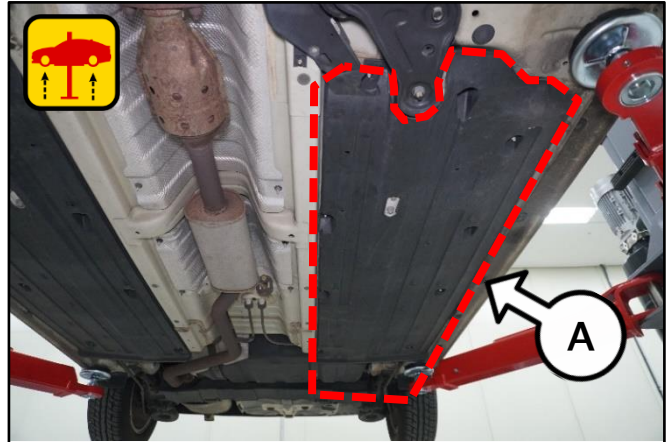
- 1a. Lift vehicle on hoist and remove the driver side undercover (A).

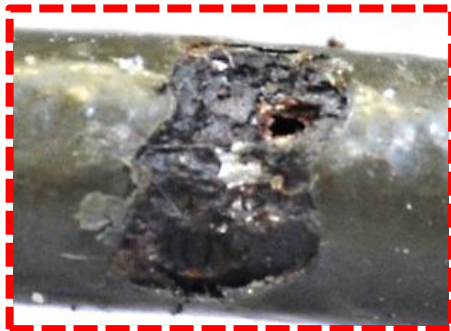
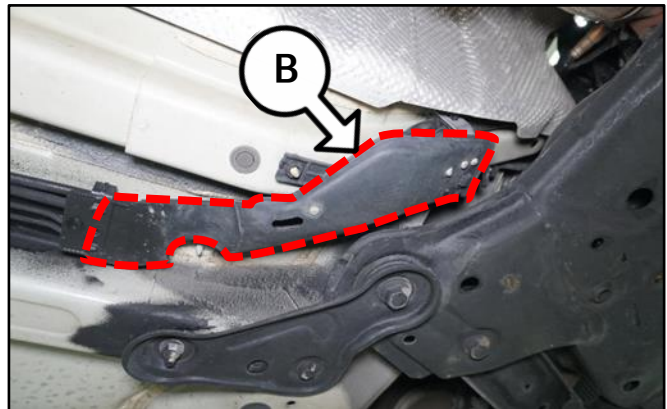
- 1b. Remove the protection cover (B).

2. Inspect the entire length of the brake lines (L&R Front to Back of the vehicle) for corrosion and/or fluid leakage, especially in the brake line retaining clip areas shown.

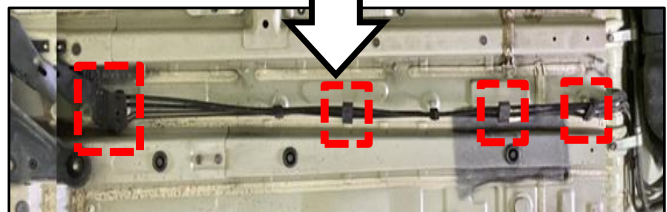
- 3a. Is there evidence of brake fluid leakage and/or corrosion, especially around the brake line retaining clips?

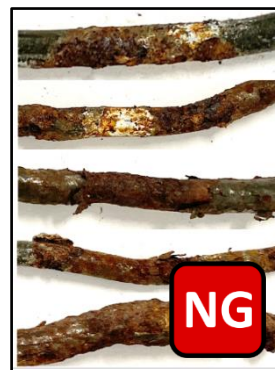
- 3b.
 - **NO (OK):** Proceed to the 'Cavity Wax Application Procedure' on page 9. (Sample of light surface rust which may be wiped off or removed light use of a wire brush and air blowing.)
- 3c.

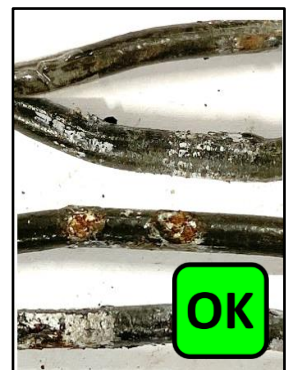
- **YES (NG):** Proceed to the 'Replacement Procedure' to replace the brake line(s). (Sample of severe corrosion and brake fluid leak).

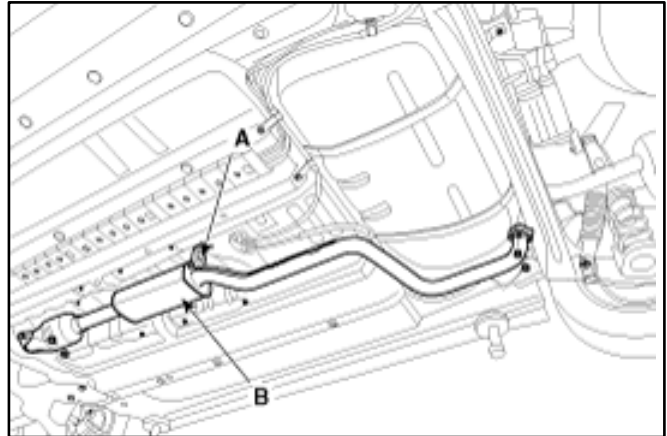
1. Remove the center muffler assembly (B) by referring to "Engine Mechanical System → Intake and Exhaust System → Muffler → Repair procedures (Center Muffler)" in the applicable Shop Manual on KGIS.

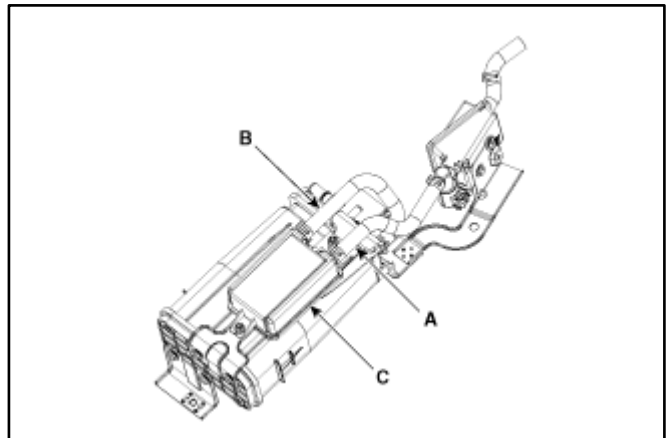
2. Remove the auxiliary canister (C) by referring to "Emission Control System → Evaporative Emission Control System → Canister → Repair procedures" in the applicable Shop Manual on KGIS.

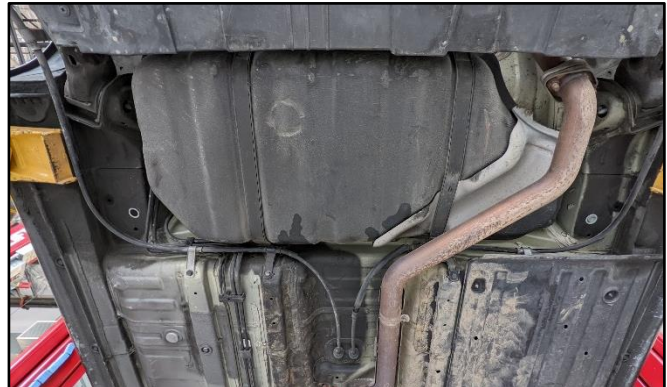
3. Remove the fuel tank by referring to "Engine Control/Fuel System → Fuel Delivery System → Fuel Tank → Repair procedures" in the applicable Shop Manual on KGIS.

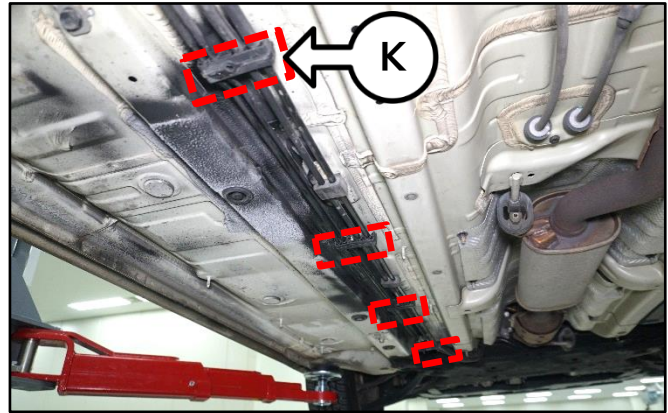
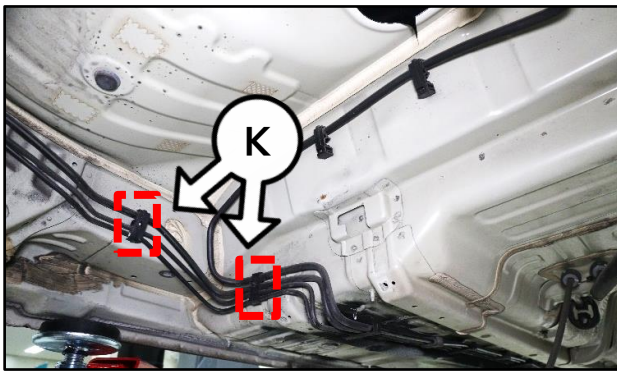
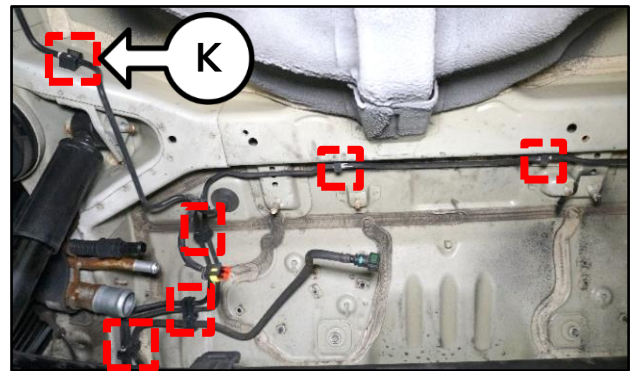
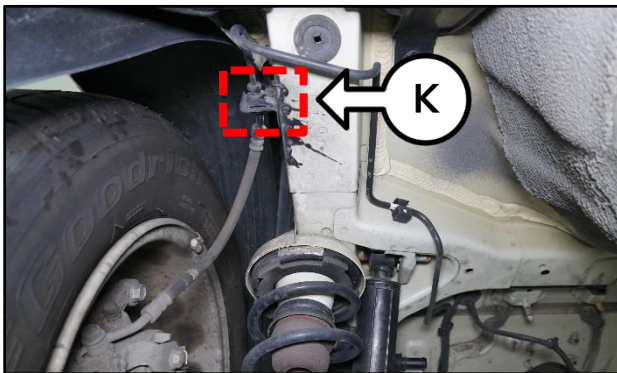
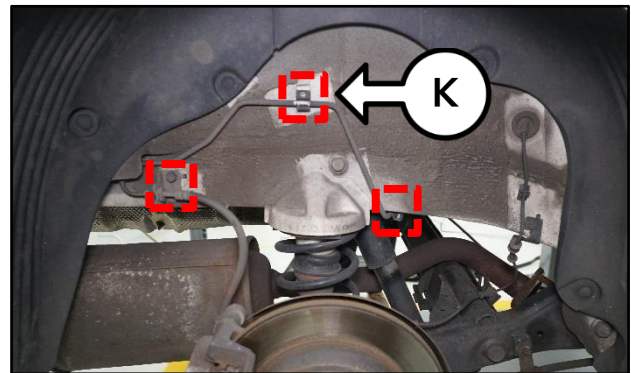
4. Remove the brake tube line by disconnecting the holder clips (K) in the locations shown.

Tightening torque for Brake Tube Nuts:
9.4 - 12.3 lb.ft (12.7 - 16.7 N.m)

5. Separate the brake line from the fuel lines and remove the left and right side brake lines.
6. Install the new brake lines in the reverse order of removal.
7. Install all removed parts in reverse order of disassembly.
8. Proceed to the Application Procedure to apply additional cavity wax and undercoating material before lowering vehicle from hoist.
9. Bleed brake system and adjust brake fluid levels by referring to "Brake System → Brake System → Repair procedures → Brake System Bleeding" in the applicable Shop Manual on KGIS.

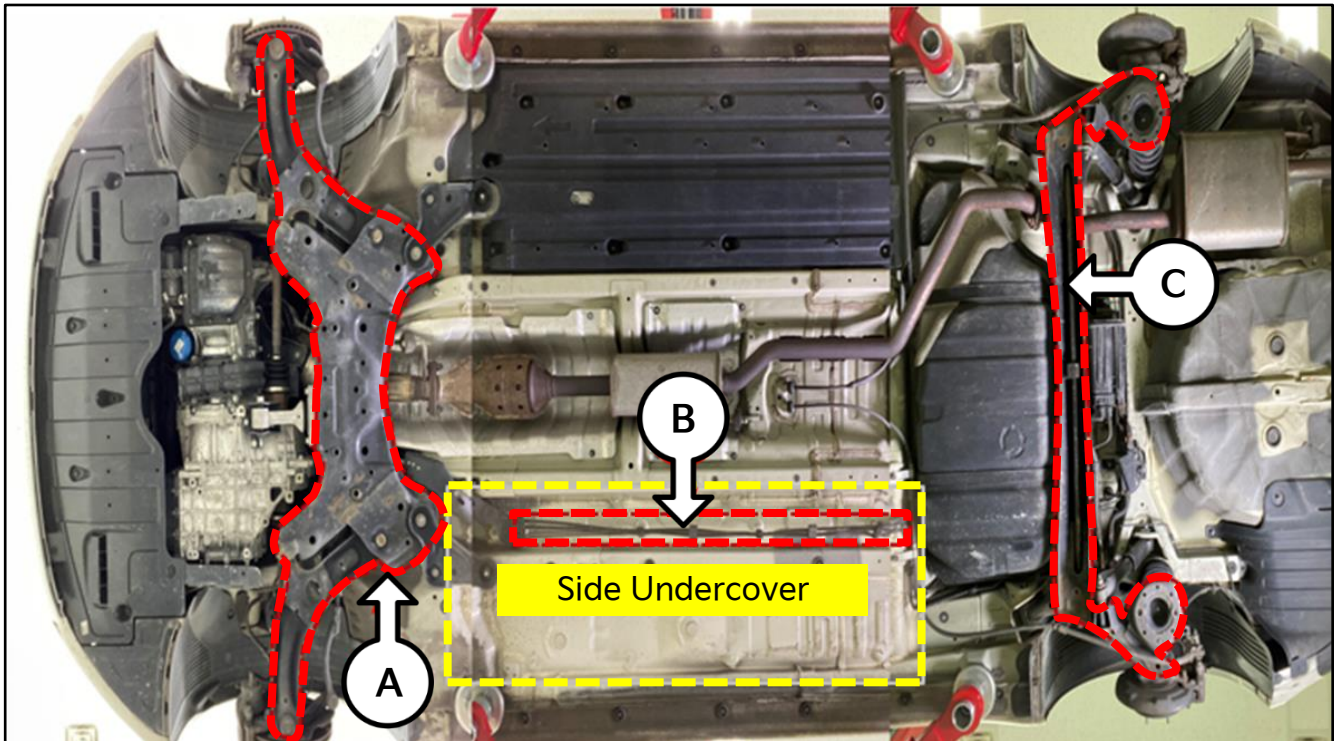
Affected Areas for Application of Anti-Corrosion Material

A: Sub Frame / Front Lower Arms

B: Fuel / Brake Tube

C: Torsion Axle Complete

Other: Two-way Brake Tube Connector / Flexible Brake Hose / Fuel Tank Band / Parking Cable Bracket

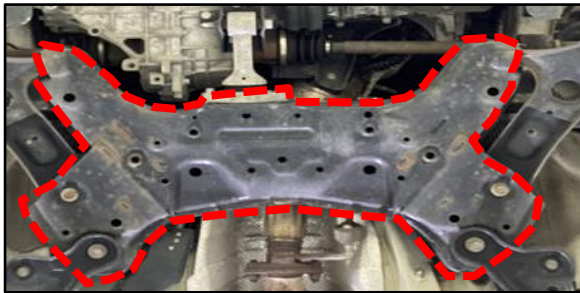
Sub-Frame

1. On vehicles equipped with a splash shield, remove the splash shield prior to starting the procedure.
2. Remove any rust scales or contaminants from the following components by hammering with a small hammer, and removing any surface rust with a wire brush.

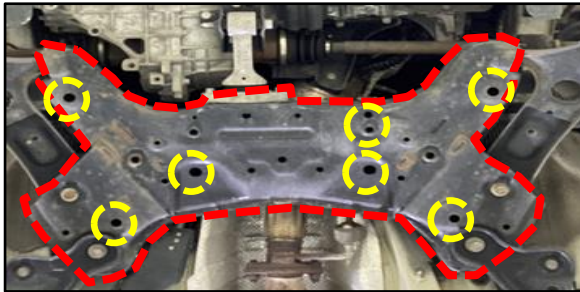
Sub-Frame

3. After hammering and wire brushing is completed, use an air gun to blow compressed air into all service holes and areas of the chassis components noted below to remove any additional rust scales or contaminants.

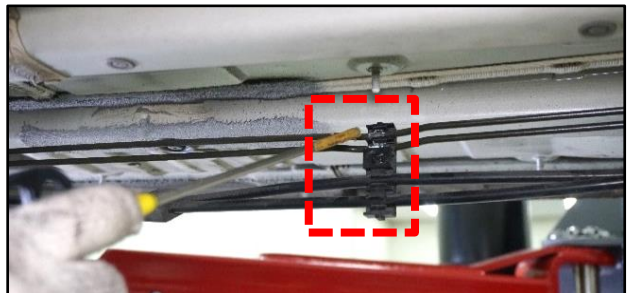
Fuel & Brake Tube Lines

Note: Be sure to remove all debris that may have collected between the fuel/brake lines.

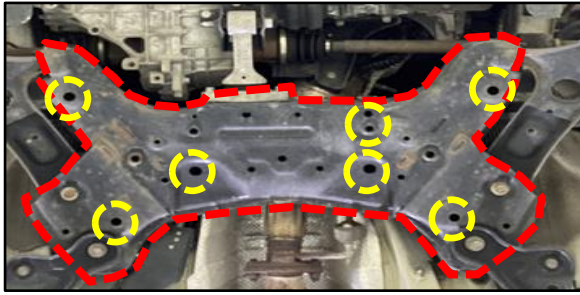
Sub-Frame

1. Using Quick Disconnect fittings suitable for the dealer's air supply system, install the in-line pressure regulator to a conveniently located wall air outlet and adjust the pressure to 70-90 PSI. Connect the air hose to the regulator, and connect the other end of the hose to the Kia Injection Gun (06700 10100), used to apply the cavity wax.
 - 2a. Insert the wax injection gun nozzle deeply into all service holes.
 - 2b. Then slowly pull out the nozzle while spraying the cavity wax inside of the components shown below.
Note: Rotate the nozzle while spraying to achieve an even coating of wax inside.

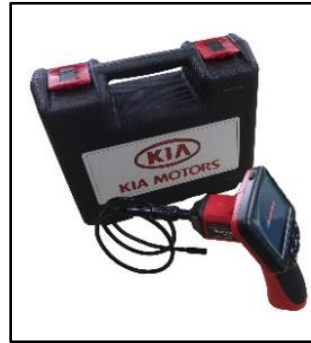
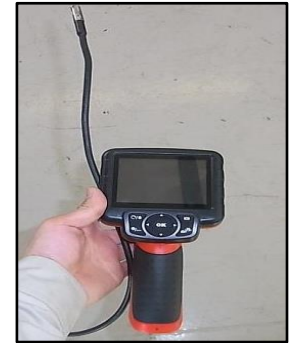
- After applying cavity wax to components, use the borescope (1K545 4D200QQK) to check for proper wax coating through the component service holes.

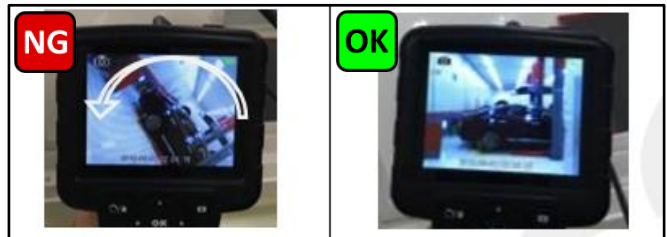
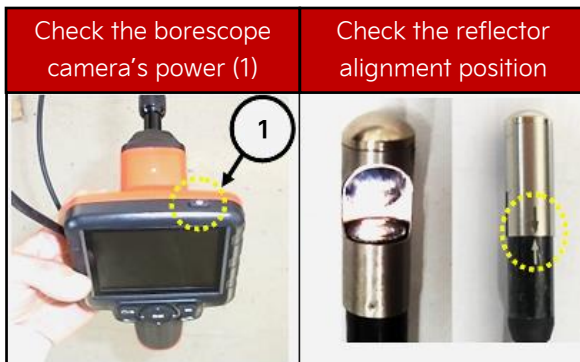
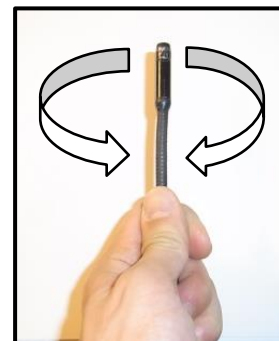
- Power up and calibrate the display orientation direction by gripping the probe and turning as required. (Apply and align the 90-degree angle adapter, as needed, for picture quality.)

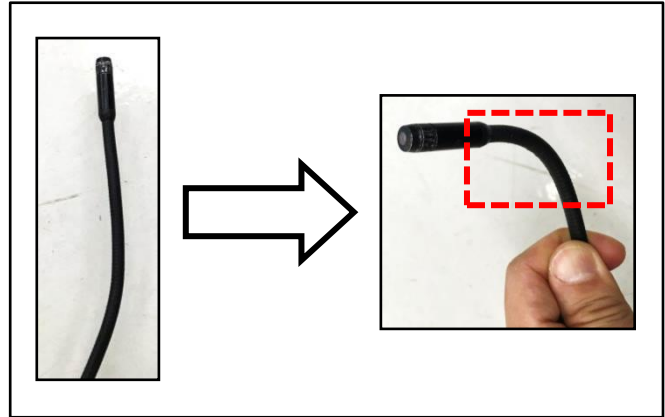
5. Once the camera and display are properly oriented, bend the probe just behind the camera to help maintain orientation during inspection.

If it is difficult to view the inside of the arm with the camera due to flexibility of the scope wand, use the 90-degree lens attachment.

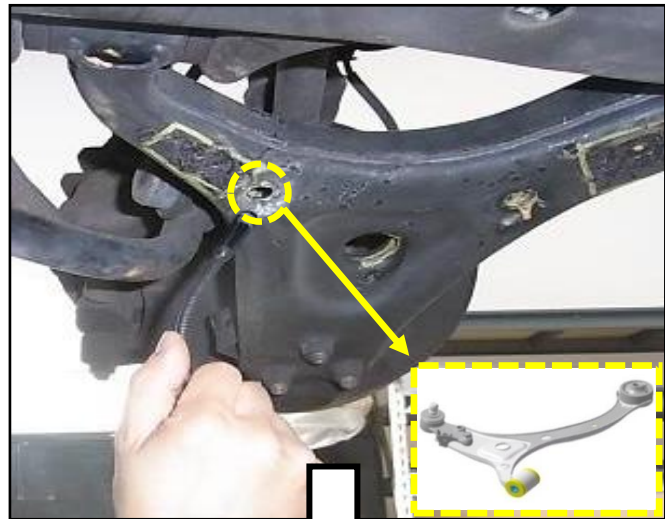
6. Insert the camera into hole as shown.

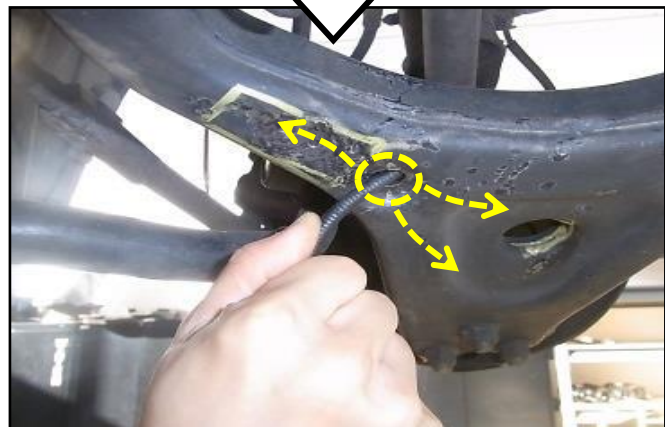
7. Rotate the camera in order to check all angles for proper wax application inside the inspected components, and to obtain your images that will be used for warranty claim submission.

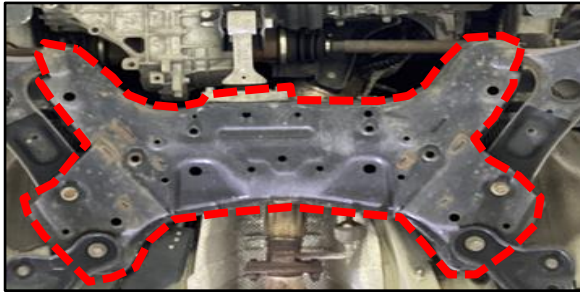
Sub-Frame

1. Using undercoating spray, be sure to completely coat the Sub Frame, Front Lower Arms, Fuel/Brake Tube Line, and Torsion Axle Complete.

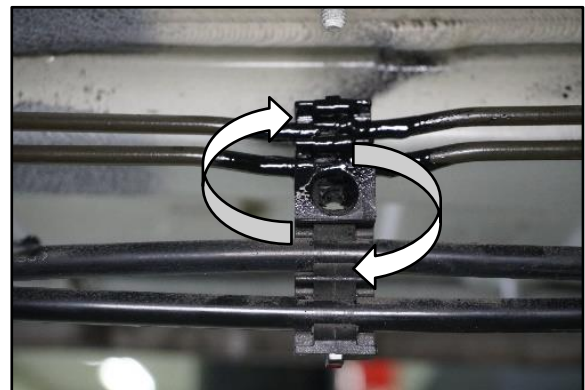
Be sure to thoroughly spray undercoating on all sides of fuel and brake tube lines (above and below).

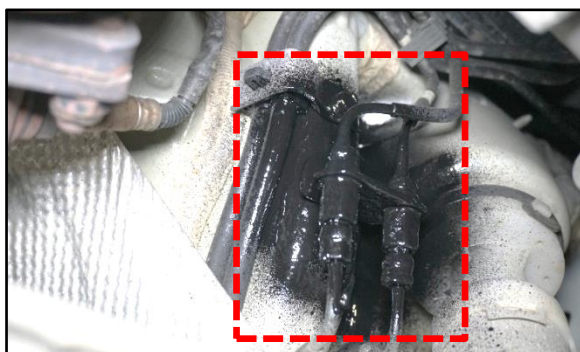
Two-way Brake Tube Connector

2. Spray undercoating on the Two-way Brake Tube Connector, Flexible Brake Hose, Fuel Tank Bands, and Parking Brake Cable Brackets.

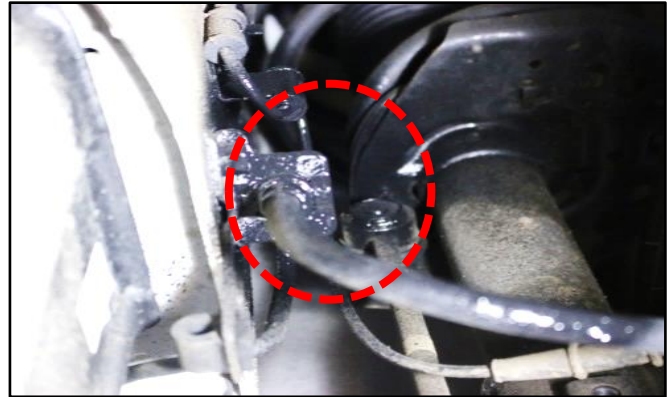
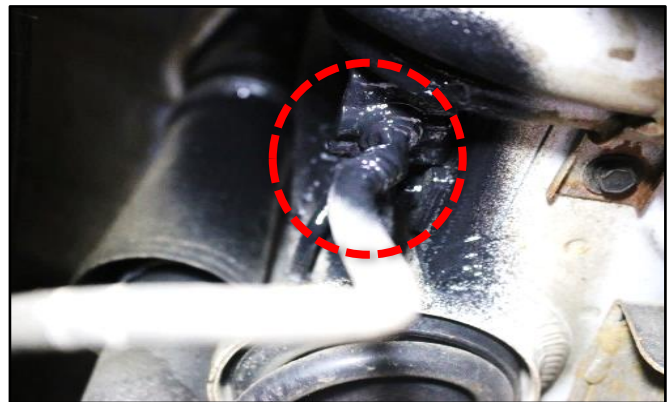
3. Be sure to completely coat the four (4) brake hose anchor clips on both sides, front and rear of the vehicle.

- Outside/exterior of Front Lower Control Arm and Sub Frame after undercoating application. One combined photo showing both Control Arms and Sub Frame clearly and completely will suffice.
