GROUP	MODEL
BOD	2021-2024MY Seltos (SP2)
NUMBER	DATE
326	July 2024

TECHNICAL SERVICE BULLETIN

HORN ASSEMBLY INSPECTION/REPLACEMENT

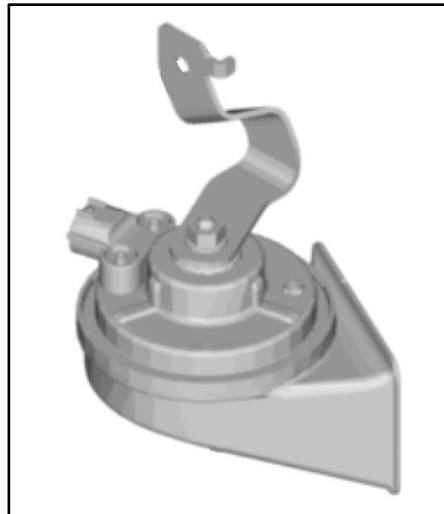
This bulletin provides information associated with the 'Warranty Extension Program' (WTY038) to inspect and, if necessary, replace the horn assembly on 2021-2024MY Seltos (SP2) vehicles produced from November 20, 2019 through May 2, 2024. The affected vehicles may experience a distorted or an inoperative horn sound caused by corrosion and dust inside the horn assembly. The warranty coverage for repairs related to the horn assembly have been extended from 5 years / 60,000 miles to 10 years / 120,000 miles, whichever comes first, starting from the date the vehicle was first put into service. Follow the procedure outlined in this publication to inspect and, if necessary, replace the horn assembly with a new one.

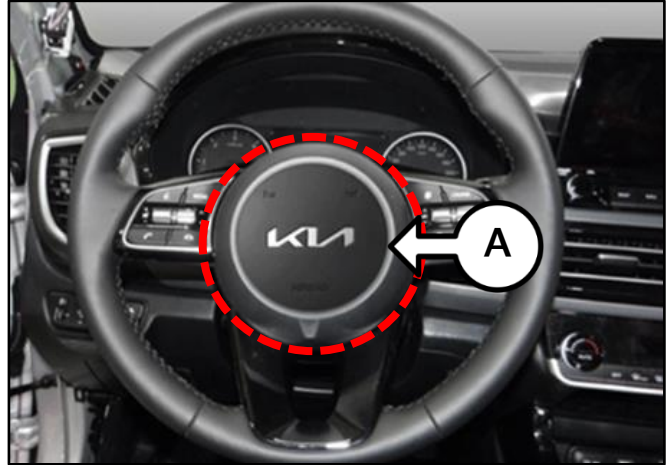
1. Press the Horn Pad (A) to confirm normal operation.
 - If the horn operates **normally**, this TSB does not apply. **Claim Inspection Only labor op 242044R1.**
 - If the horn is **inoperative** or the **tone is distorted**, proceed to the 'Replacement Procedure' below.
