REFERENCE:	TSB: 03-007-24 REV. A GROUP: 03 - Differential and Driveline	Date:	July 19, 2024	REVISION:	03-007-24
VEHICLES AFFECTED:	2024 (JL) Jeep Wrangler This bulletin applies to vehicles built on or before **June 10, 2024 (MDH 0610XX)** equipped with the Dana M220 Wide Full Floating RR Axle (Sales Code DRN).			MARKET APPLICABILITY:	
				<input type="checkbox"/> NA	<input type="checkbox"/> MEA
				<input type="checkbox"/> SA	<input checked="" type="checkbox"/> IAP
				<input type="checkbox"/> EE	<input type="checkbox"/> CH
CUSTOMER SYMPTOM:	Customers may experience the following: <ul style="list-style-type: none"> Intermittent grinding, screeching, ratcheting noise coming from the right hand side of vehicle on the rear axle. 				
CAUSE:	Lack of lubrication

REPAIR SUMMARY:

This bulletin involves cleaning and lubricating the axle shaft and hub splines.

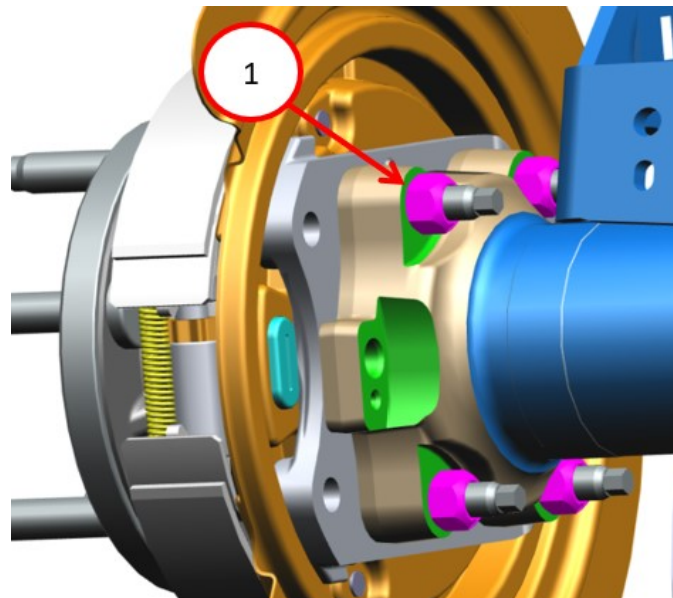
Fig. 1
Hub Nuts

1. Remove the brake caliper and rotor. Refer to the detailed service procedures available in DealerCONNECT/Service Library under: Service Info> Refer to 05 - Brakes, Base/Hydraulic/Mechanical/ Rotor, Brake/Removal.
2. Remove the wheel speed sensor from the tube assembly. Refer to the detailed service procedures available in DealerCONNECT/Service Library under: Service Info> Refer to 05 - Brakes, ABS/Electrical/ Sensor, Wheel Speed, Rear/Removal.
3. Disconnect the parking brake cable from the parking brake actuator at the backing plate.
4. Remove and **DISCARD** the four nuts [Fig. 1](#) from the hub assembly.

1 - Axle Housing

12. Install the axle shaft, hub and bearing assembly with backing plate onto the shaft then into the tube aligning the four hub studs ensuring the wheel speed sensor hole in the backing plate aligns with the wheel speed sensor hole/pad on the tube assembly.
13. Install four **NEW** hub nuts [Fig. 1](#) on the hub assembly.
14. Connect the parking brake cable from the parking brake actuator at the backing plate.
15. Install the wheel speed sensor from the hub. Refer to the detailed service procedures available in DealerCONNECT/Service Library under: Service Info> Refer to 05 - Brakes, ABS/Electrical/Sensor, Wheel Speed, Rear/Installation.
16. Install the brake caliper and rotor. Refer to the detailed service procedures available in DealerCONNECT/Service Library under: Service Info> Refer to 05 - Brakes, Base/Hydraulic/Mechanical/Rotor, Brake/Installation.

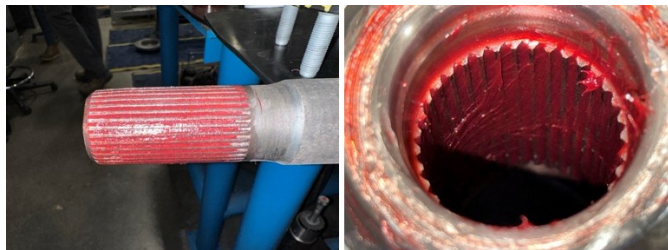
Fig. 3
Lubricated Axle Shaft/Hub splines

- Use wheel bearing grease to lubricate both the hub splines and the axle shaft splines. Ensure to coat the whole surface of the spline interface on the shaft and hub [Fig. 3](#).
