TECHNICAL INSTRUCTIONS

CONSUMER ADVISORY 24TE03

Rav4 Battery Class Action Settlement

CERTAIN 2013 – 2018 Model Year RAV4

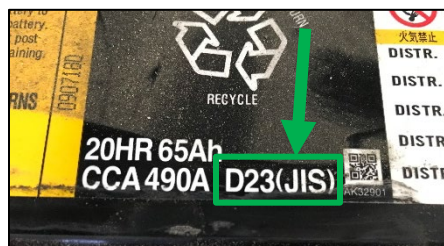
Japan produced OE battery (VINs starting with "J")

- If the label is too dirty to read, clean with a rag.
- TrueStart / True-2 battery group numbers are contained in the part number (see image to the left). For example, XXXXX-35XXX-XX or XXXXX-X35XX-XX.
- If the vehicle is built in Japan (VIN begins with "J"), the OE battery will not show the group number. Instead, look for JIS number D23.

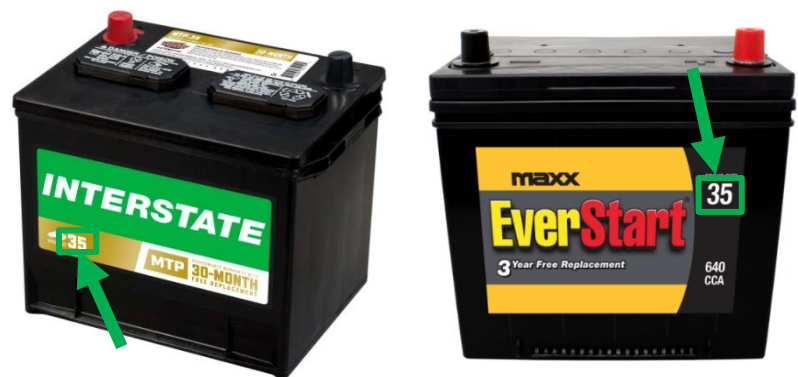
Aftermarket group 35 battery examples

b. Confirm that the battery installed is a group 35 or JIS D23.

c. If the battery is not a group 35 or JIS D23, offer to replace it with a Toyota True-2 battery. Be sure to take a picture of the incorrect size battery and the RO together in the engine compartment before removing the battery .

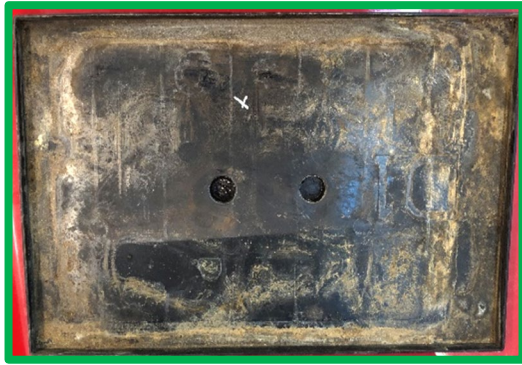
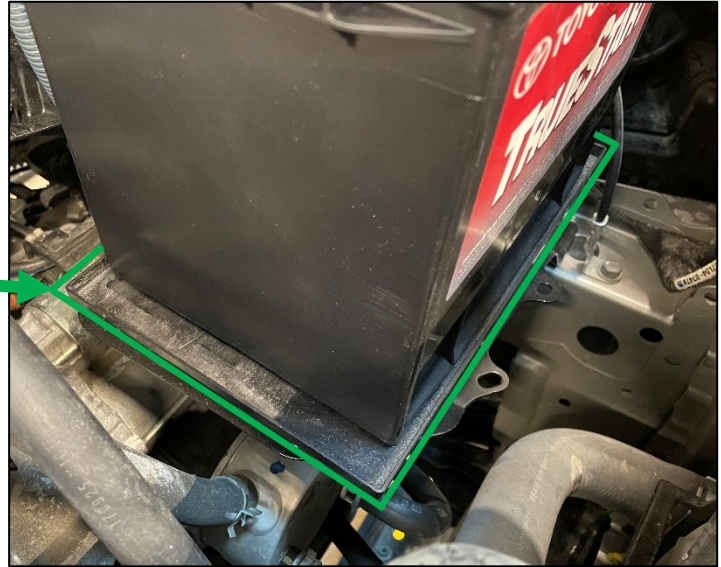
a. Check the battery tray.

- i. Ensure that the battery tray is installed.
- ii. Replace the tray if it is missing, or damaged/deformed to the point where it will not properly secure the battery.

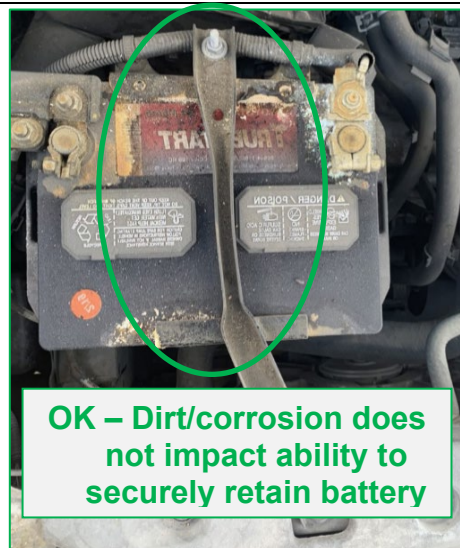
OK – Dirt/corrosion does not impact ability to securely retain battery

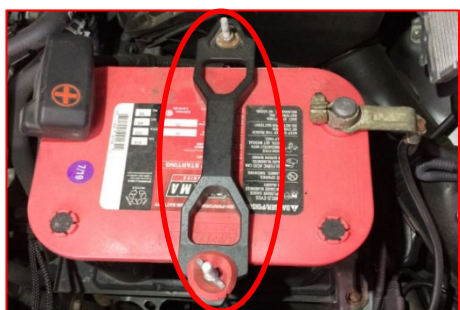
NG – Not a genuine Toyota hold-down clamp

- i. Ensure that the battery hold-down clamp is installed.
- ii. Replace the hold-down clamp if it is missing, not a genuine Toyota part, or deformed/corroded to the point where it cannot properly secure the battery

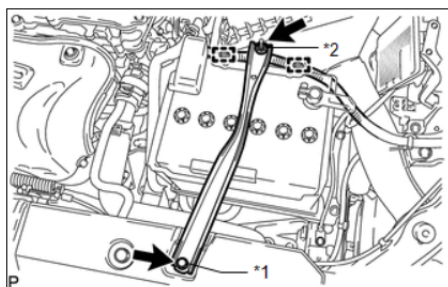
| *1 | Bolt |
| *2 | Nut |

c. Check the bolt.

- i. Confirm that the bolt is installed and torqued to the specification below.
- ii. Replace the bolt if it is damaged or corroded to the point that it cannot be properly torqued.

Torque for bolt :
17 N·m {173 kgf·cm, 13 ft·lbf}

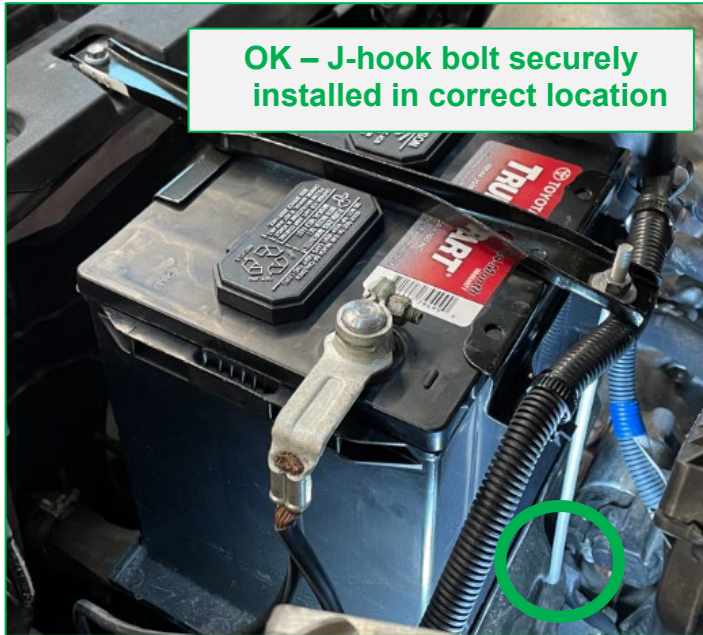
OK – J-hook bolt securely installed in correct location

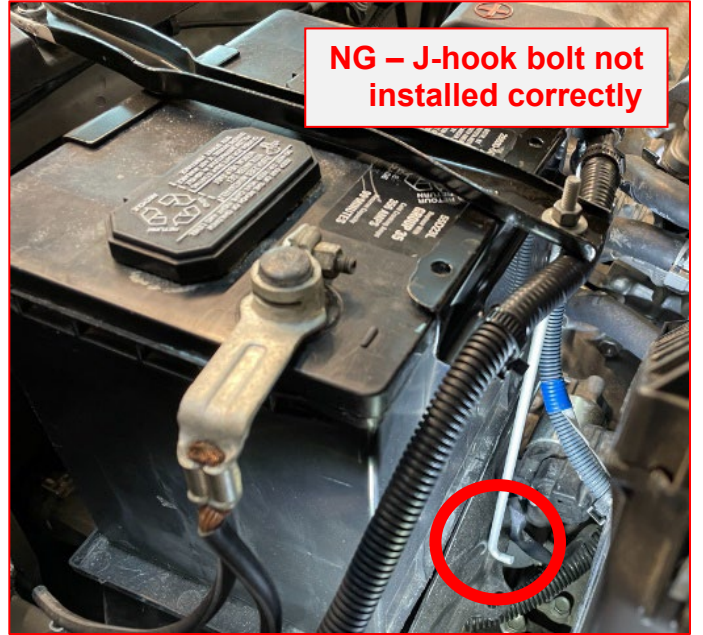
NG – J-hook bolt not installed correctly

ii. If J-hook bolt or nut is missing, not a genuine Toyota part, or deformed/corroded to the point where they cannot be properly torqued to the specification below, replace the J-hook bolt and/or nut.

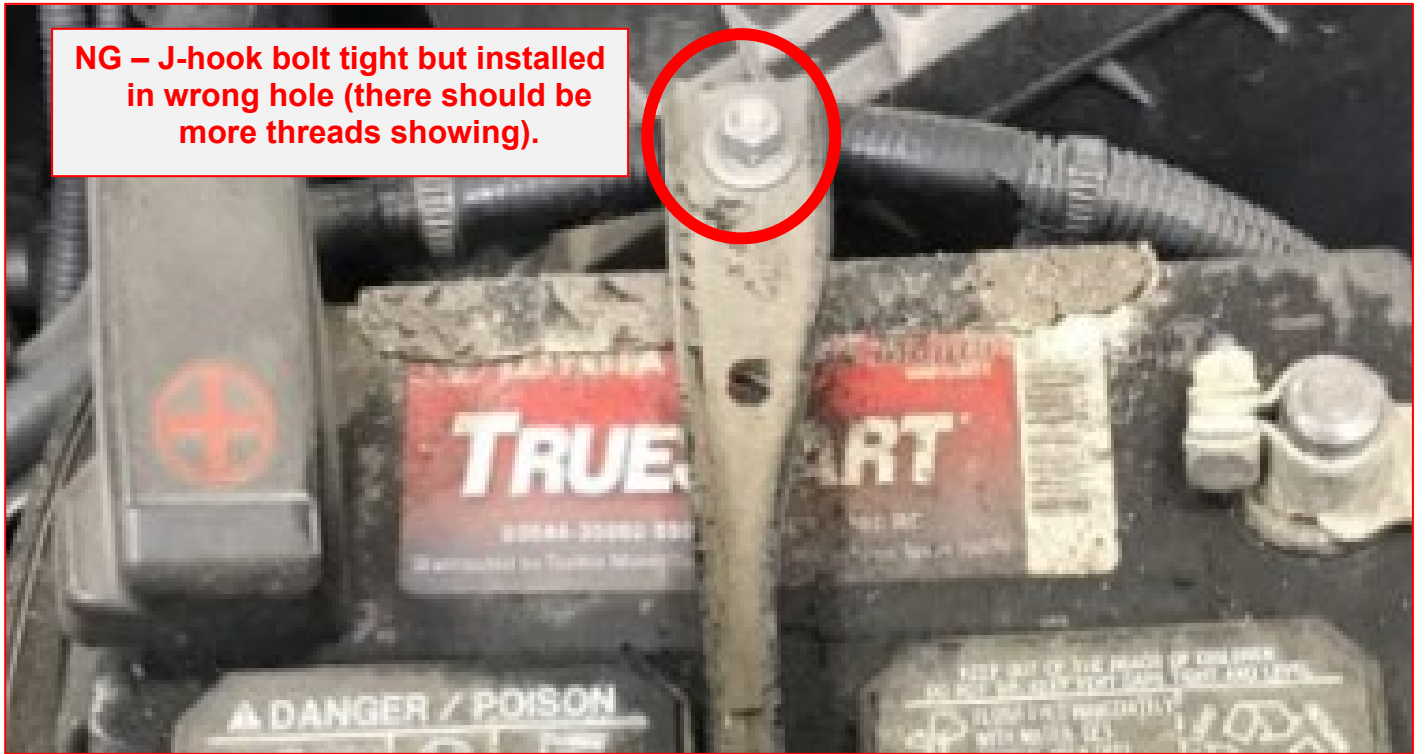
NG – J-hook bolt tight but installed in wrong hole (there should be more threads showing).

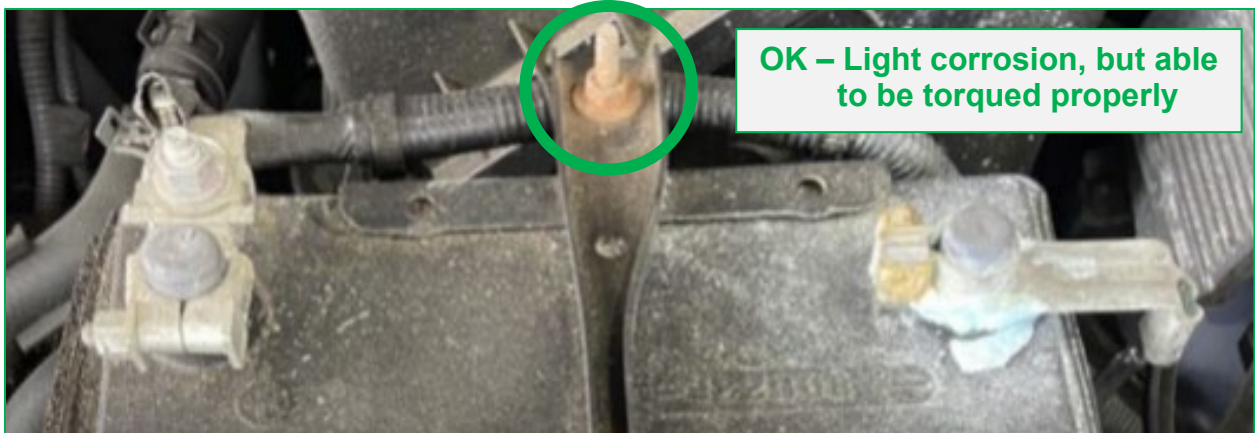
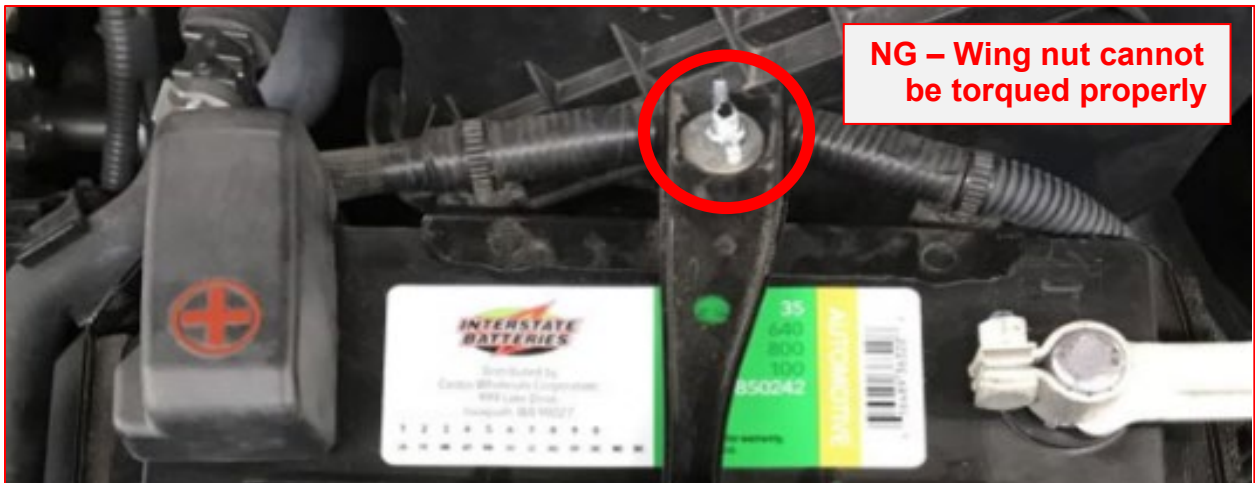
- You may be able to identify some aftermarket J-hook bolts by the threaded portion of the J-hook being longer than two (2) inches and/or the angle of the hook NOT being less than 90 degrees.
- The genuine Toyota nut has an integral washer.

Torque for nut :
4.9 N·m {50 kgf·cm, 43 in·lbf}
